CITY OF TALKEETNA
Matanuska Susitna Borough

**SEWER CONDITION ASSESSMENT
STUDY**

August 2024

Prepared By:
Stephl Engineering LLC
3900 Arctic Blvd., Suite 204
Anchorage, AK 99503
907.562.1468

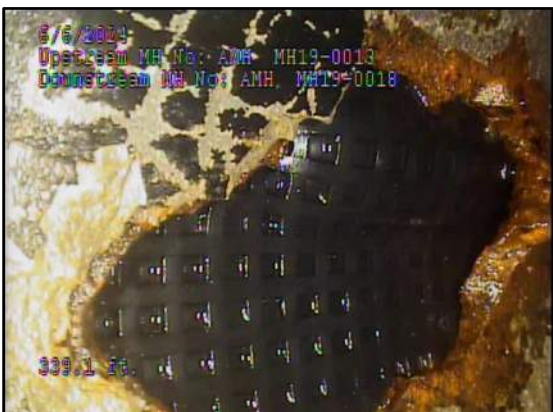
MH 19-0013 to MH 19-0018, defective repair patch with I&I coming through

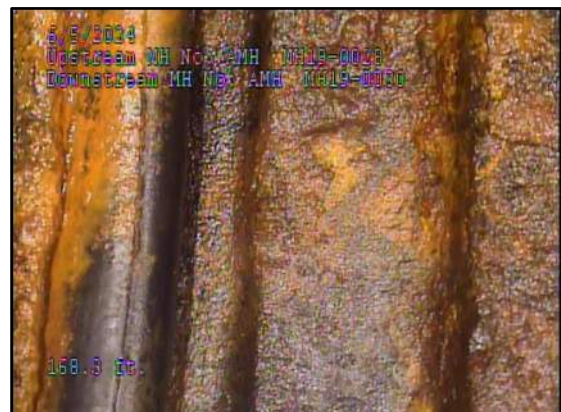
MH 19-0028 to MH 19-0030, large joint separation, gasket visible

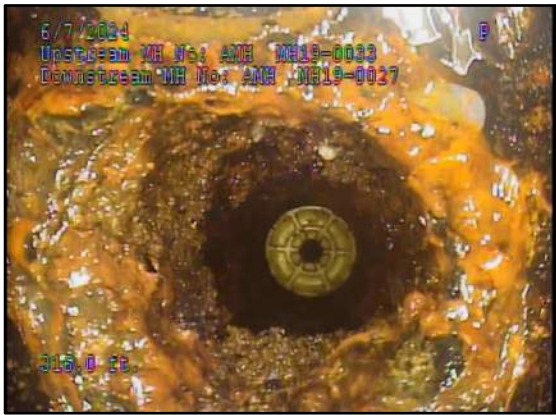
MH 19-0033 to MH 19-0027, Infiltration runner from capped service connection

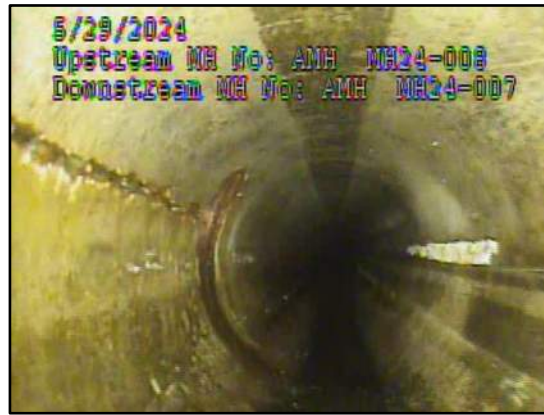
MH 24-008 to MH 24-007, longitudinal fracture and infiltration runner at tap connection

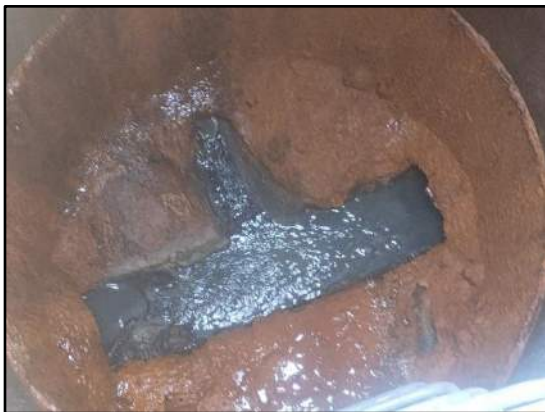
MH 19-0021, infiltration at cone-base joint

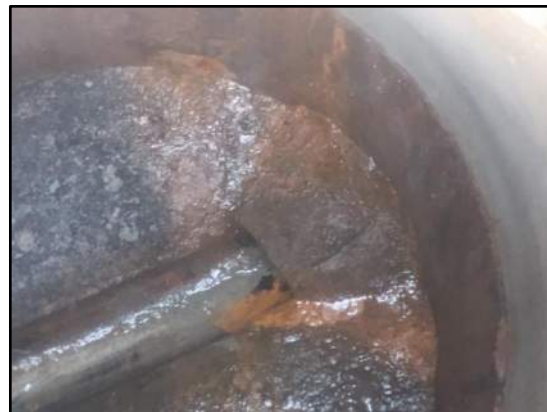
MH 19-0023, infiltration at North connection

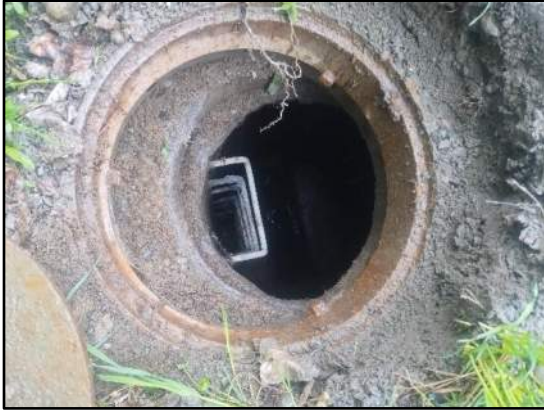
MH 19-0027, frame-chimney offset

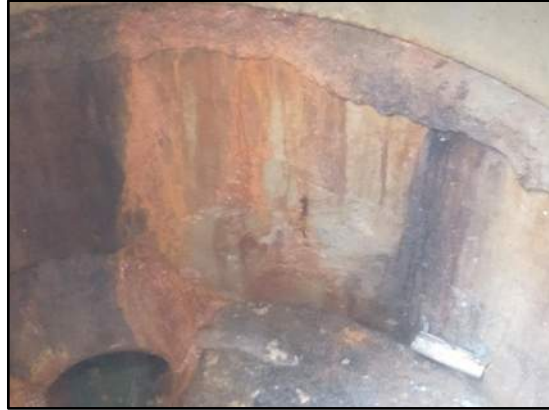
MH 19-0028, infiltration and offset

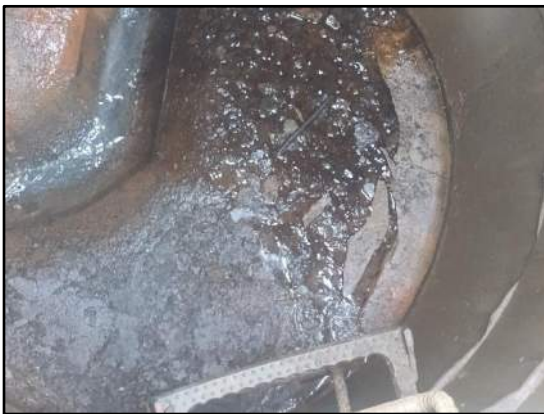
MH 19-0030, infiltration and eroding shelf

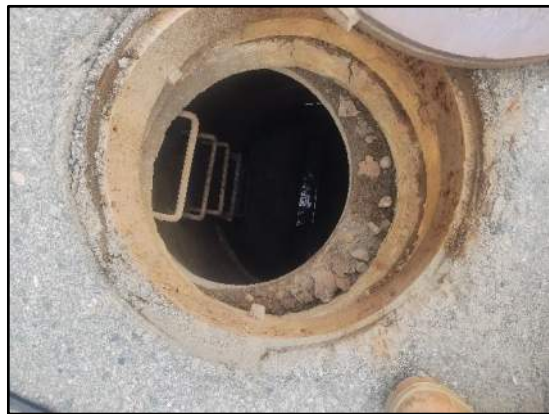
MH 19-0031, cone and chimney offset

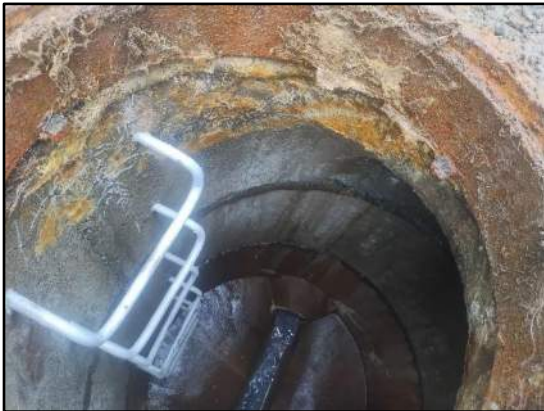
MH 24-0017, root growth along frame and cone

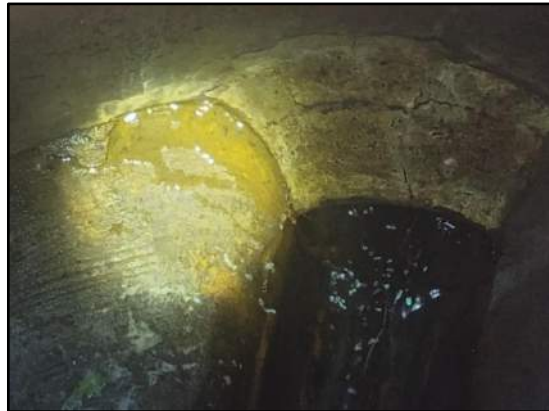
MH 25-003, infiltration at influent connection

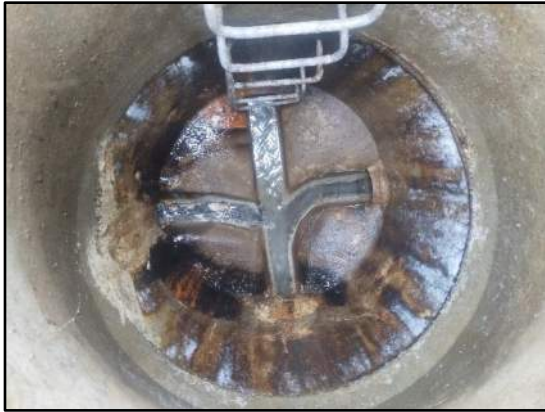
MH 25-004, infiltration and cracks in base

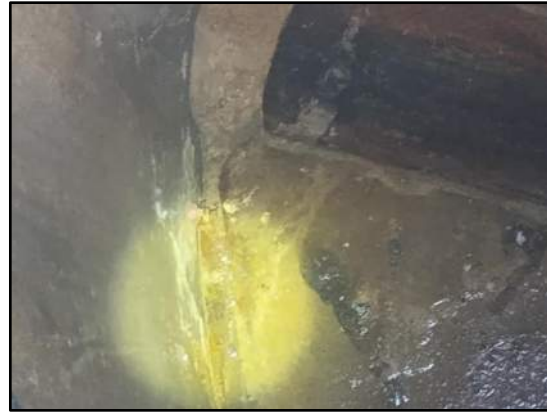
MH 25-010, infiltration from cracks in base

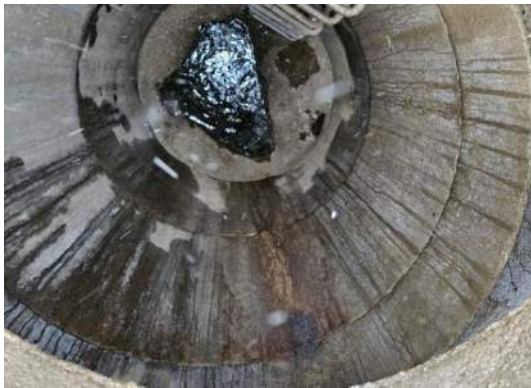
Seepage through joints was a common observation in the manholes experiencing I&I as seen in the images below. Without excavating, this issue can be solved by installing an internal joint seal band. Cretex Specialty Products is one manufacturer of this type of repair and can be seen in Image 2. The band is made of an elastic rubber with stainless steel expansion bands that form a compression seal over the joint. The elastic material allows the band to maintain the seal if the manhole should move and can be tightened and compressed in the future. A similar band can be installed in the chimney of a manhole to stop I&I through the grade rings or beneath the frame. The chimney seals and joint seals are estimated to cost up to \$1000 and \$2000 each, respectively.

I&I seeping through joints
