Appendix A
TALKEENTA SEWER FIGURES

Talkeetna Sewer Pipe Likelihood of Failure (LOF) Rating Map

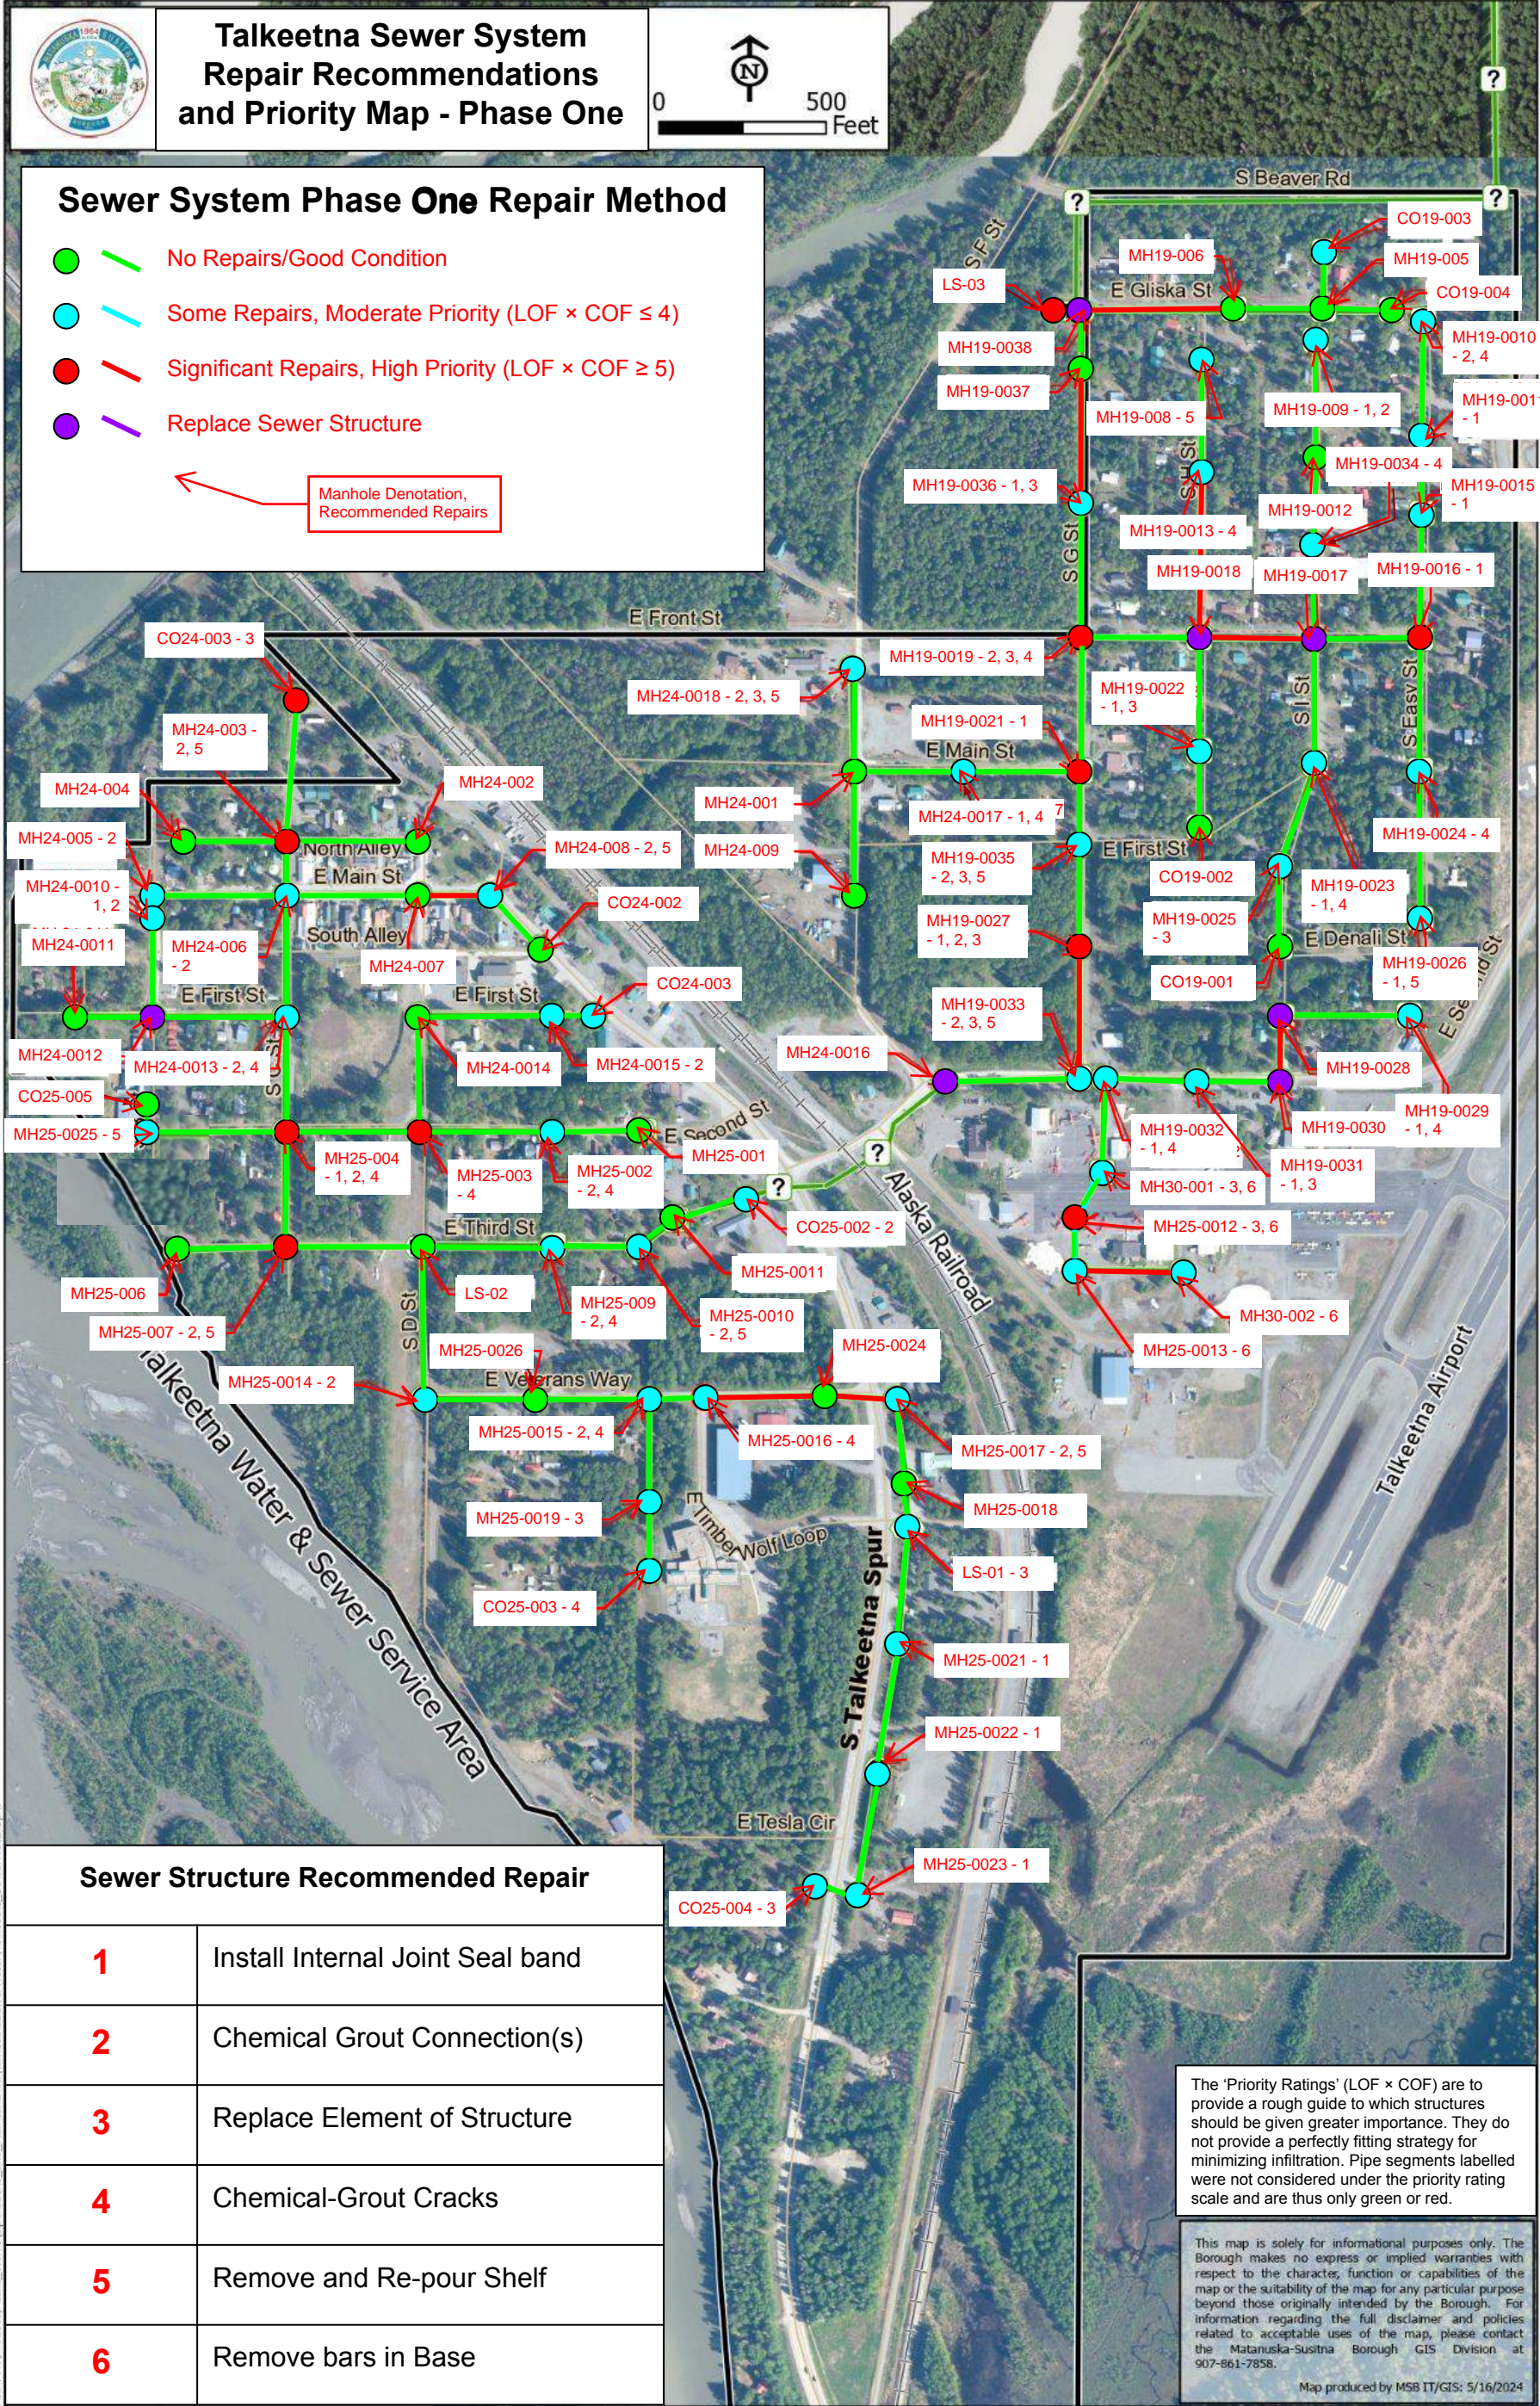
Talkeetna Sewer System Repair Recommendations and Priority Map - Phase One

The 'Priority Ratings' ($LOF \times COF$) are to provide a rough guide to which structures should be given greater importance. They do not provide a perfectly fitting strategy for minimizing infiltration. Pipe segments labelled were not considered under the priority rating scale and are thus only green or red.

1	Install Internal Joint Seal band
2	Chemical Grout Connection(s)
3	Replace Element of Structure
4	Chemical-Grout Cracks
5	Remove and Re-pour Shelf
6	Remove bars in Base
