Appendix B
CCTV SUMMARY AND REPAIR RECOMMENDATIONS

Sewer Main Inspection with Pipe-Run Graph

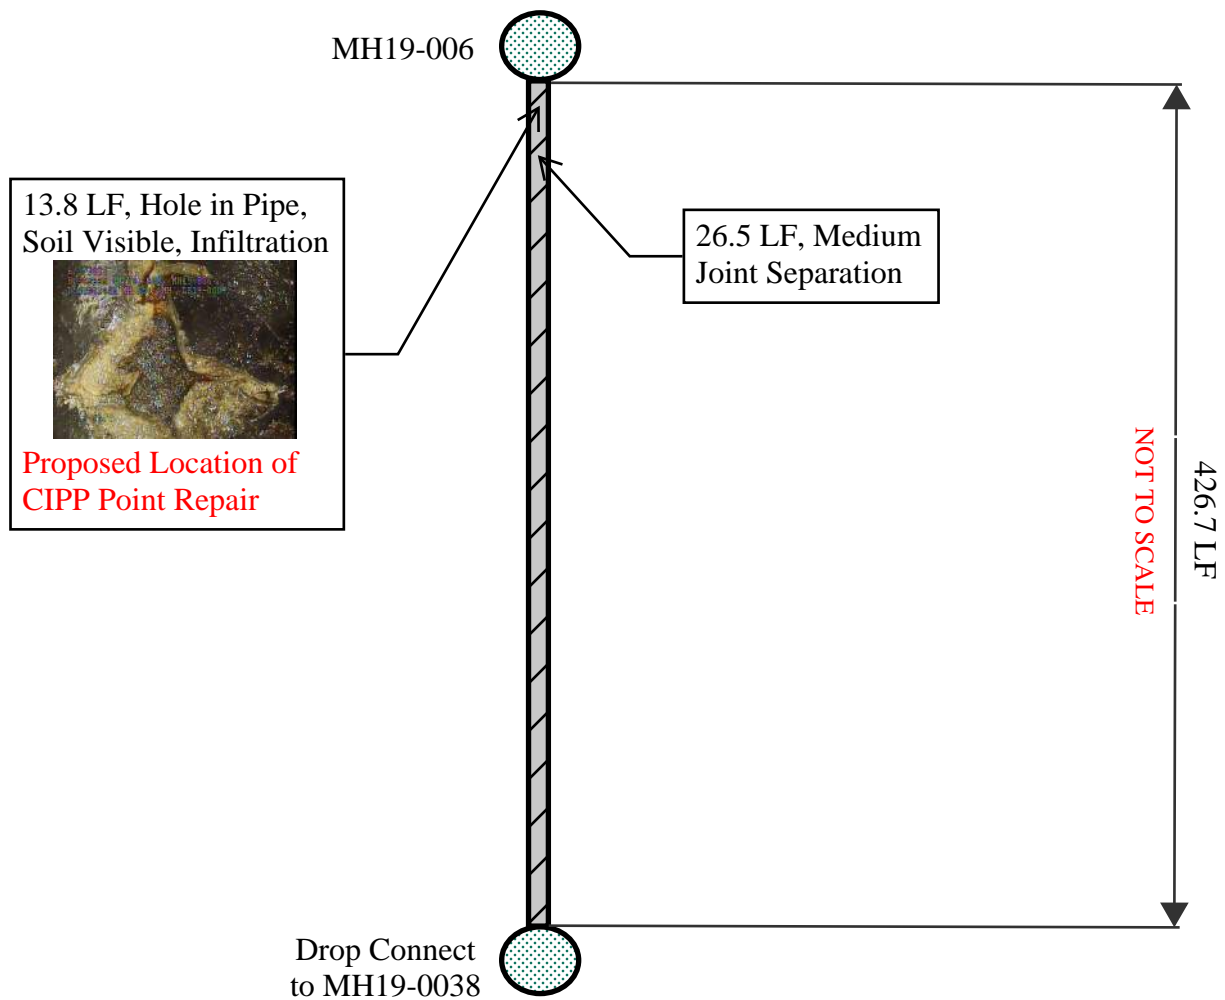
MH19-006	MH19-0038	E Gliska St	8	DIP	Yes	6/7/2024	426	Downstream	1	2	1	<ul style="list-style-type: none"> -9.6 LF, TF at 2:00 position, mineralized -13.8 LF, approx. 3" HSI/SAP section at 12:00 position -13.8 LF, IWB from hole at 12:00 position -18.9 LF, SAM at 4:00 position -26.5 LF, JSM along circumference -27.4 to 31.4 LF, SAM from 5:00 to 7:00 position -38.1 LF, SAM at 9:00 position -57.6 LF, SAM at 4:00 position -177.7 LF, 4" TF at 10:00 position, large DAGS build-up in pipe and around connection -188.5 LF, 4" TFA at 2:00 position -218.4 LF, 4" TF at 2:00 position -266.4 LF, 4" TF at 10:00 position -286.8 LF, SAM at 3:00 position -300.7 LF, SAM at 9:00 position -374.6 LF, 4" TFA at 2:00 position, mineralized -413.0 LF, SAM at 10:00 position -421.9 to 426.7 LF, SAM from 5:00 to 7:00 -426.7 LF, AMH drop connect to 19-0035

CIPP Point Repair at 13.8 LF from MH19-006	
MH19-008	MH19-0013	S H St	8	DIP	Yes	6/6/2024	416	Upstream	1	2	1	<ul style="list-style-type: none"> -17.6 LF, CC from 7:00 to 11:00 near/across joint -54.1 LF, SAM at 9:00 position along joint -62.1 LF, 4" TFD at 10:00, 0.5" offset along bottom of connection, SAM at connection, mineralized, possible IDC -11.5 LF, SAM at 6:00 in pipe invert -113.8 LF, SAM at 4:00 position -125.0 LF, 4" TF at 2:00 position, highly mineralized -126.9 LF, 4" TFD at 9:00, 0.5" offset along bottom of connection, standing water accumulated -166.1 LF, SAM at 5:00 position -208.8 LF, 4" TFA at 1:00, highly mineralized -214.1 LF, 4" TFA at 10:00, mineralized, slightly offset, possible IDC -218.8 LF, CC from 12:00 to 5:00 adjacent to pipe joint -224.0 to 233.2 LF, SAM at 7:00 position -283.9 LF, 4" TF at 9:00 position, slight separation at connection -288.3 LF, 4" TFA at 11:00 position -302.4 LF, SAM at 7:00 position -367.1 LF, 4" TF at 12:00 position, highly mineralized -381.0 LF, 4" TFA at 3:00 position -409.1 LF, 4" TF at 2:00, SAM directly below connection -412.0 LF, TFA at 10:00 position, mineralized -416.1 LF, AMH 19-008, AEP 	Respect pipe every 10 years

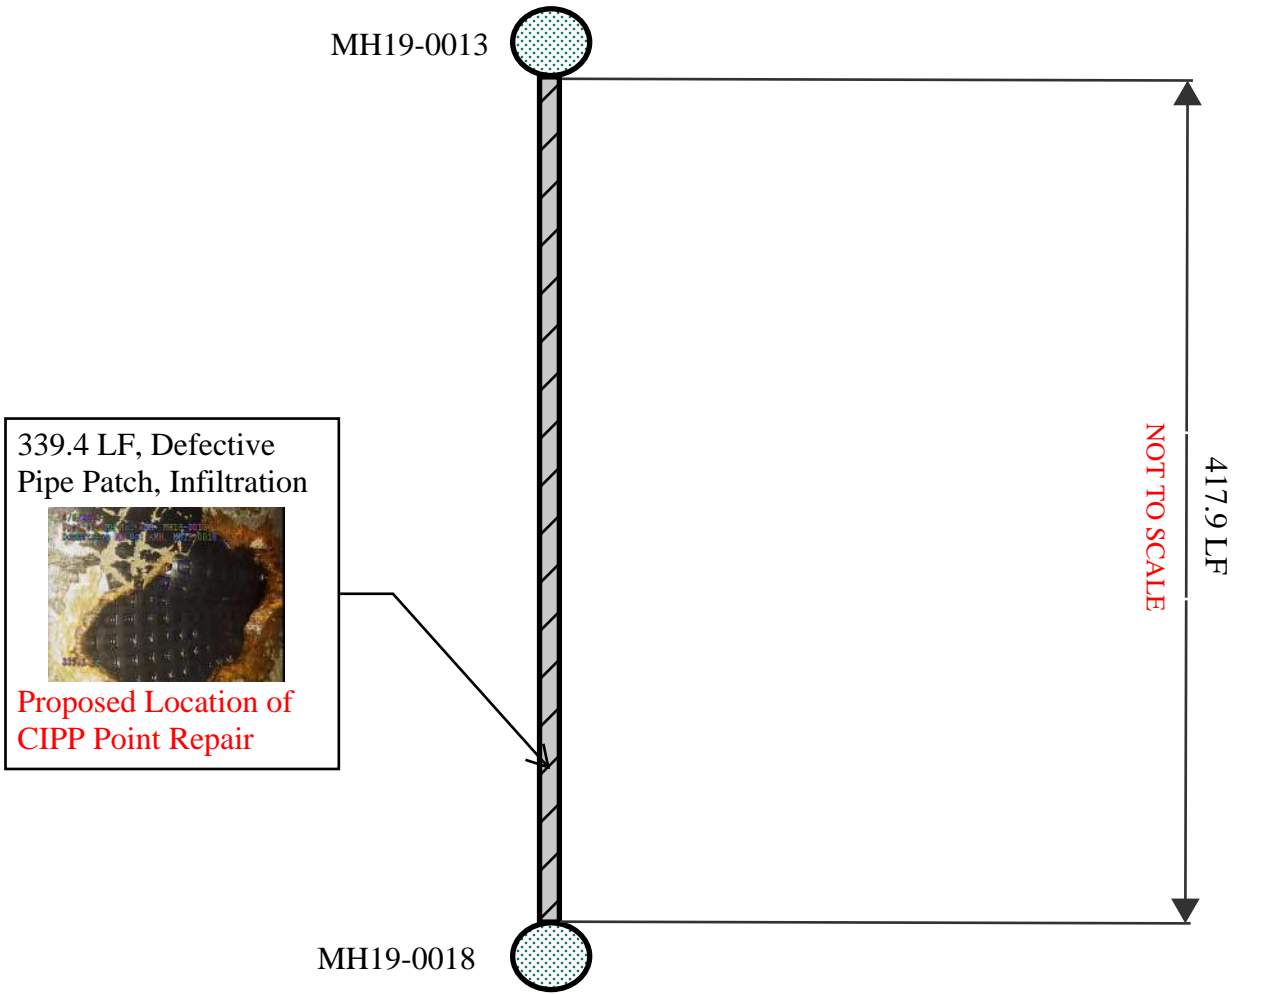
Upstream Structure: MH19-0013	Downstream Structure: MH19-0018	Direction of Survey: Downstream	Length Surveyed: 418 LF
---	---	---	-----------------------------------

MH19-0013	MH19-0018	S H St	8	DIP	Yes	6/6/2024	418	Downstream	<1	2	1	-4.0 LF, 4" TF at 1:00 position, mineralized -32.5 LF, SAM at 7:00 position -40.3 LF, 4" TF at 10:00 position, slight offset, mineralized, possible IWC -75.6 LF, 4" TF at 11:00 position, mineralized, SAM around connection -116.9 LF, 4" TF at 2:00 position, SAM around connection -142.8 LF, SAM at 7:00 position -229.8 LF, 4" TF at 2:00 position, mineralized -250.7 to 252.1 LF, SAM at 6:00 position in invert -254.7 LF, 4" TF at 10:00 position, mineralized, slight offset -289.1 LF, SAM at 5:00 position -331.5 LF, 4" TF at 10:00 position, slight offset, standing water in connection -339.4 LF, RPPD at 12:00 position, 6" patch appears to still have IDB coming through -380.8 LF, SAM from 6:00 to 9:00 along joint edge -399.1 LF, SAM from 5:00 to 8:00 along joint edge -417.9 LF, AMH drop connect to 19-0018

CIPP Point Repair 78.5 LF from MH19-0018

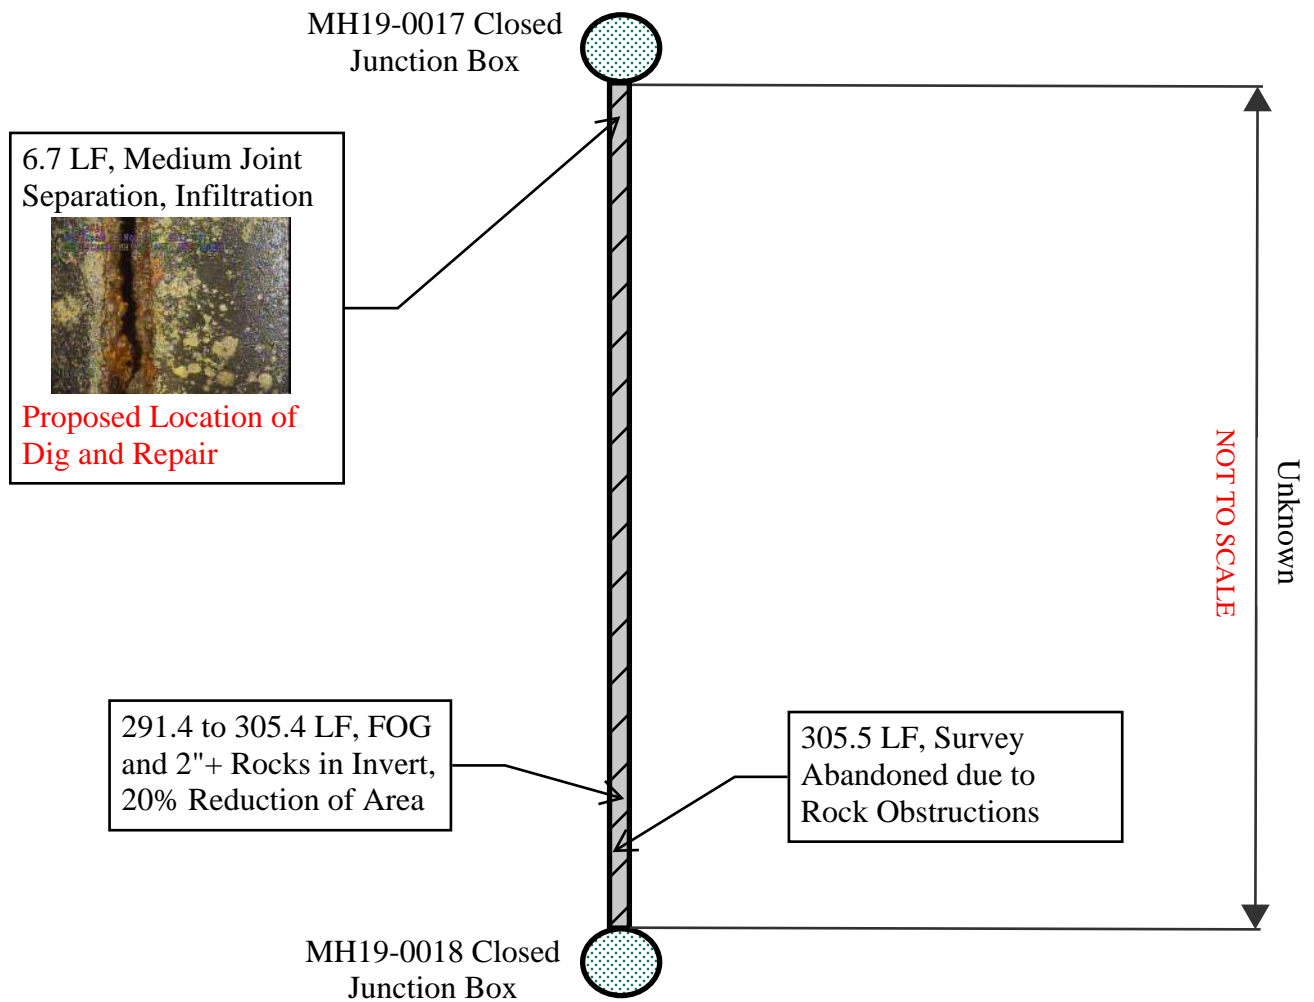
MH19-0017	MH19-0018	E Front St	8	DIP	No	6/4/2024	Unknown	Downstream	2	2	2	-6.7 LF, JSM, significant mineralization, IWJ likely -38.0 to 291.4 LF, sustained DAGS build up at 5:00 and 7:00, 5-15% reduction in area -205.7 to 208.1 LF, SAM at 4:00 to 5:00 position -251.3 LF, JSS, moderate mineralization and DAGS -291.4 to 305.4 LF, 2" DSC/DAGS along invert of pipe, 20% reduction in area -305.5 LF, OBR obstructing camera and damming invert -305.5 LF, MSA due to OBR

CIPP Point Repair 6.7 LF from MH19-0017
MH19-0018	MH19-0019	E Front St	8	DIP	Yes	6/8/2024	370	Upstream	2	1	2	- Inspection of invert is difficult with high flows present -25.9 LF, JSM, significant mineralization -202.1 LF, JSS, moderate mineralization -249.8 LF, 4" TF at 2:00 position -283.3 LF, SAM at 6:00 position -358.1 LF, SAM at 8:00 and 4:00 - 5:00 -369.6 LF, AJB in MH19-0018, highly mineralized inside with 2 IDC cases along top of sealed junction box	Reinspect pipe every 10 years

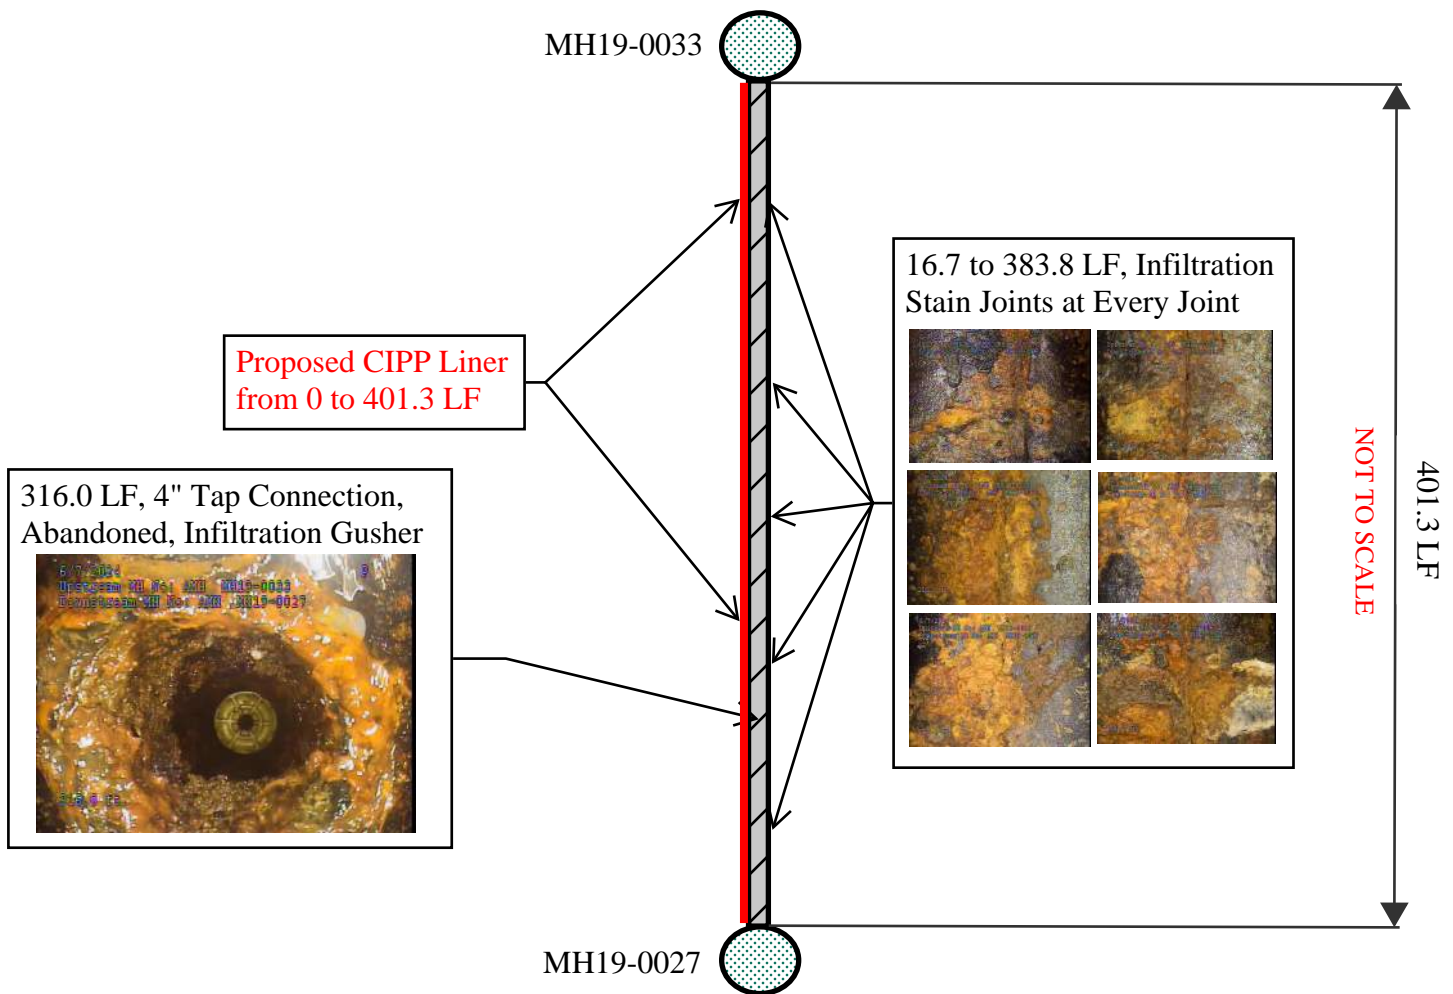
Talkeetna Sewer System Pipe Summary Table				General Condition Grade Score Values: 1=No or Minor Defect, 2=Minor to moderate Defect, 3=Moderate defect, 4=Significant defect, 5=Most significant defect										
Upstream Structure No.	Downstream Structure No.	Location	Pipe Dia. (in.)	Material	CCTV Complete	Inspection Date	Inspection Length (ft)	Inspection Direction	Flow Depth (in.)	Likelihood of Failure (LOF)	Consequence of Failure (COF)	General Comments (See Pipe Logs for Highlighted Pipe's Summaries)	Photos of Damage to be Repaired	
MH19-0033	MH19-0027	S G St	12	DIP	Yes	6/7/2024	401	Downstream	3	2	2	<ul style="list-style-type: none"> -16.7 LF, ISJ from 8:00 to 4:00 -53.5 LF, ISJ from 8:00 to 4:00, SAM at 9:00 position -71.9 LF, ISJ from 8:00 to 4:00 -95.7 LF, 4" TFB at 12:00 position, heavily mineralized -145.4 LF, ISJ from 8:00 to 4:00 -163.7 LF, ISJ from 8:00 to 4:00 -182.1 LF, ISJ from 8:00 to 4:00 -200.5 LF, ISJ from 8:00 to 4:00 -218.9 LF, ISJ from 8:00 to 4:00 -237.2 LF, ISJ from 8:00 to 4:00 -255.4 LF, ISJ from 8:00 to 4:00 -273.7 LF, ISJ from 8:00 to 4:00 -292.3 LF, ISJ from 8:00 to 4:00 -310.5 LF, ISJ from 8:00 to 4:00 -316.0 LF, 4" TFC, highly mineralized, actively flowing IRC from connection -328.8 LF, ISJ from 8:00 to 4:00 -347.1 LF, ISJ from 8:00 to 4:00 -365.5 LF, ISJ from 8:00 to 4:00 -383.8 LF, ISJ from 8:00 to 4:00 -401.3 LF, AMH 19-0027

CIPP Liner for Entire Length, not cutting out Service Connection that is 85 LF from MH19-0027

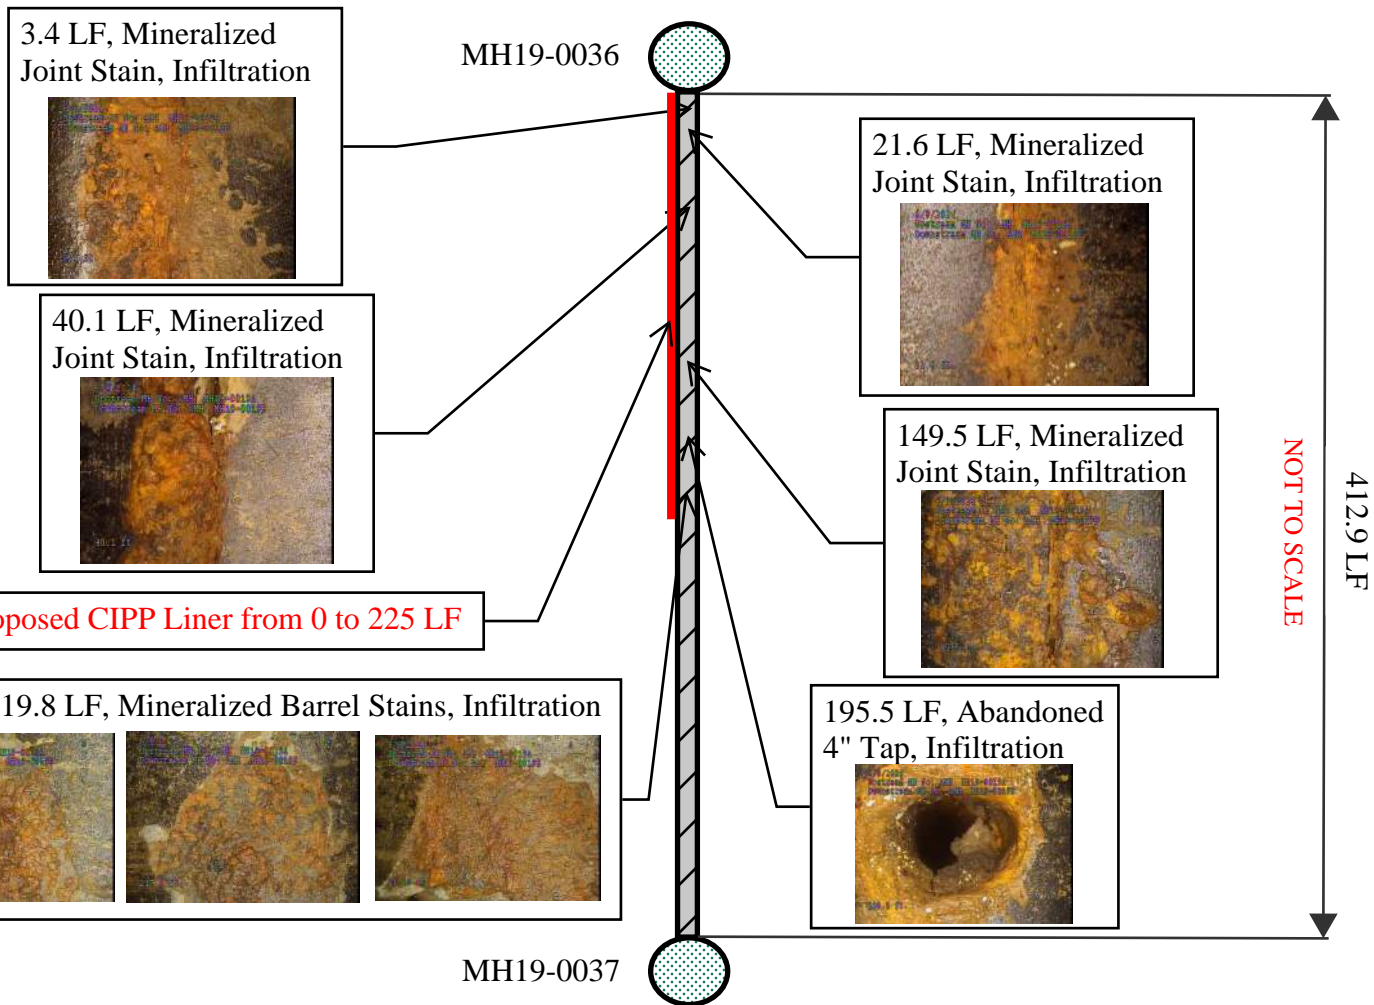
MH19-0019	MH19-0036	S G St	12	DIP	Yes	6/8/2024	400	Downstream	3	1	2	- Pulses of high flow do not allow proper camera inspection for intervals throughout video -60.1 LF, ISJ from 8:00 to 4:00 -102.8 LF, 4" TFC, mineralized -133.2 LF, ISJ from 8:00 to 4:00 -188.3 LF, ISJ from 8:00 to 4:00, SAM at 3:00 -206.7 LF, ISJ from 8:00 to 4:00 -267.7 LF, 4" TFB at 12:00, DAE covering almost entire pipe, extremely mineralized, 80% reduction in area -298.2 LF, ISJ from 10:00 to 2:00 -388.8 LF, SAM at 9:00 position, mineralized -399.9 LF, AMH 19-0019A	Reinspect pipe every 10 years
MH19-0036	MH19-0037	S G St	12	DIP	Yes	6/8/2024	413	Downstream	3	2	2	- Invert difficult to inspect due to high flow rates -3.4 LF, ISJ from 8:00 to 4:00, extremely mineralized -21.6 LF, ISJ from 8:00 to 4:00, extremely mineralized -40.1 LF, ISJ from 8:00 to 4:00, extremely mineralized -41.6 LF, 4" TFC at 12:00, IDC from service pipe -94.6 LF, JSS with ISJ from 8:00 to 4:00 -110.4 LF, SAM at 9:00 -149.5 LF, ISJ from 8:00 to 4:00, extremely mineralized -170.9 LF, 4" TF at 1:00, mineralized, SAM around connection, possible IWC -195.5 LF, 4" TFB at 12:00, DAE present in service, 50% reduction in area, extremely mineralized, IWCs likely -215.9 LF, SAM and ISB from 11:00 to 1:00 -217.8 LF, SAM and ISB from 10:00 to 11:00 -219.8 LF, SAM and ISB from 10:00 to 12:00 -353.0 LF, 4" TF at 12:00 position, mineralized -412.9 LF, AMH 19-0019B, DAGS build-up along transition from pipe to shelf in MH

CIPP Pipe from 0 to 225 LF to Seal from Infiltration/Barrel Stains

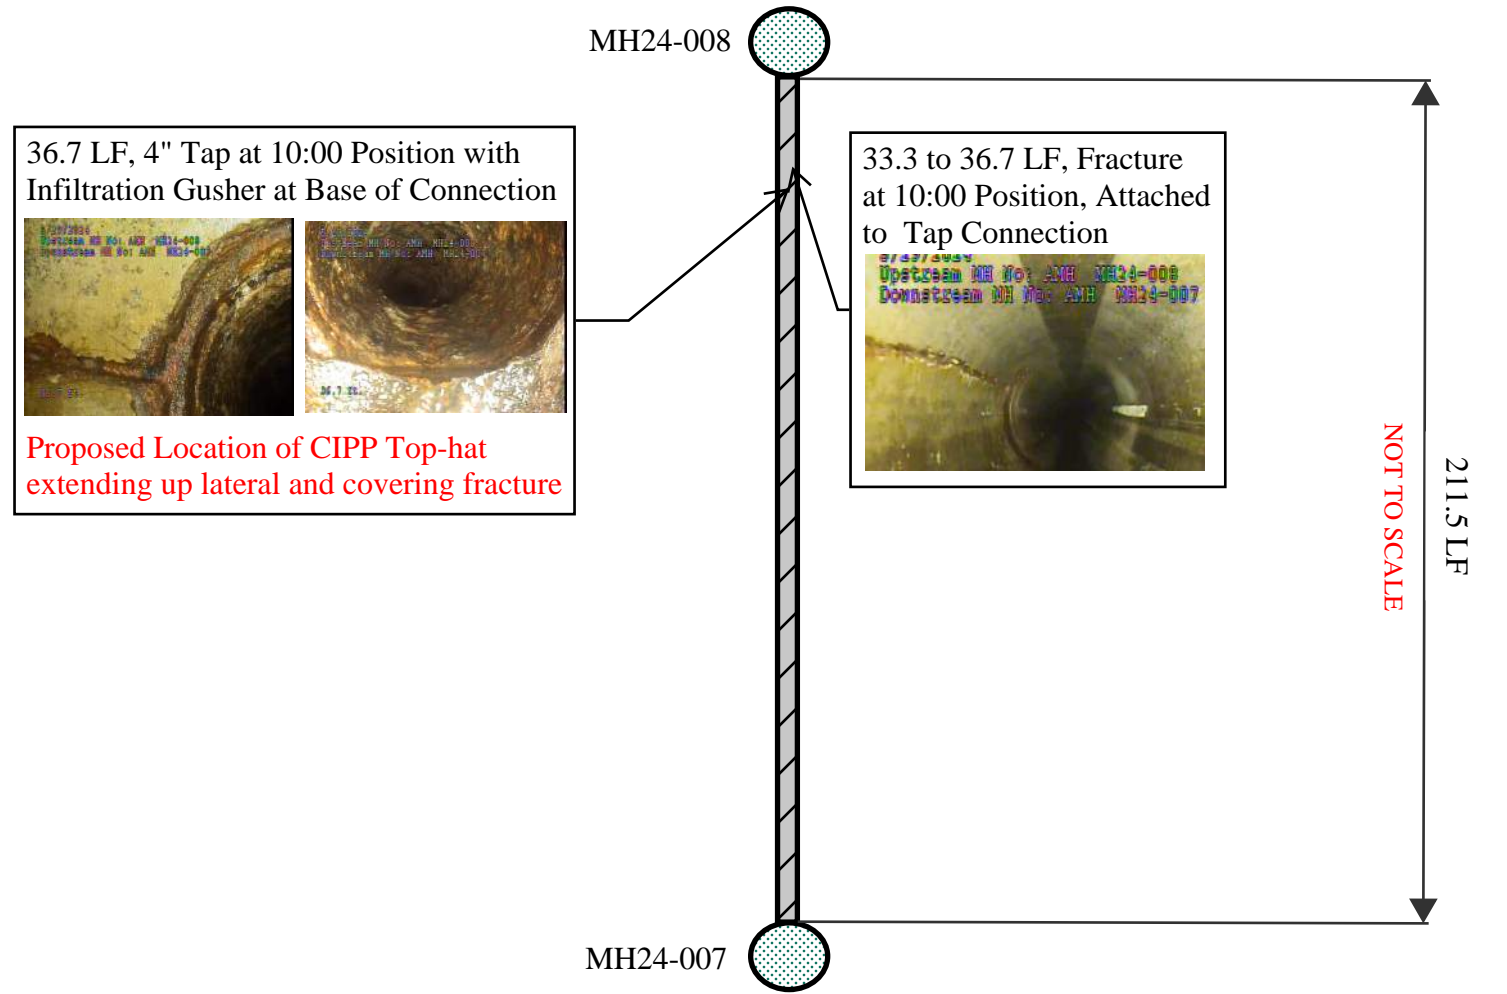
MH24-008	MH24-007	E Main St	8	DIP	Yes	5/29/2024	212	Downstream	1	2	2	<ul style="list-style-type: none"> -33.3 to 36.9 LF, FL at 10:00 position, attached to TF connection -36.7 LF, 4" TFA at 10:00 position, SAM around connection, possible IRC -92.3 LF, 4" TFA at 10:00 position, mineralized -98.6 LF, 4" TF at 2:00 position, mineralized -102.1 LF, SAM from 4:00 to 8:00 along joint -119.4 LF, 4" TF at 10:00 position -165.4 LF, 4" TFA at 10:00 position -175.5 LF, SAM from 5:00 to 7:00 -197.8 LF, SAM from 3:00 to 5:00, possible IWB -211.5 LF, AMH 24-007

<p>CIPP T-Liner tophat over service connection at 36.7 LF from MH24-008, w/ at least 3 ft mainline sleeve to cover fracture</p>
MH24-009	MH24-001	S F St	8	DIP	Yes	6/3/2024	383	Downstream	1	1	1	<ul style="list-style-type: none"> -10.5 to 15.1 LF, interspersed DAE from 2:00 to 5:00, 5% reduction in area -53.4 to 61.0 LF, 1" DSF along invert at 6:00 -94.8 LF, SAM from 2:00 to 5:00 along joint -124.2 LF, 4" TF at 11:00 position -216.8 LF, 4" TF at 2:00 position -260.8 LF, JSM -278.5 LF, JSM -316.5 LF, JSM -347.9 LF, 4" TF at 2:00 position, SAM around connection -353.7 LF, JSM -383.0 LF, AMH 24-009 	Respect pipe every 10 years

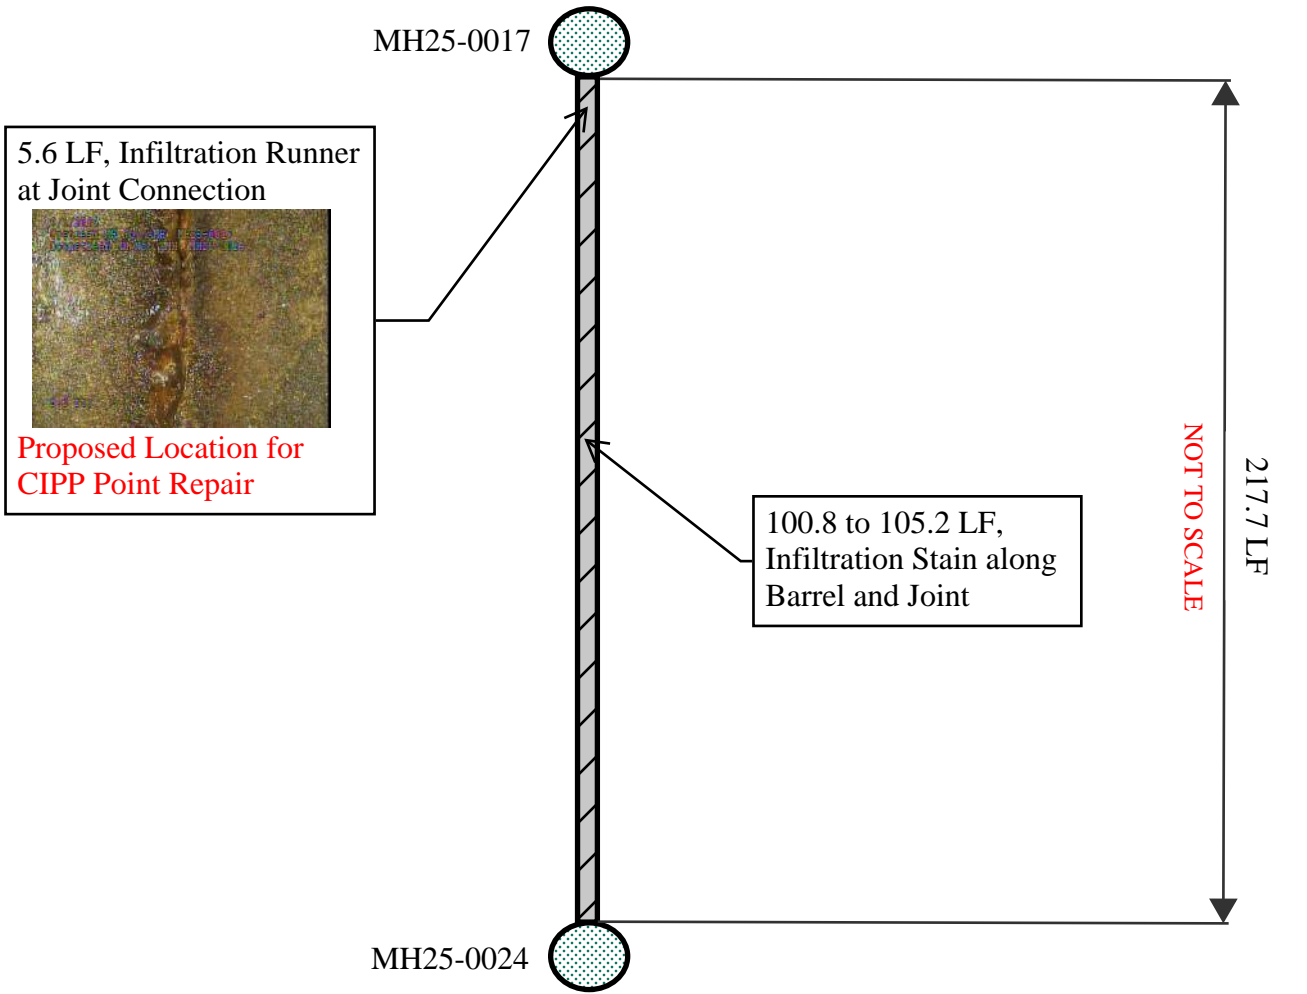
Upstream Structure: MH25-0017	Downstream Structure: MH25-0024	Direction of Survey: Downstream	Length Surveyed: 218 LF
---	---	---	-----------------------------------

MH25-0012	MH30-001	Talkeetna Airport	8	DIP	Yes	6/2/2024	147	Downstream	1	2	3	- 16.0 LF, JSM, mineralization - 34.4 LF, JSM, mineralization - 71.6 LF, JSM, little/no mineralization - 90.1 LF, JSM, mineralization - 112.0 to 112.8 LF, SAM at 5:00 position - 127.0 LF, JSM, mineralization - 147.1 LF, AMH 25-001	Pipe is high-risk, but there are no signs of failure. The joint separation should be monitored and reinspected every 5 years	
MH25-0013	MH25-0012	Talkeetna Airport	8	DIP	Yes	6/2/2024	159	Downstream	1	2	2	- 2.0 to 10.3 LF, LFDC from 5:00 to 7:00 - 47.0 LF, JSM, mineralization - 91.3 LF, 4" TF at 9:00 position - 102.3 LF, JSM - 121.7 to 147.5 LF, 2-3" DSF in invert, 6:00 position - 139.1 LF, JSM, mineralization - 158.7 LF, AMH 30-012	Respect pipe every 10 years	
MH25-0017	MH25-0024	E Veterans Way	8	DIP	Yes	6/1/2024	218	Downstream	<1	2	3	- 5.6 LF, IRJ at 11:00 to 1:00, mineralized - 8.4 LF, 4" TF at 2:00 position - 100.8 to 105.1 LF, ISJ from 3:00 to 9:00 position - 105.2 LF, ISJ from 8:00 to 4:00 - 154.8 to 156.9 LF, SAM interspersed from 5:00 to 7:00 - 215.9 LF, JSM with ISJ from 8:00 to 4:00 - 217.7 LF, AMH 24-0024

- CIPP point repair 5.6 ft from MH25-0017

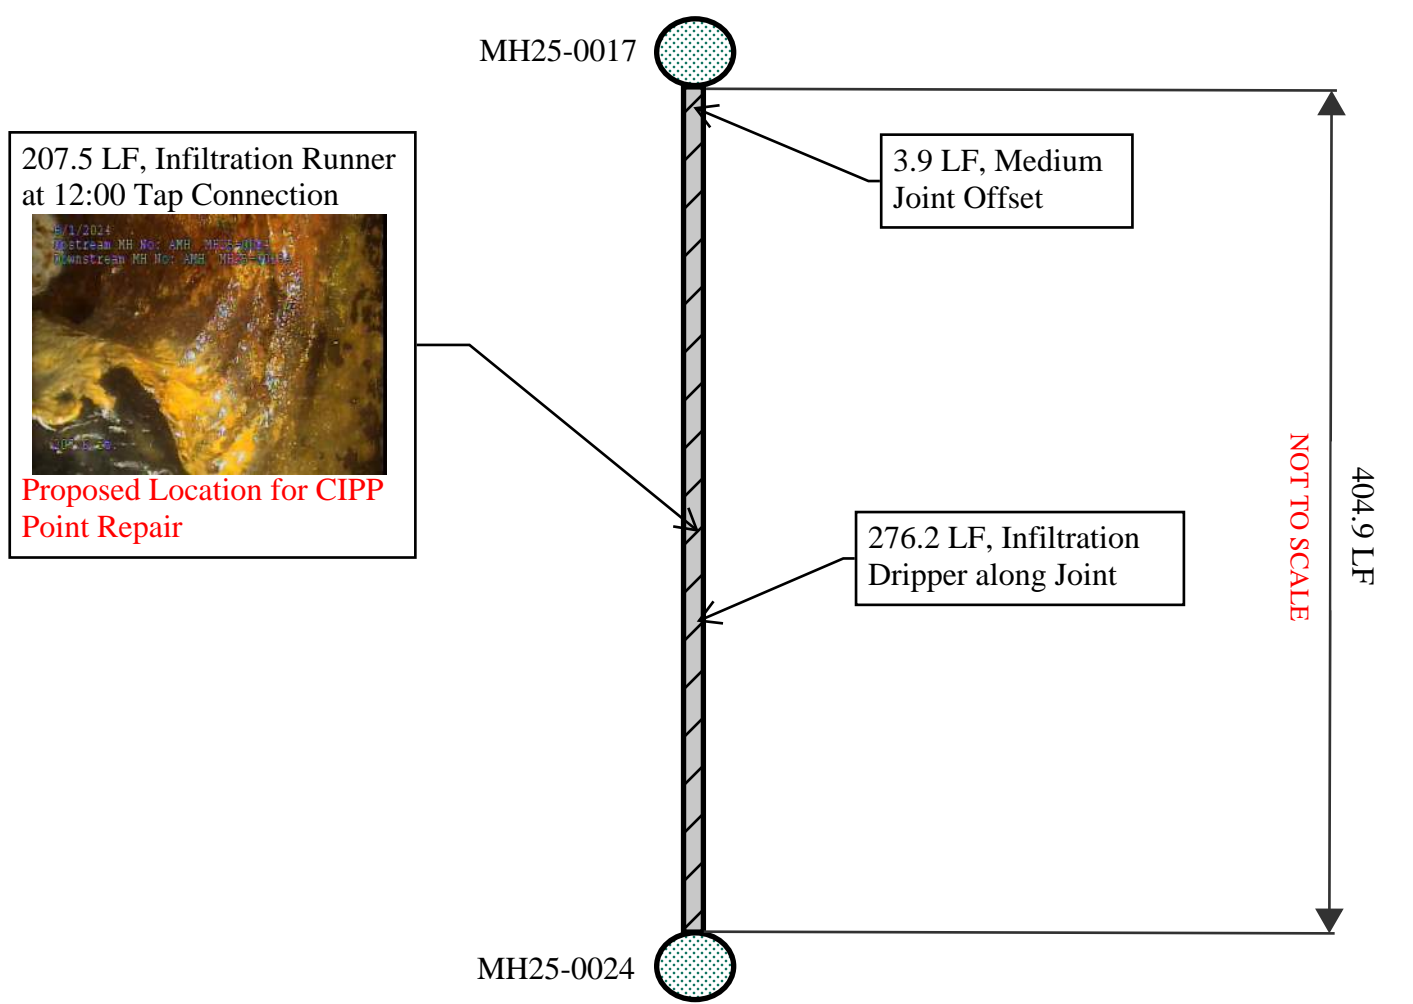
MH25-0024	MH25-0016	E Veterans Way	8	DIP	Yes	6/1/2024	405	Downstream	<1	2	1	- 3.9 LF, JOM - 8.6 LF, SAM at 3:00 position - 98.6 LF, SAM at 3:00 position - 148.0 to 161.0 LF, SAM at 3:00 position - 165.5 LF, ISJ from 9:00 to 3:00 - 203.6 LF, 4" TFA at 12:00 position, possible infiltration - 207.5 LF, 4" TFA at 12:00 position, leaking at connection, IRC - 257.9 LF, ISJ from 9:00 to 3:00 - 257.9 to 403.7 LF, SAM interspersed from 3:00 to 7:00 - 276.2 LF, IDJ at 11:00 position, mineralized - 344.6 LF, SAM at 9:00 position - 372.2 LF, SAM at 3:00 position - 277.8 LF, SAM at 5:00 position - 385.3 LF, SAM at 2:00 position, mineralized, possible infiltration - 404.9 LF, AMH 25-016

CIPP T-Liner Tophat at service connection 207.5 LF Downstream

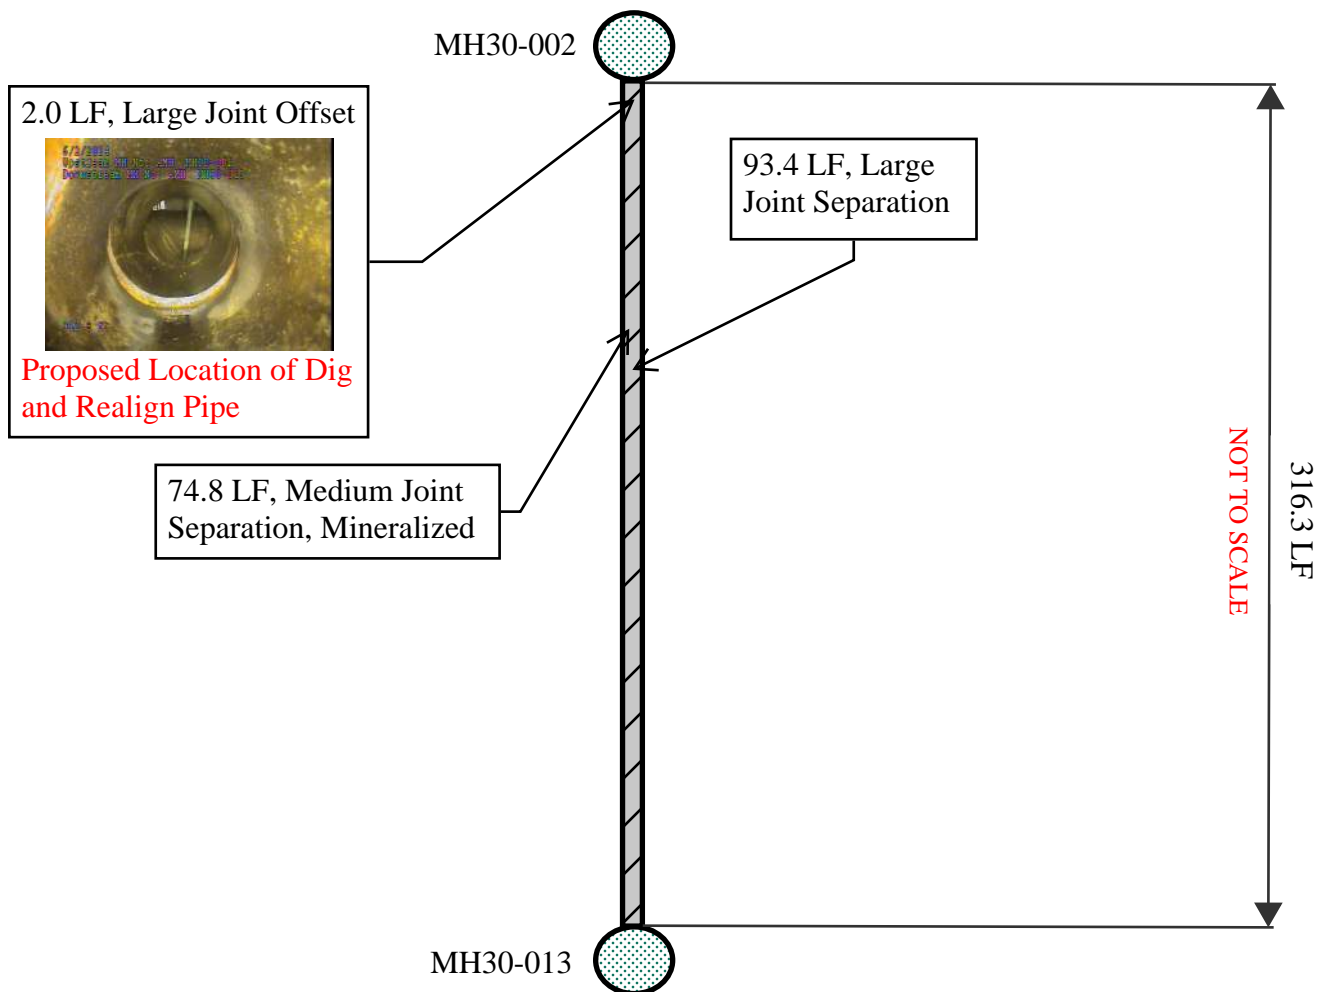
MH30-002	MH25-0013	Talkeetna Airport	8	DIP	Yes	6/2/2024	316	Upstream	<1	2	1	<ul style="list-style-type: none"> - 37.7 LF, SAM at 8:00 position, along joint - 56.4 LF, JSM, little/no mineralization - 93.6 LF, JSS, mineralization - 112.1 LF, JSM, little/no mineralization - 116.7 LF, 4" TFA at 10:00 position, mineralized - 149.1 LF, JSM, mineralization - 162.4 LF, 4" TF at 12:00 position - 167.6 LF, JSS - 174.3 LF, SAM at 5:00 position - 222.9 LF, JSL, little/no mineralization - 241.5 LF, JSM, mineralization - 246.8 LF, 4" TF at 10:00, mineralized, SAM around connection - 278.5 LF, JSM - 296.9 LF, JSM - 313.8 LF, 4" TF at 10:00 position - 314.3 LF, JOL, mineralization visible at offset - 316.3 LF, AMH 30-002

<p>Excavate and realign pipe connection 2 LF from MH30-002</p>
