Appendix C
MANHOLE SUMMARY AND REPAIR RECOMMENDATIONS

Talkeetna Sewer Condition Assessment

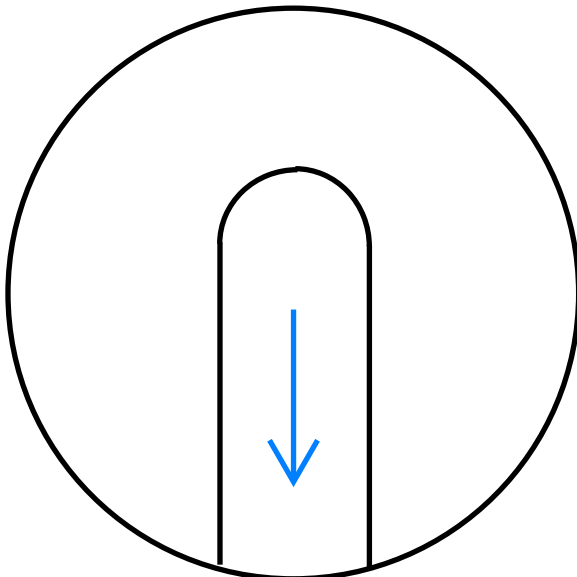
- Minor Hazard: the city's drinking water wells are within 200 ft of cleanout
- Cleanout does not have cover should it back up

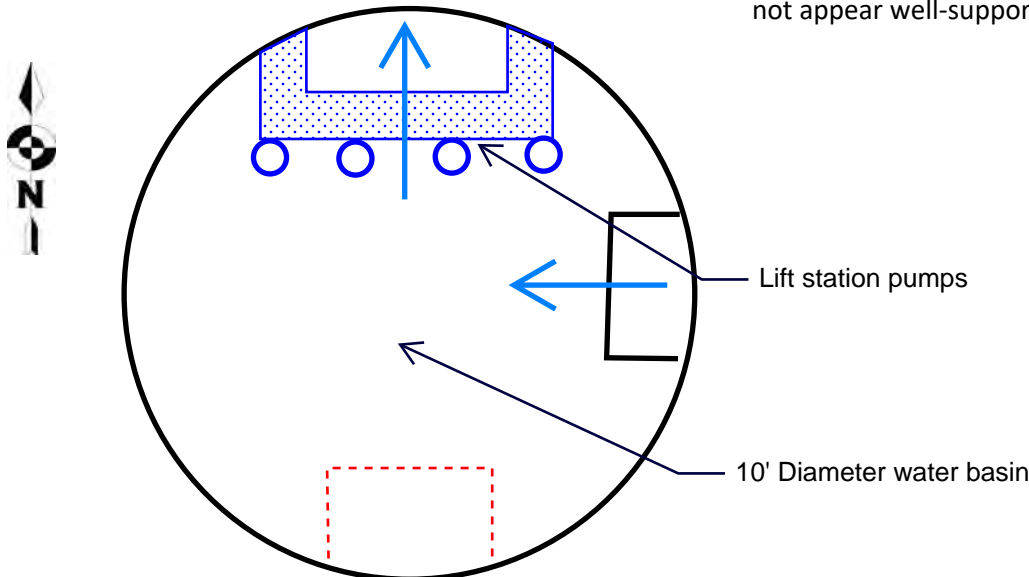
- Frawner was able to powerwash structure, but unable to vacuum it due to a closed roof
- Base of Lift Station widens out to approximately 10 ft diameter basin
- 2 grout repair sections in top barrel section, both appear solid
- No obvious I&I, nor heavy mineralization
- Biggest Concern: 1 ton winch's Metal I-Beam does not appear well-supported, hazardous to load to WLL

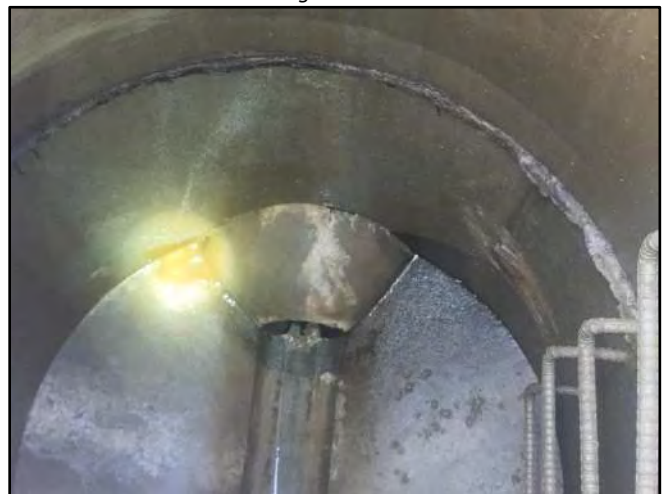
Image 5 – I&I runner along West Side, Crack

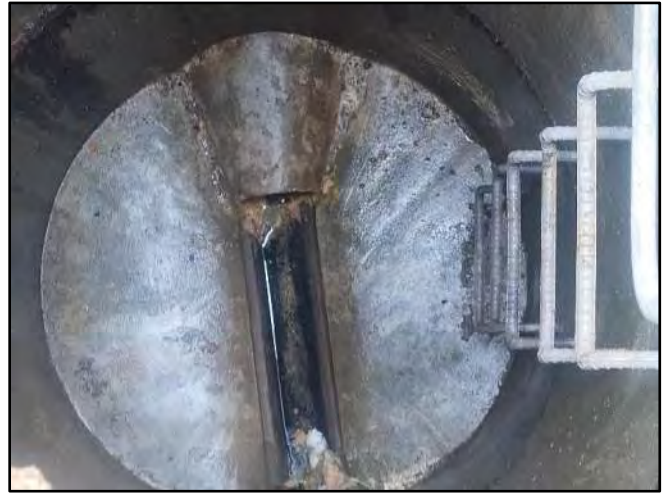
Image 3 – Chimney Cracking

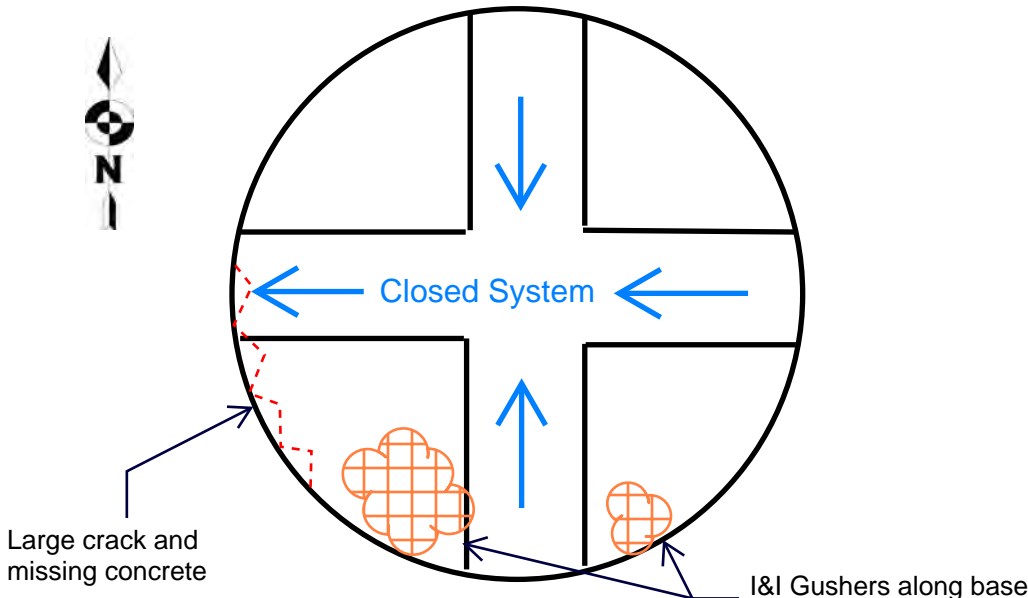
- All pipes are closed & sealed within manhole, no pipe's interior is visible
- Extremely heavy I&I with multiple gushers present along South and West portion of base
- Base is very corroded, likely experiences freeze/thaw damage as ice was present upon opening
- Unclear whether I&I enters the sealed pipes

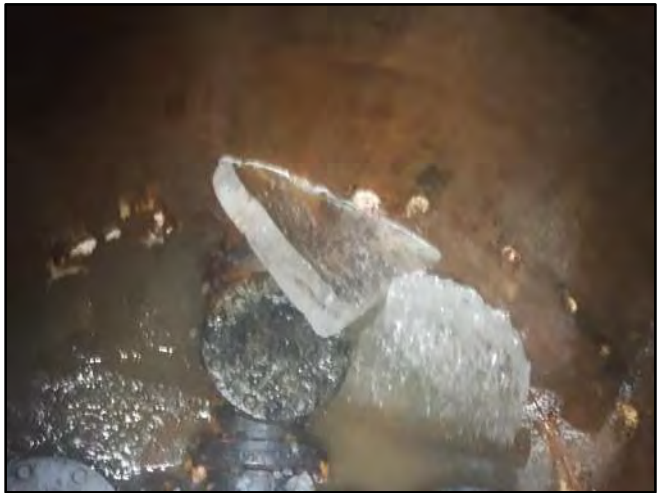
Image 3 – South Connection with Large Cracks and Heavy I&I

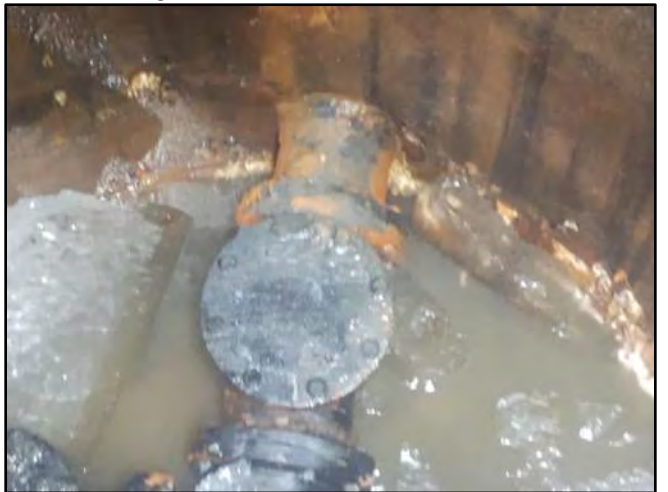
Image 6 – West Connection, Large Cracks

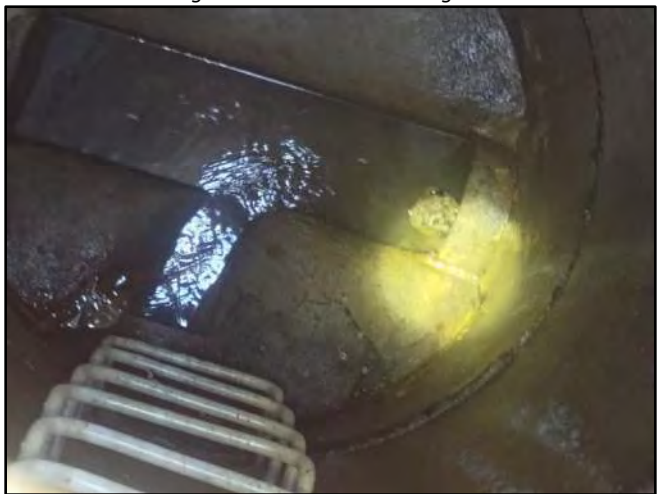
Image 5 – I&I Runner along East Portion of Base

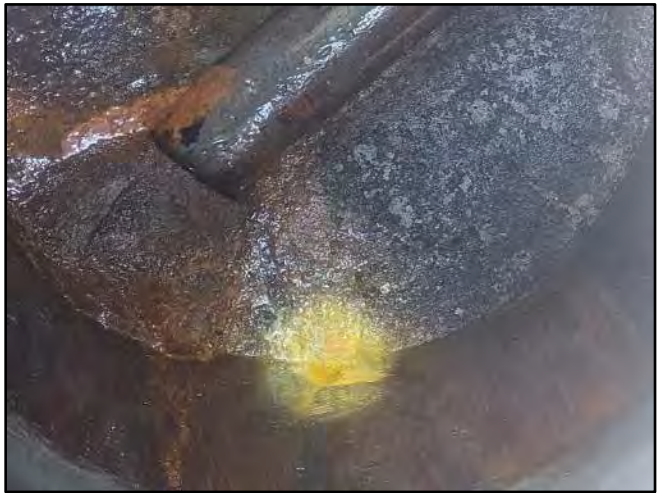
Image 4 – Missing Concrete and Dripper

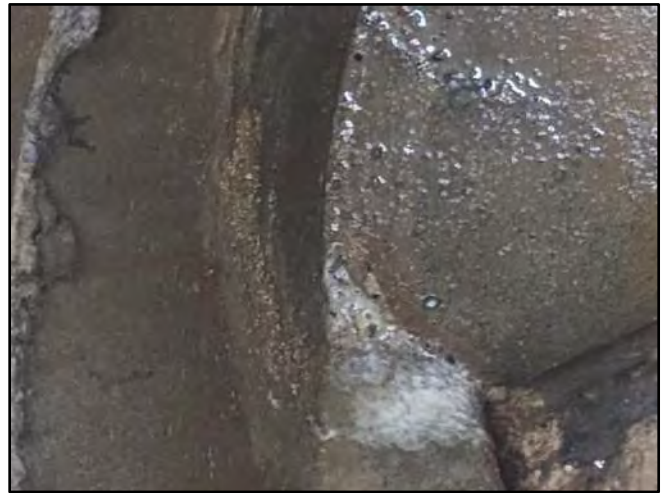
Image 3 – Crack along West side of base

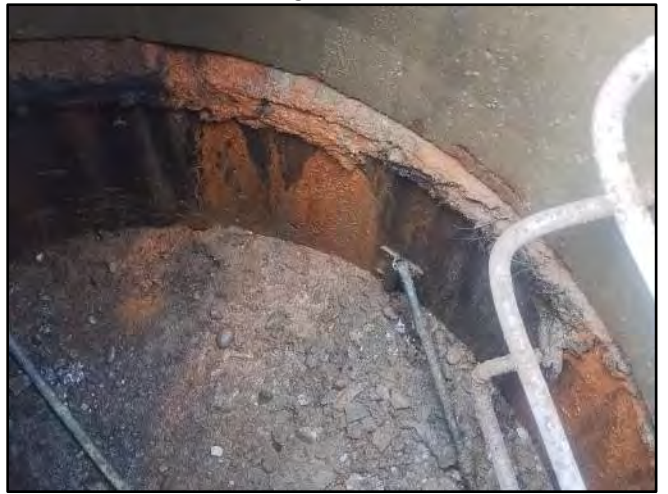
Image 6 – I&I along North Base

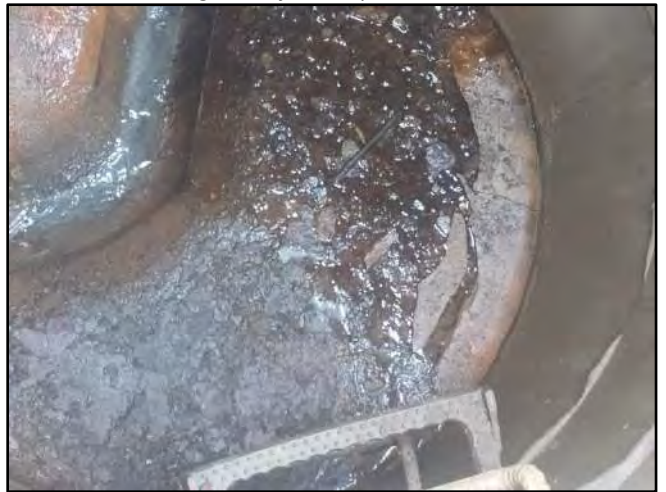
Image 6 – I&I Gusher and Eroding Shelf

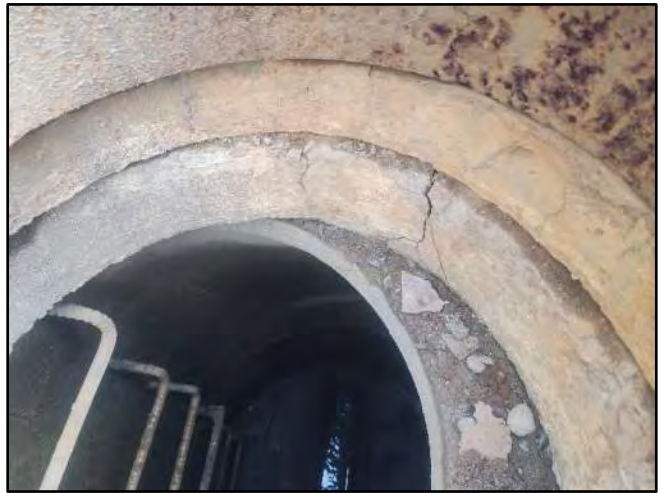
Image 4 – Chimney Cracking

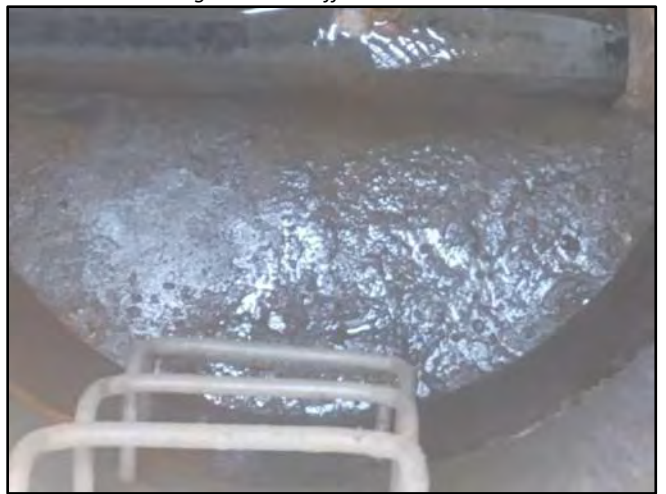
Image 6 – Standing Water on Shelf

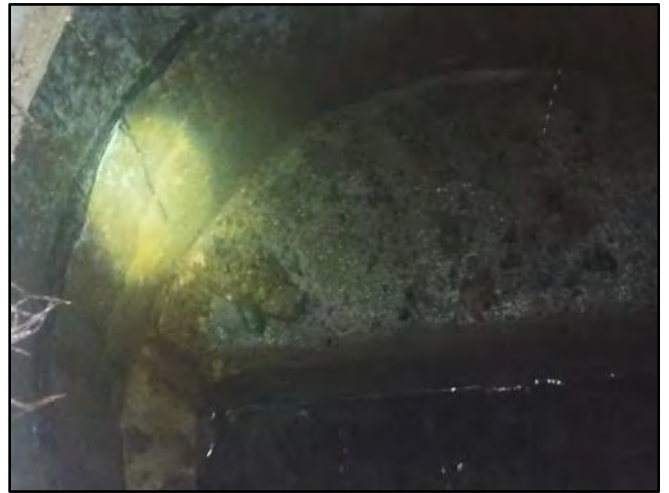
Image 3 – Large crack in Base

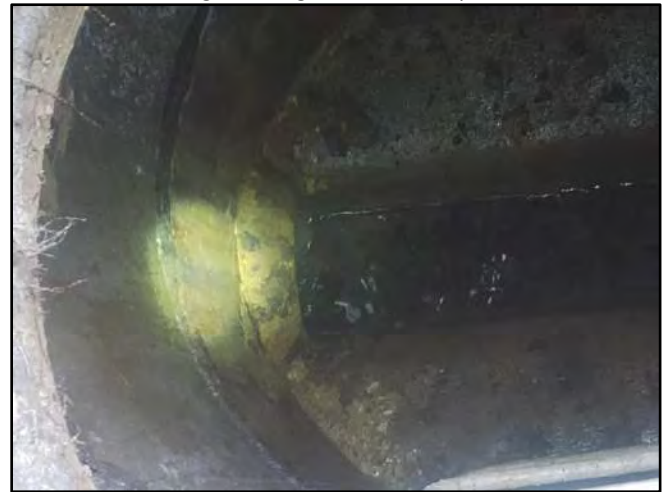
Image 6 – Mineralization from Barrel/Base Joint
