Talkeetna Sewer Condition Assessment

SEWER STRUCTURE INSPECTION REPORT

Structure #: MH19-0037

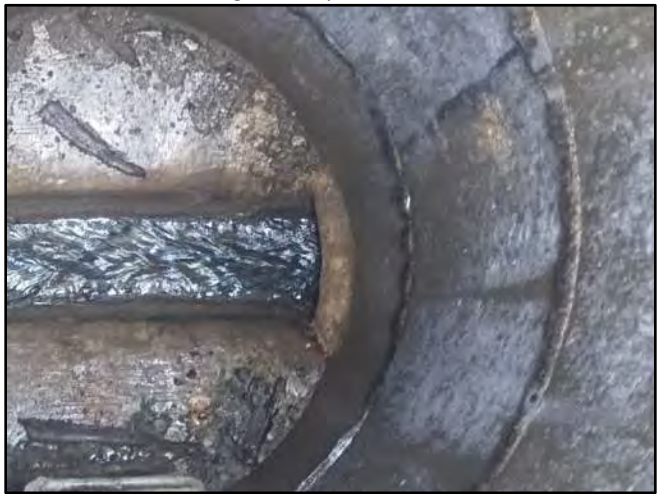
Image 6 – North Effluent Connection

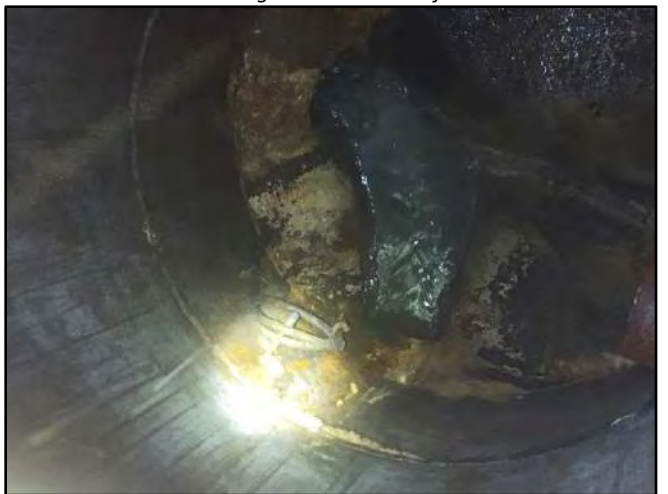
- Catch pan is unfunctional and has rusted entirely through
- I&I drippers present along East decommissioned pipe connection and North along significant cracks in the barrel
- Standing moisture present on entire shelf
- South base features old hand-turn valve that has been mineralized and warped

Image 6 – Old Warped Valve & Base

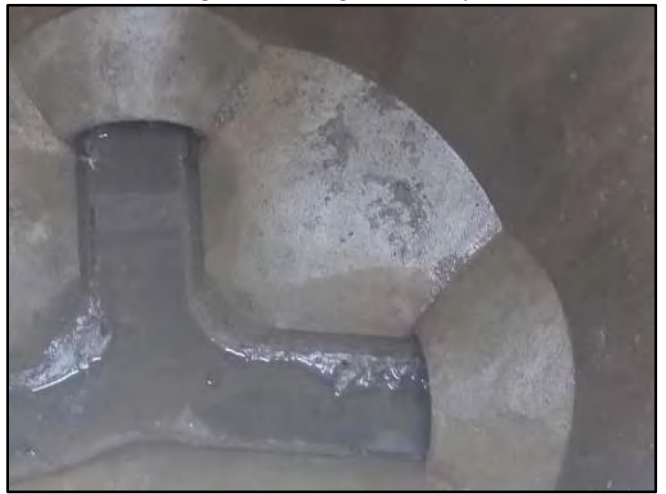
Image 6 – South and East Connections

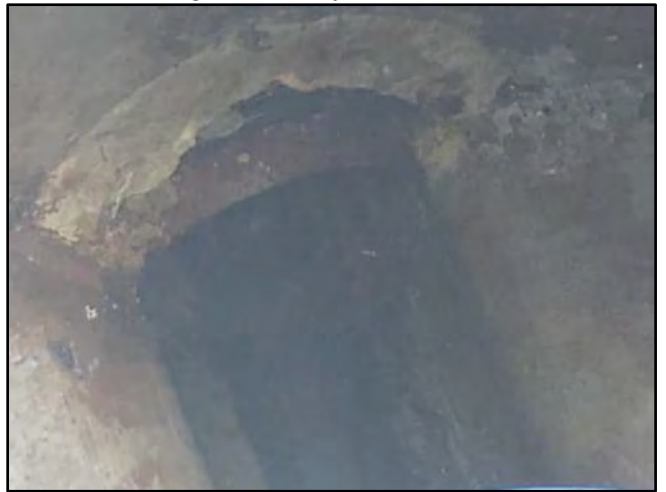
Image 6 – East Influent Connection

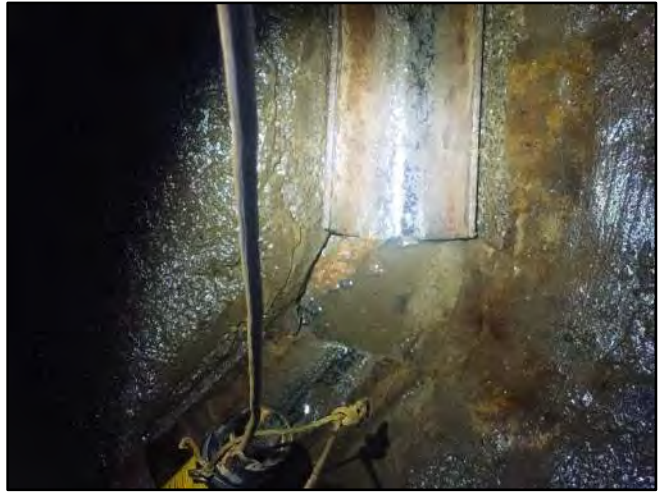
- Pipes' inverts are not connected for approximately 6"
- Frame is offset from the remainder of structure
- North side of Effluent pipe has significant chunk of concrete pipe missing

Image 4 – Missing Invert

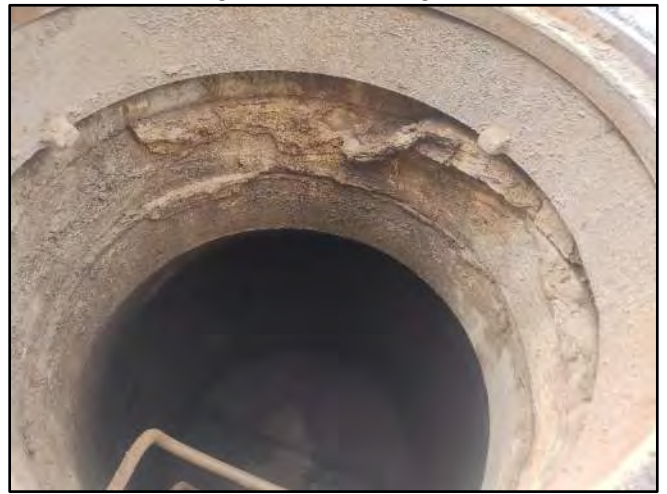
Image 6 – Chimney's Concrete Peeling

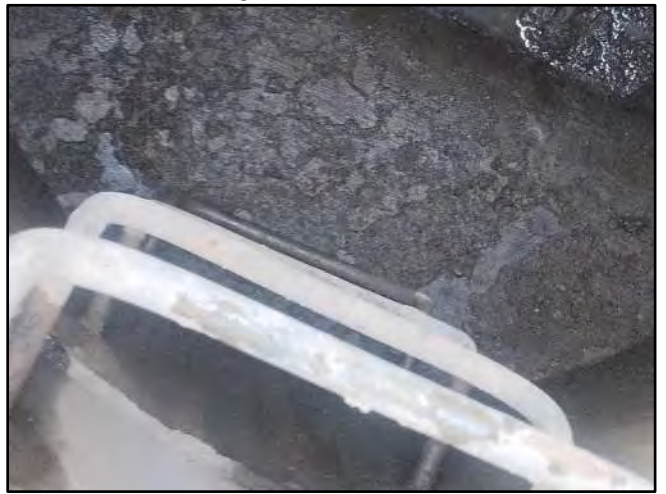
Image 6 – Sediment along Shelf

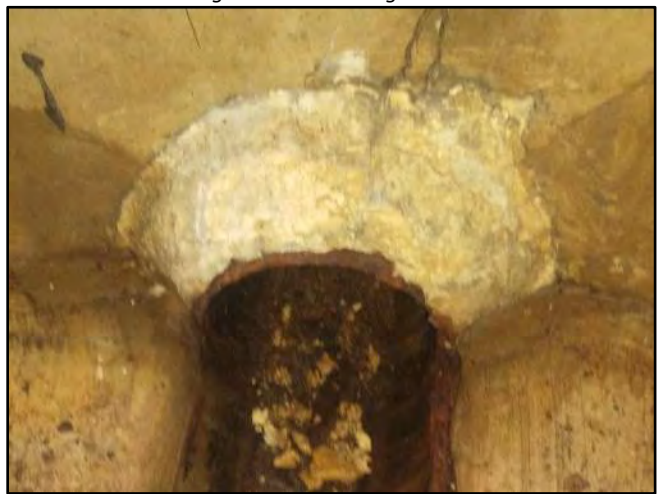
Two cracks extending diagonally along base from connection

Image 6 – Cracks above Connection

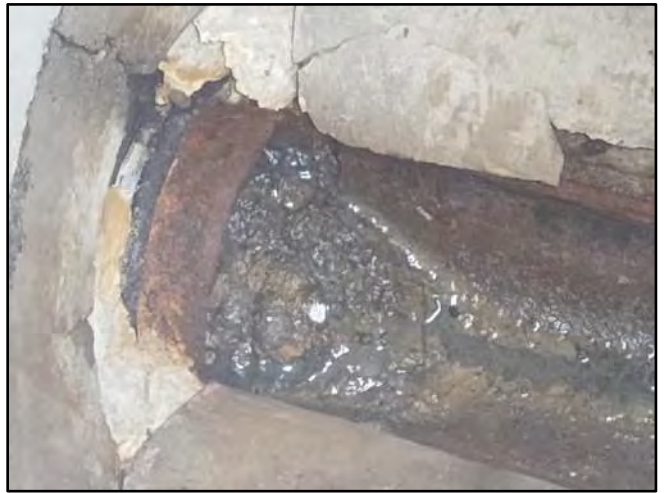
Both influent connections have exposed gaskets
Grouting is receding, Z-boot connection
Large crack extends from West connection
Graded score of 3

Image 4 – West Influent Connection and Crack

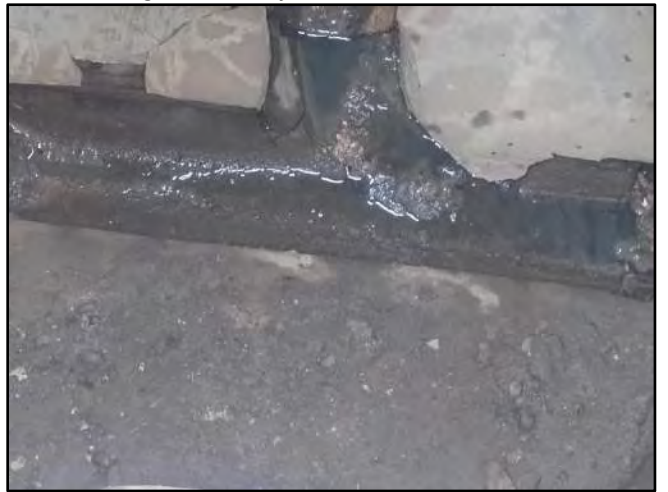
- Deep concrete fractures in multiple parts of the shelf
- Large amounts of sediment on South shelf
- Invert missing from North connection to East-West pipe, groundwater infiltration suspected beneath pipe
- Upon secondary visit, multiple I&I sources around connections, especially West connection

Image 6 – Missing Invert and Sediment on Shelf

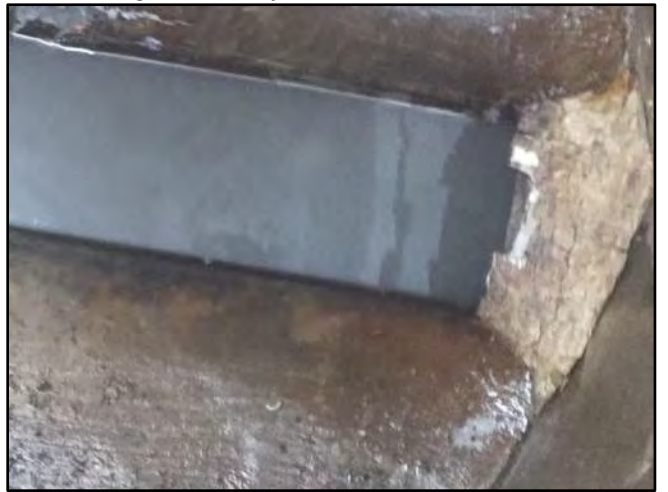
- Infiltration along shelf on the West section of base and East side of North connection
- Runner along the North side of West connection
- Significant crack on South side of West connection

Image 6 – North Influent Connection and Dripper

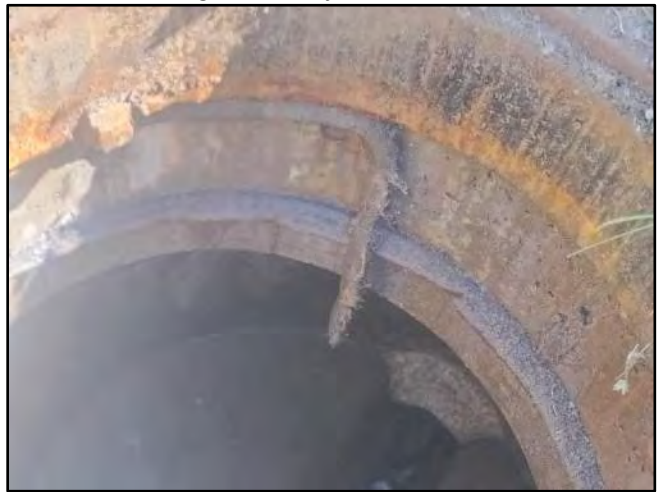
Image 6 – Sealant Between Frame and Chimney

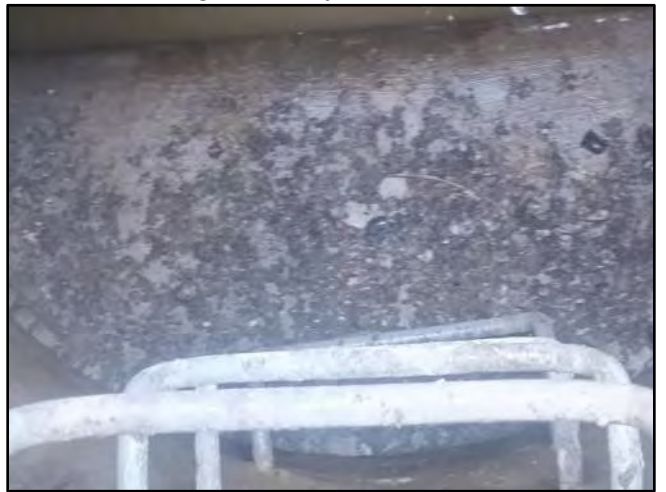
Image 6 – Sediment Build-up on Shelf

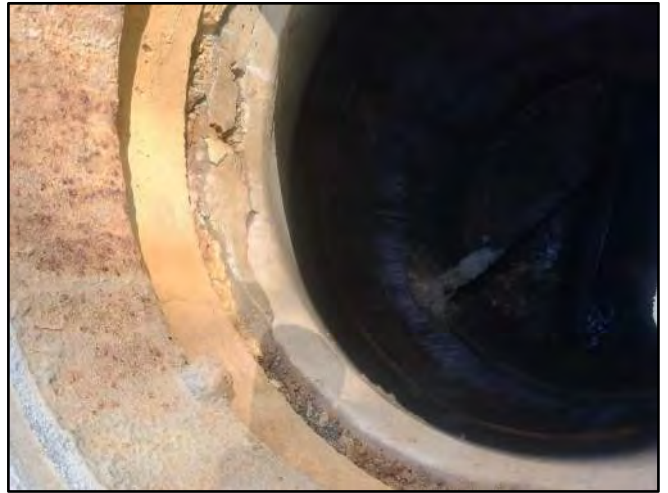
- Pipe expands from 8" to 12" diameter
- Significant cracking along the top of cone and the chimney/cone joint
- Moisture present throughout the base
- Severe wear on the shelf has created lots of loose debris from excess I&I

Image 2 – Cracking Along top of Cone and Joint

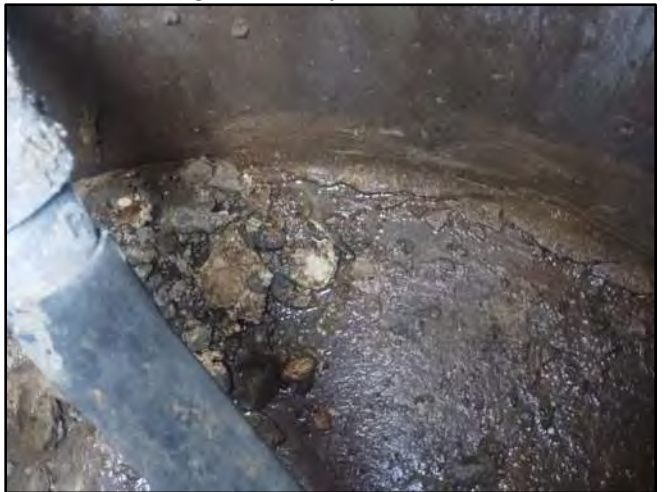
Image 6 – Debris and Moisture along Base's Shelf

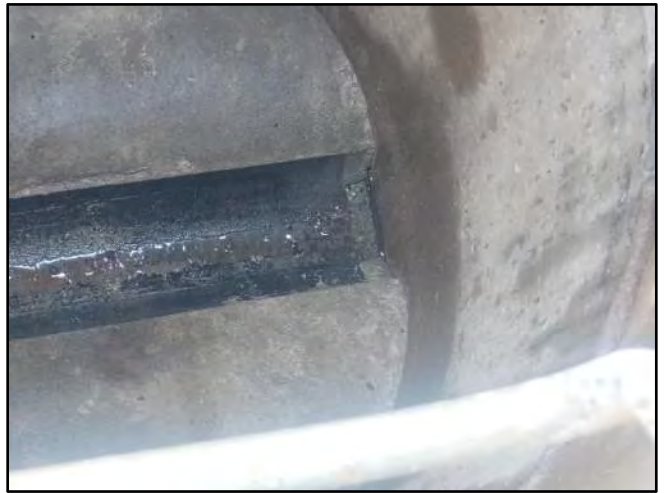
- Catchpan is rusted through and unfunctional
- No influent as North end of pipe ends in shear wall
- Steel bottom missing in invert right before shear wall, allowing I&I runner directly into pipe
- Steel bottom missing in invert directly before effluent connection as well
- Cone/base joint has some gaps, but no obvious mineralization
- All flow reflected in this MH is a product of I&I

Image 4 – Missing Invert and I&I Runner

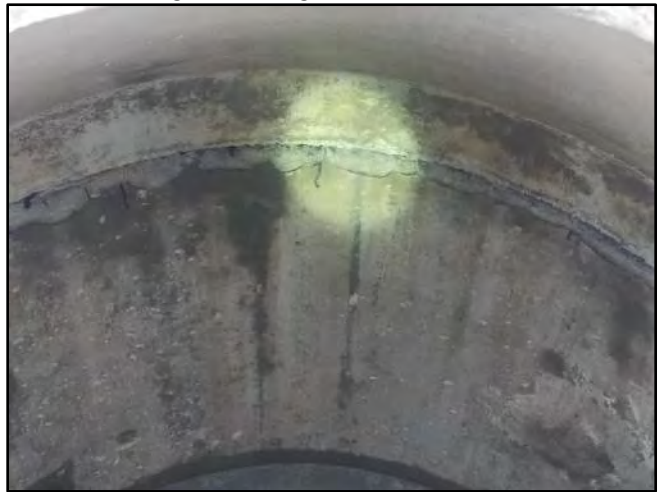
Image 6 – Cone/Base Joint

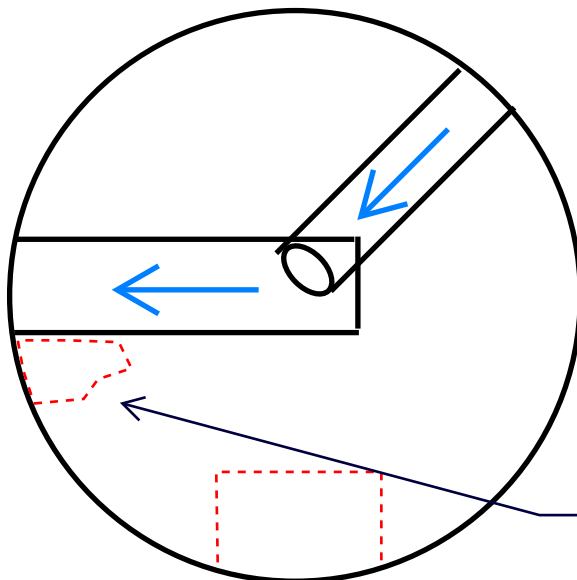
- Before cleaning large amounts of sediment along shelf
- Large, fractured concrete chunk along South side of West Effluent connection

Fractured concrete along shelf

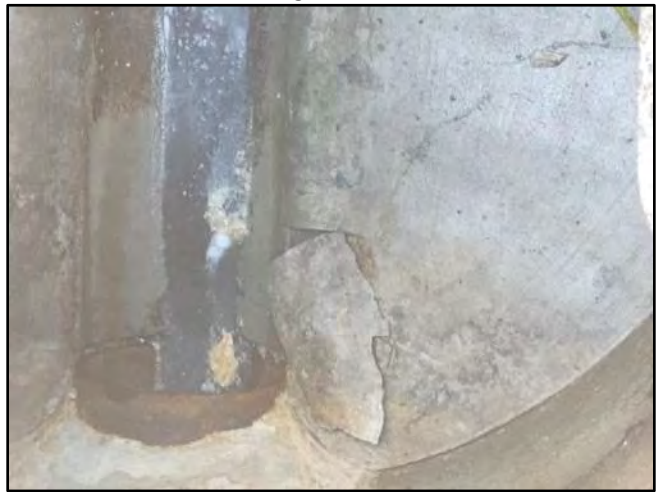
Image 6 – Fractured Concrete Section

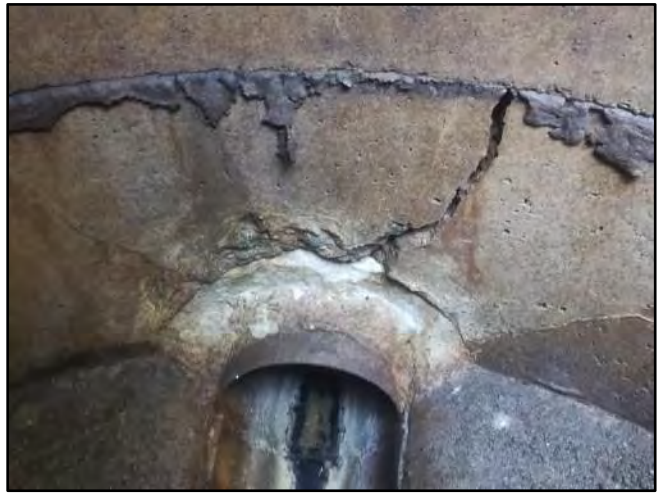
- Significant structural cracking above both East and West Connections

Image 4 – East Influent Connection and Crack

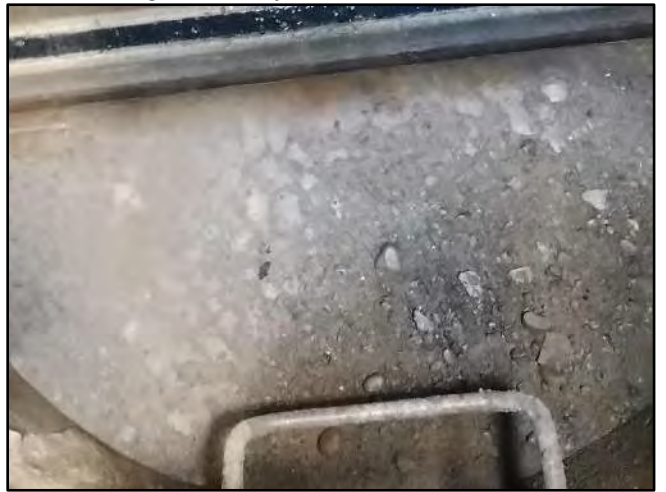
- Sediment deposit on South side of shelf, likely from excavation

Image 6 – Sediment along South Shelf

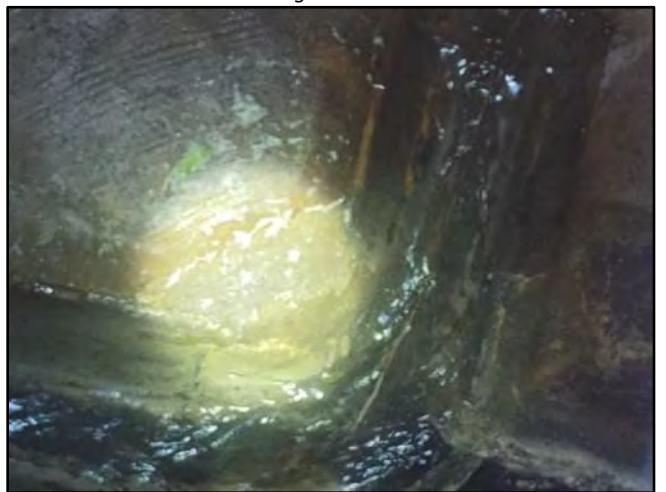
- Chunk of concrete is missing from shelf where the North Influent meets the West Effluent
- Mineralization flowlines along base & cone

Image 6 – Missing Concrete Section

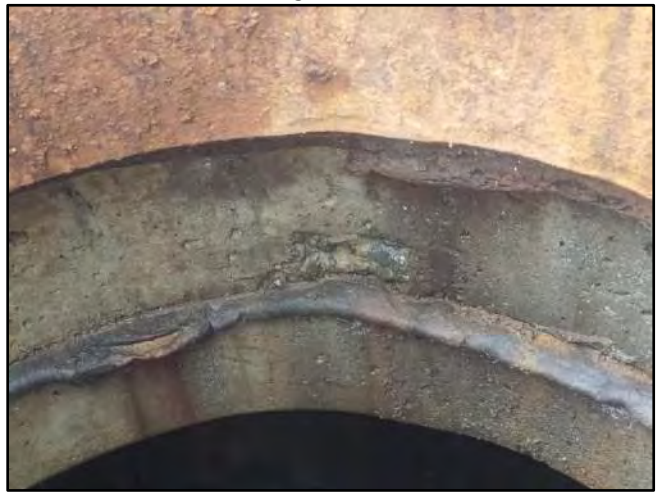
- Pipe ends along West side of shelf
- Chimney is experiencing some spalling
- High sediment build-up in invert before cleaning

Image 6 – Chimney's Concrete Spalling

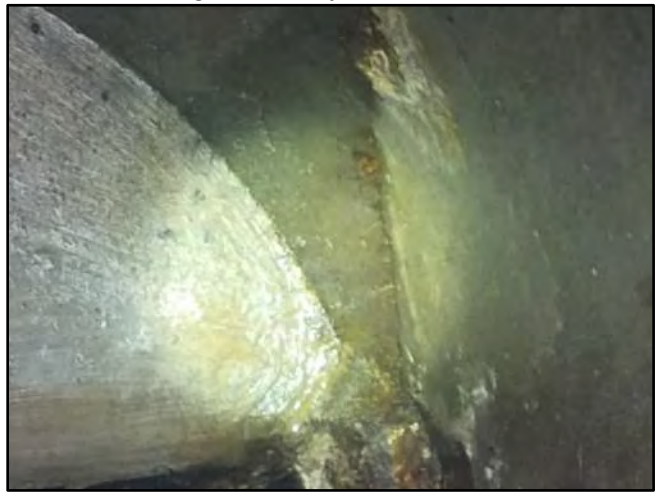
- I&I dripper coming from crack in West side
- Some mineralization present along South shelf

Image 6 – Crack and I&I Dripper

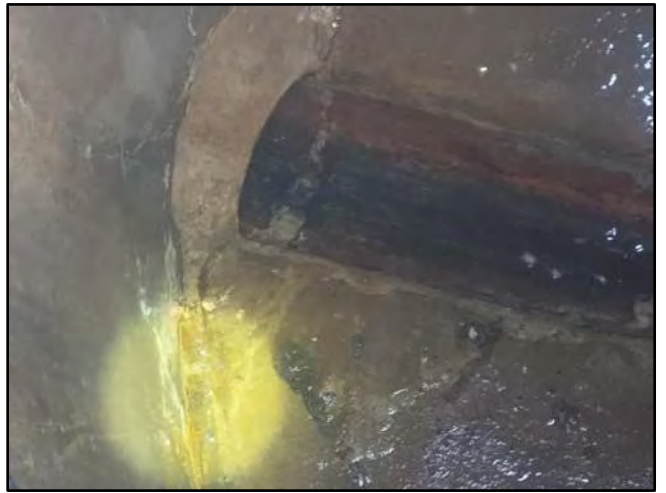
Image 4 – West Effluent Connection and I&I Dripper

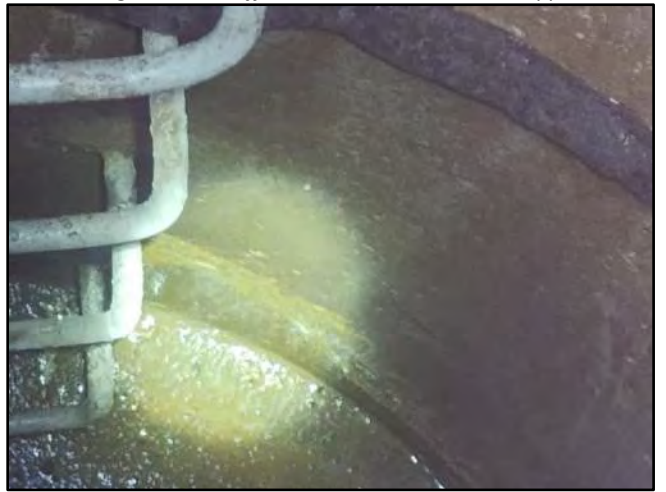
- Steel missing in 2" sections along both ends of invert's connection
- Steel missing in center of pipe for approximately 6"
- Concrete missing along South side of base
- Large amounts of moisture present on shelf

Image 6 – Missing Concrete along Base

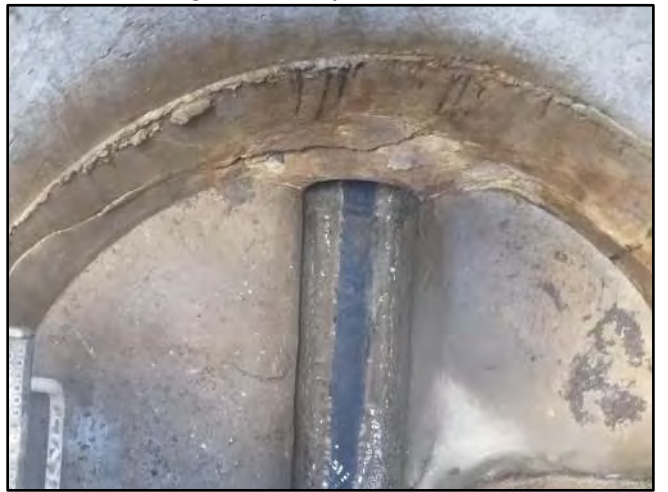
- Hairline crack along base that runs half the circumference along the East side (No I&I visible)
- Influent Pipe connections are in very poor shape

Image 6 – Base Hairline Crack

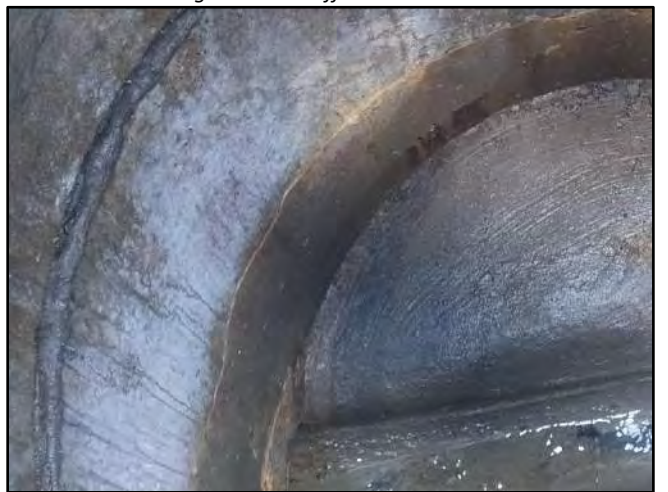
- Large crack along centerline of base for half the circumference along North side
- Several pieces of concrete missing
- Light mineralization descending from crack

Image 6 – West side of North Crack in Base

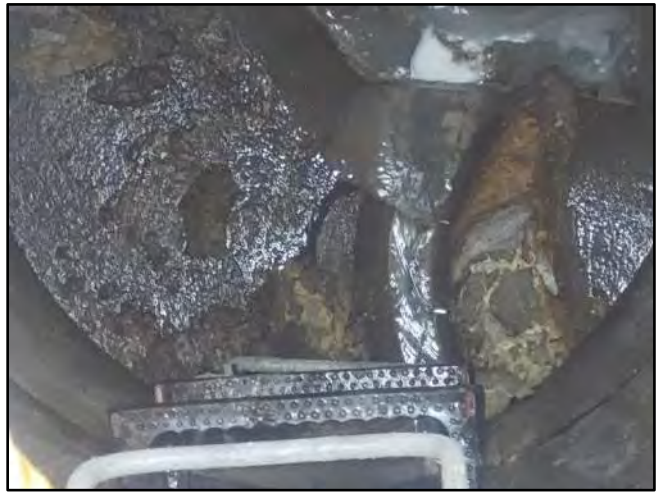
- Shelf missing concrete in several sections
- Concrete shelf extending from North pipe is actively eroding and very soft
- Invert is missing at attachment point from North pipe to main flow, water pooling in exposed concrete
- Moisture and sludge present along shelf, possible I&I but likely from high flows
- Cone's concrete spalling slightly

Image 4 – Missing Invert and Moisture on Shelf

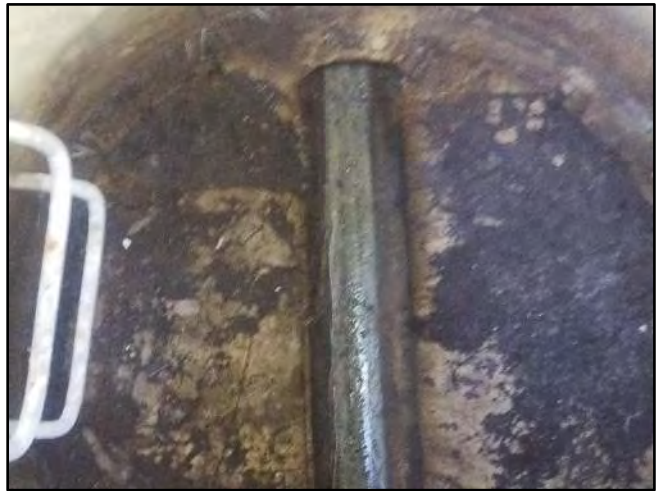
- South part of invert is missing pipe for 1" section
- Joint between cone and base is experiencing root intrusion on several sides
- Soil present along shelf before cleaning

Image 3 – South Influent with Missing Invert

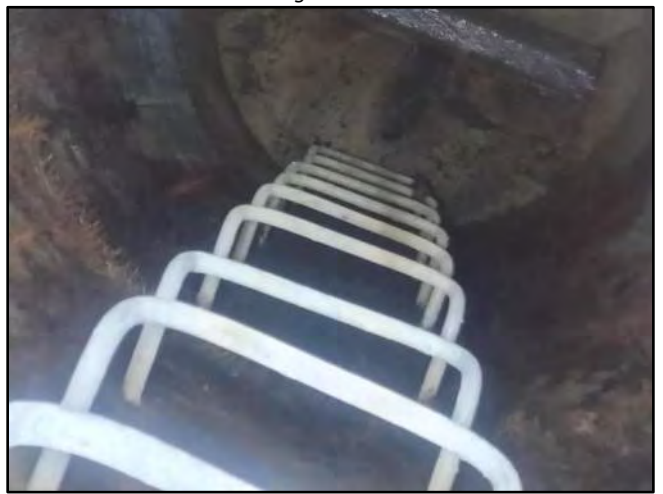
- Root & plant growth along East interior of cone, barrel and base, no cracks visible

Image 6 – Root Growth along Barrel and Base

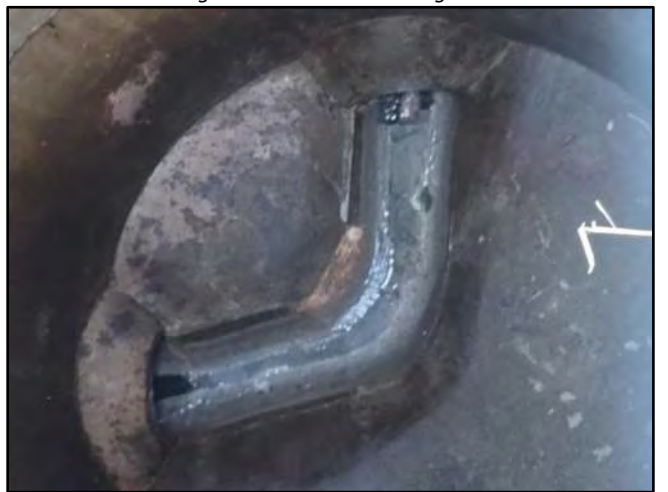
- Extensive plant roots growing along West side of cone
- No evidence of I&I from plant roots
- Missing concrete section along shelf with mineralization present

Image 5 – Missing Concrete on Shelf
