Appendix C
MANHOLE SUMMARY AND REPAIR RECOMMENDATIONS

Talkeetna Sewer Condition Assessment

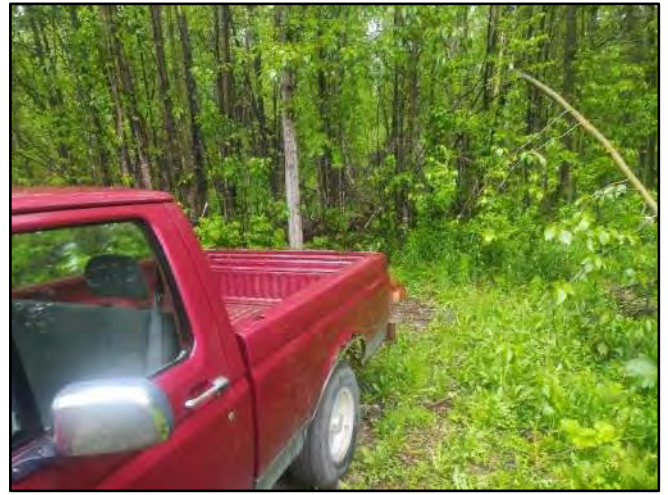
- Access is extremely restricted due to mass foliage in the way

Image 2 – Easement to Access Cleanout

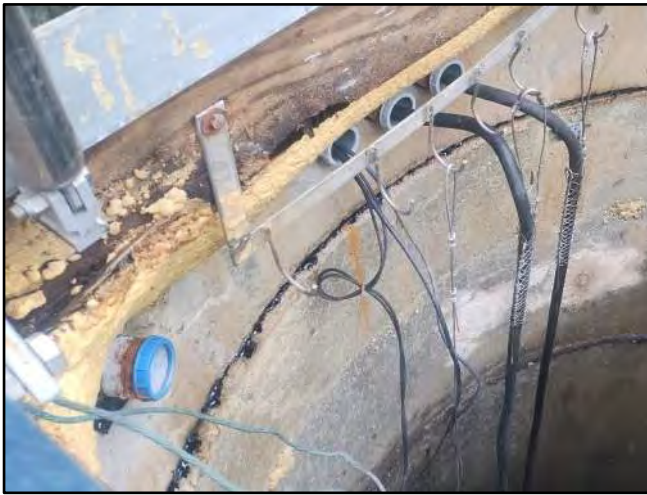
- Mechanical equipment appears to be in solid condition
- Spray foam insulation sprayed along chimney, appears to be deteriorating the wooden studs
- No mineralization or obvious I&I

Image 3 – Wooden Studs & Spray Foam Insulation

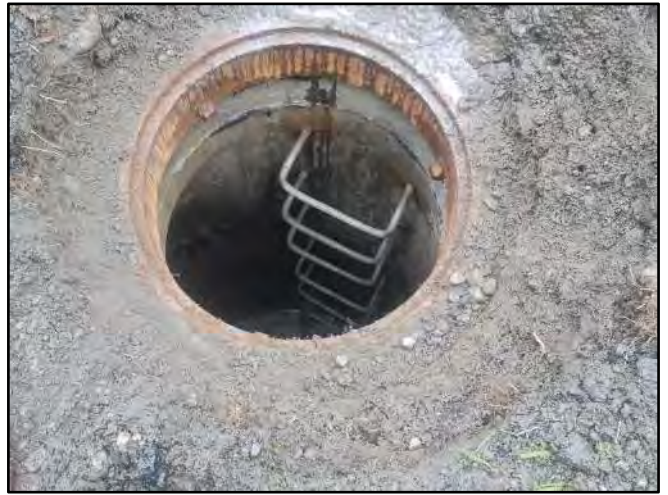
- Surface corrosion on frame and lid

Image 2 – Frame and Chimney

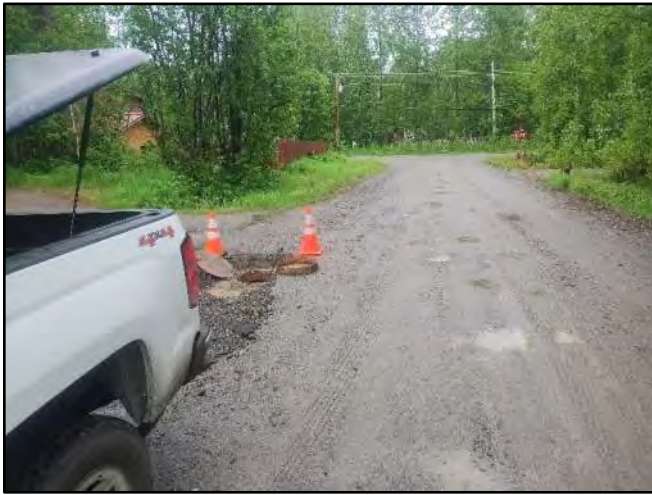
Image 1 – MH facing North towards intersection

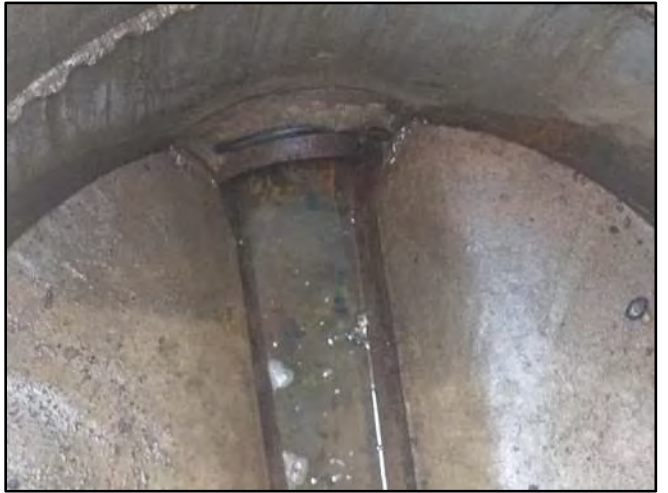
Image 4 – South Effluent Connection

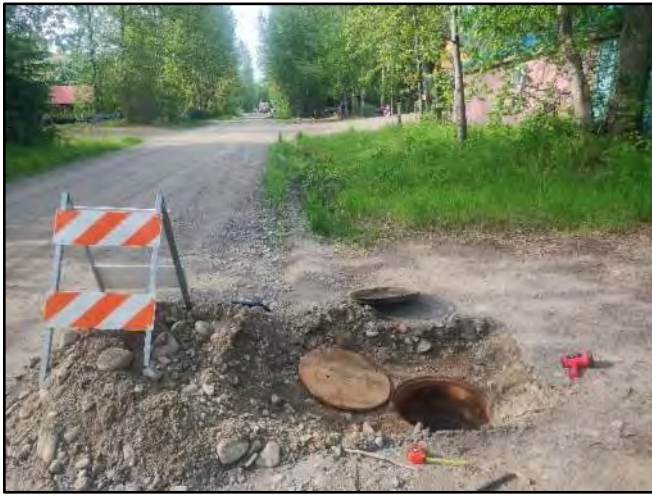
Image 1 – MH facing South along I St

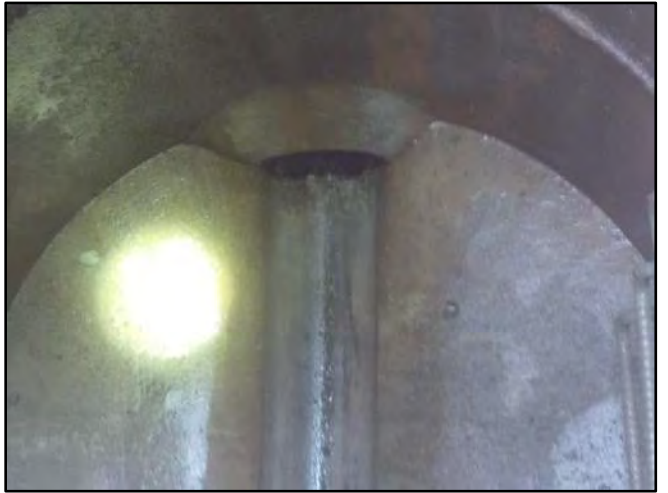
Image 4 – South Effluent Connection

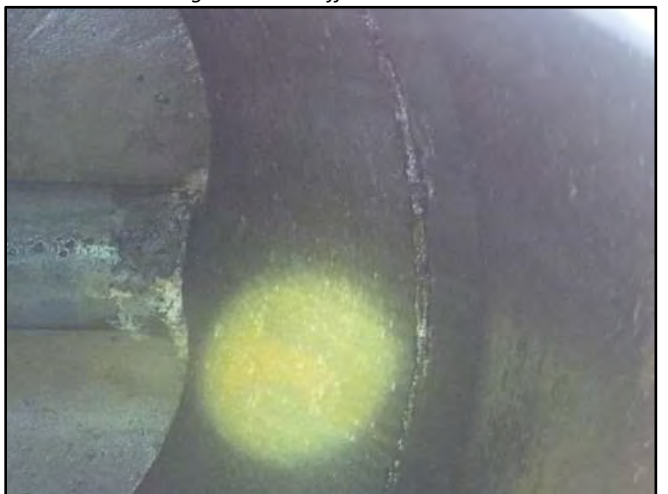
Mineralized flowlines from base/cone joint along

Northwest section

Image 6 – Flowlines from Cone/Base Joint

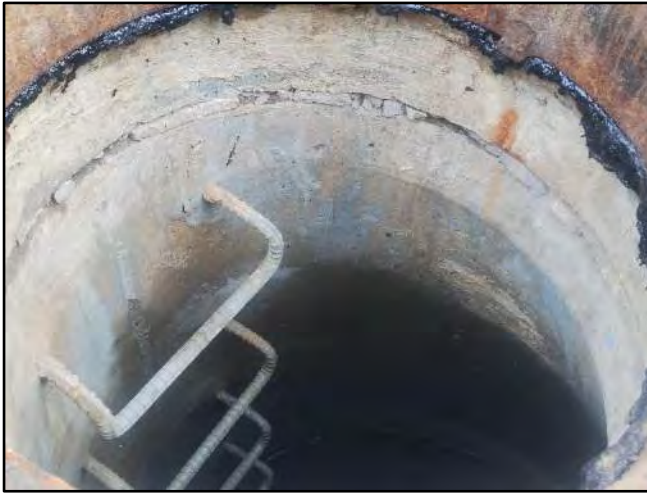
Image 3 – Chimney and Cone

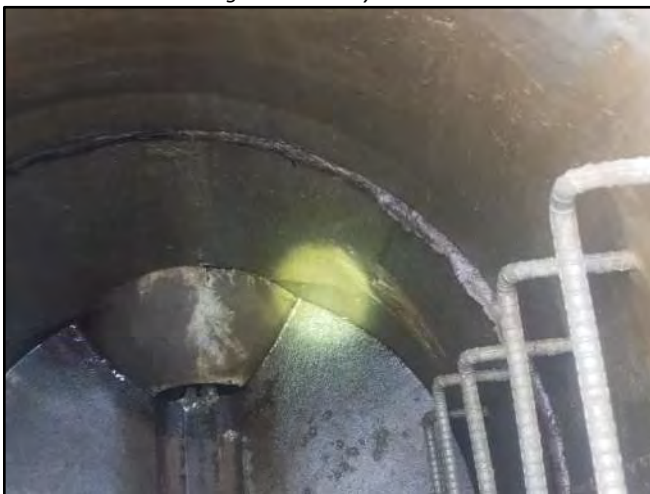
Image 5 – I&I runner along West Side, Crack

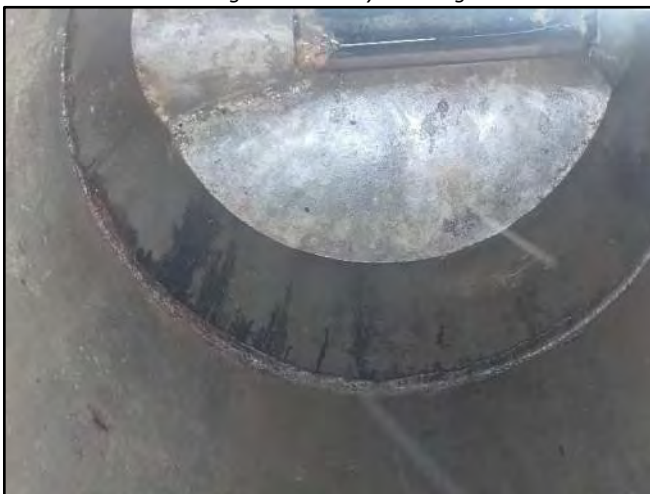
- Evidence of I&I along barrel/base joint

Image 5 – I&I flowlines along West Side

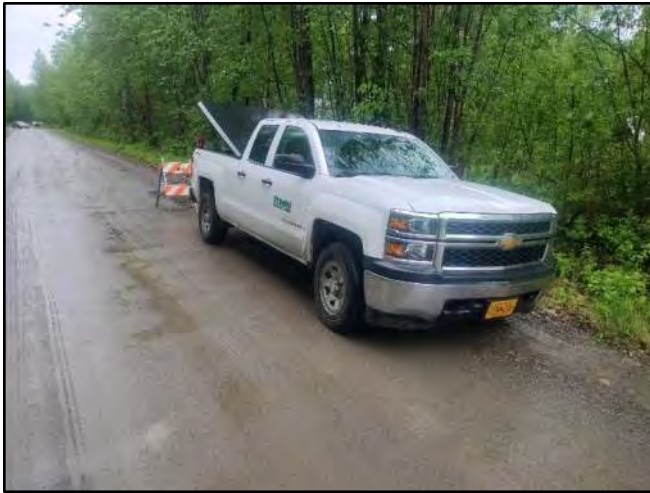
Image 1 – MH facing South along H St

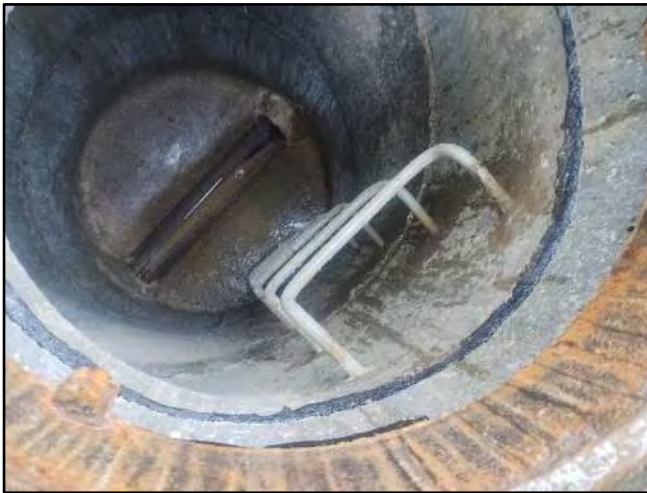
Image 3 – Chimney, Cone, and Stairs

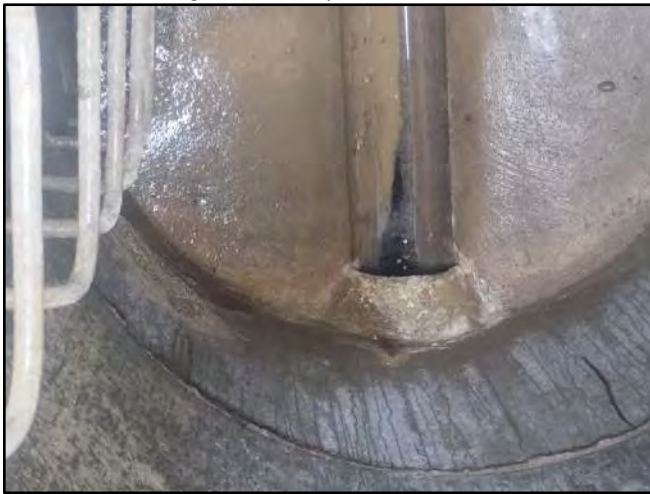
Image 5 – I&I Dripper to the West of North Connection

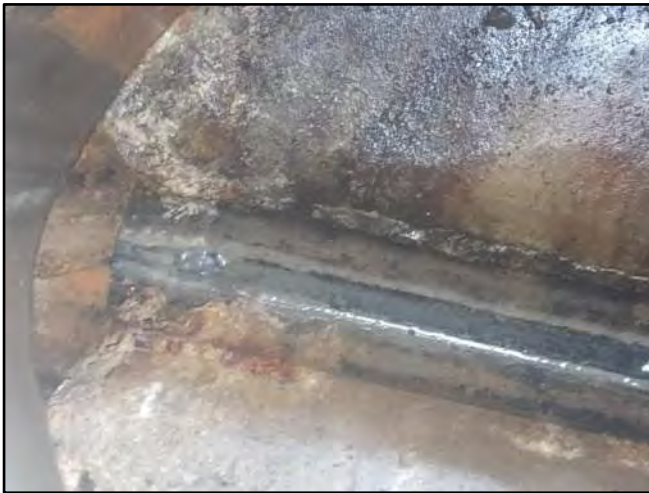
Image 3 – Dripper along East side of South Connection

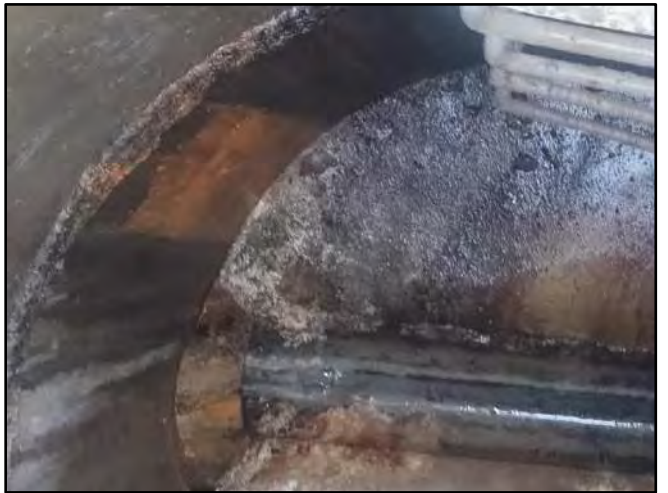
- Mineralization / flowlines from cone/base joint on SW side of structure
- Standing moisture present along west shelf

Image 4 – Flowlines along SW Base

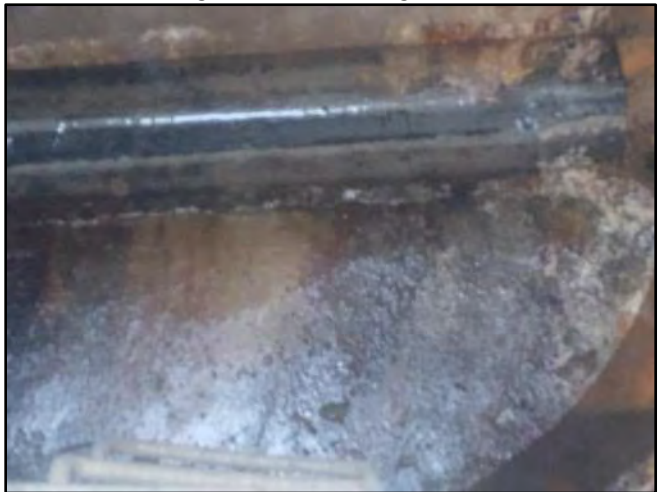
Image 6 – Moisture along West Shelf

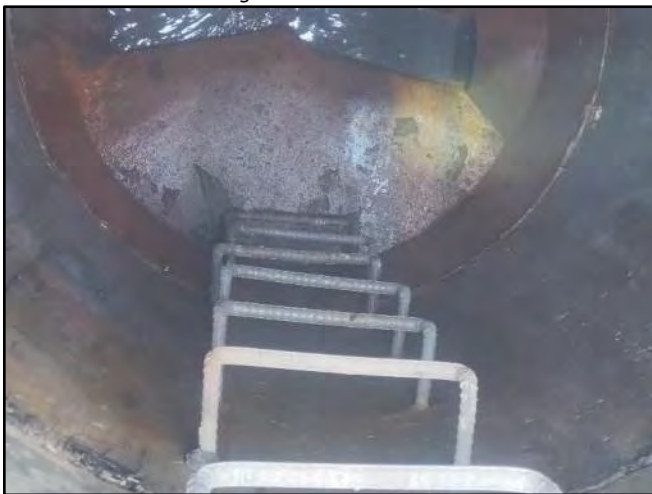
- Flowlines / Mineralization descending from barrel / base joint along all sides
- Several drippers present near South, West, and North side

Image 5 – Dripper along North Connection

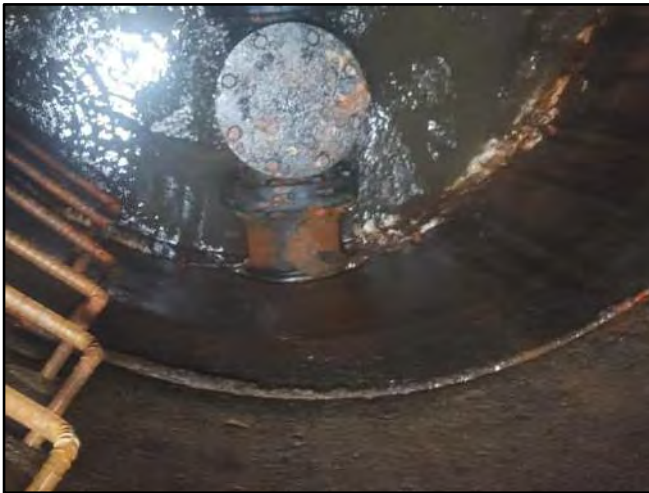
Grouting missing along top of connection
Connection ties into crack with I&I gusher
Graded score of 4

- All pipes are closed & sealed within manhole, no pipe's interior is visible
- Extremely heavy I&I with multiple gushers present along South and West portion of base
- Base is very corroded, likely experiences freeze/thaw damage as ice was present upon opening
- Unclear whether I&I enters the sealed pipes

Image 3 – South Connection with Large Cracks and Heavy I&I

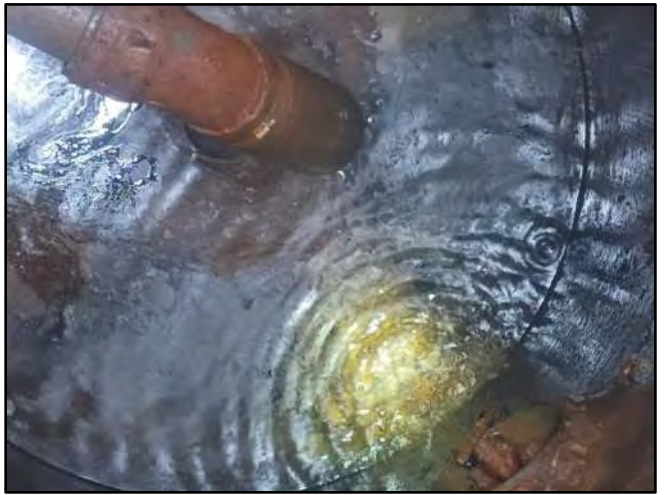
- All pipes are closed and sealed within manhole, no pipe's interior is visible
- Manhole's volume refills at approximately 6 in / min (approx. 50 gpm)
- No obvious signs of I&I into the pipes
- Massive I&I gushers along SE and North side of base

Image 4 – North Connection with Massive Submerged Gusher

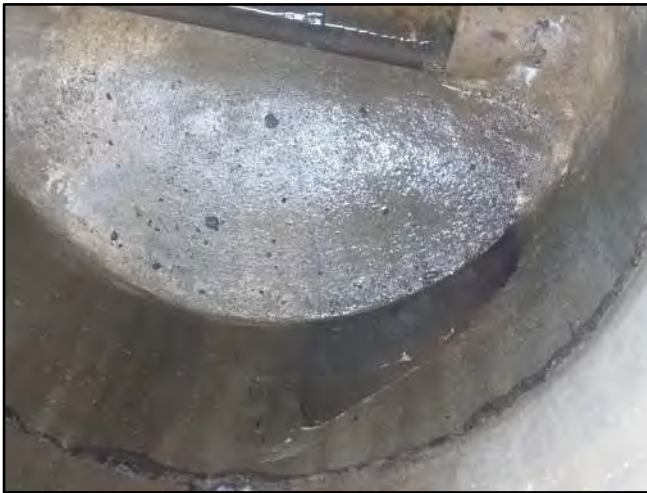
- Large crack along West side with I&I drippers present
- More I&I along East side, adjacent to North & South connections
- I&I appears to be a result of hairline cracks in the base

Image 3 – Crack along West side of base

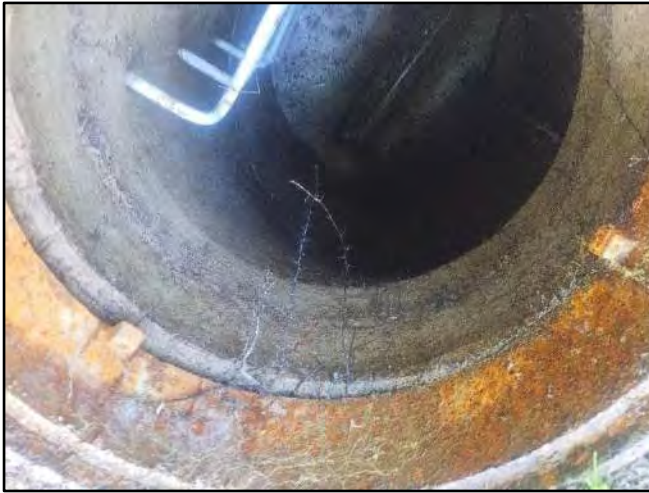
- Effluent Pipe exits in NNE direction
- Frame is offset approx. 1" from chimney
- Joints between frame/chimney and chimney/cone are facing significant root intrusion

Image 3 – Roots at Structure's Joints

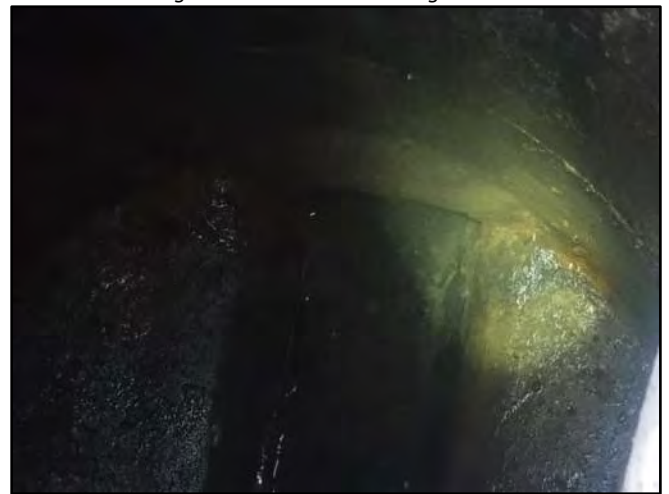
- First and Second Chimney are approx. 6" offset from one another
- Second chimney and base are approx. 2" offset
- Some root intrusion at chimney/cone joint
- Mineralization flowlines coming from barrel/base connection along East section
- Missing Concrete section to the East of influent connection

Image 6 – Missing Concrete and I&O dripper

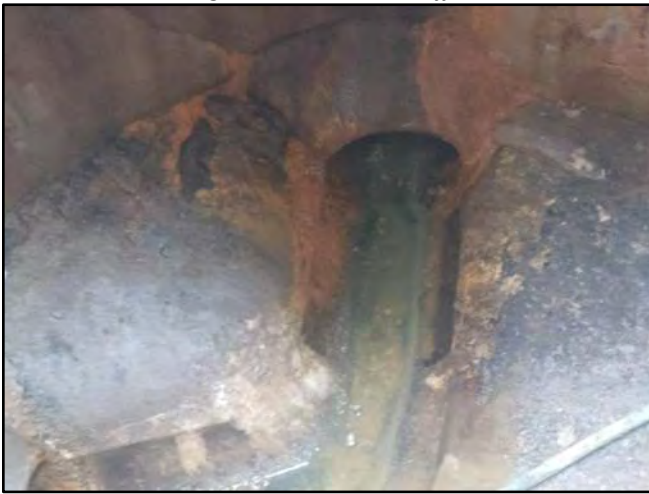
- Chimney & frame offset: 1"
- Cone & chimney offset: 2"
- Base & cone offset: 1"
- Root intrusion along joints between frame, chimney, and cone
- Heavy mineralization and I&I along base/cone joint
- Large cracks on North and South of base, unclear whether I&I is from these cracks or joints

Image 5 – I&I along South Effluent

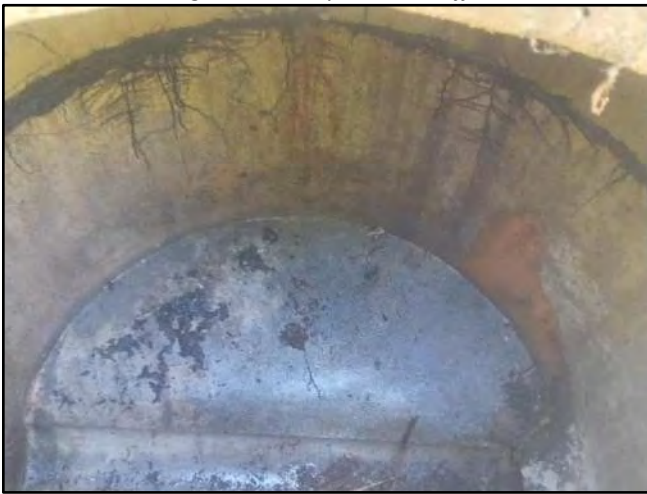
- No Influent as East pipe ends in a shear wall
- Chimney & cone are 4" off-center
- Root intrusion at base/cone joint
- Mineralization present along the South section of base

Image 5 – Root Intrusion at Cone/Base Joint

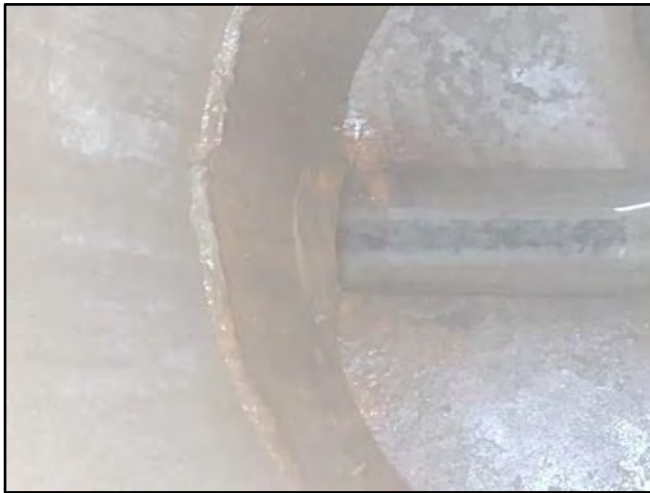
- Chimney, frame, and cone are approximately 2" offset in total
- Joint between barrel and base has multiple drippers and mineralization
- Southwest portion of base features some cracking
- Standing water/sludge on the North side of shelf

Image 3 – I&I Drippers above East Influent Connection

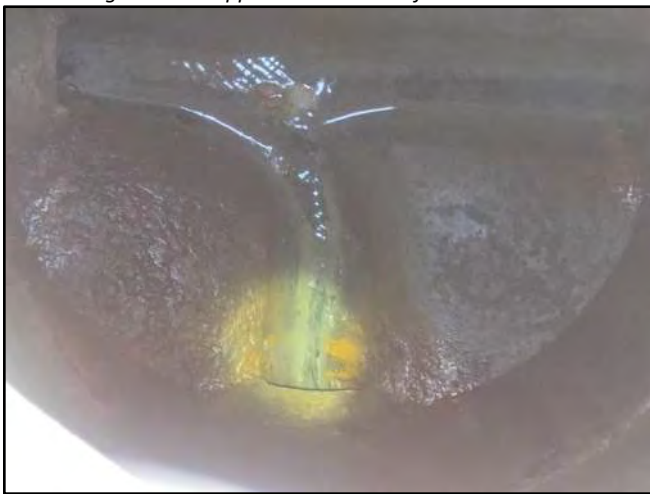
Decent grouting
Both South and East connection have significant mineralization and damage
Graded score of 3

Image 5 – I&I Drippers and South Influent Connection

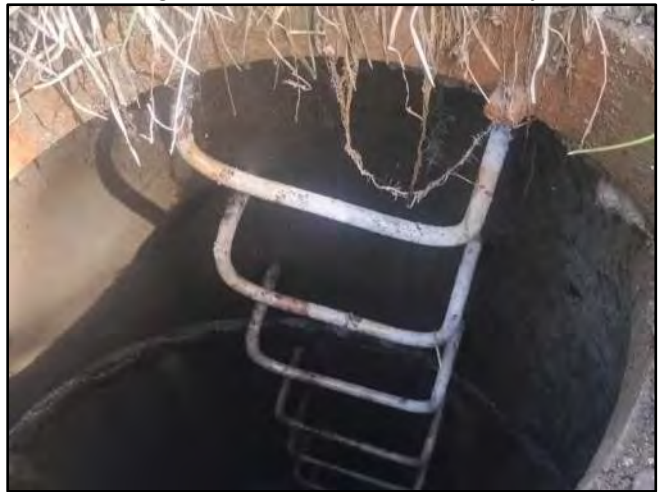
- Frame has shifted 6" off-center from cone
- Joint between frame and cone is experiencing major root intrusion
- Sludge and solids present on Southern section of shelf, high mineralization suggests I&I

Image 6 – Root Intrusion along top of Cone

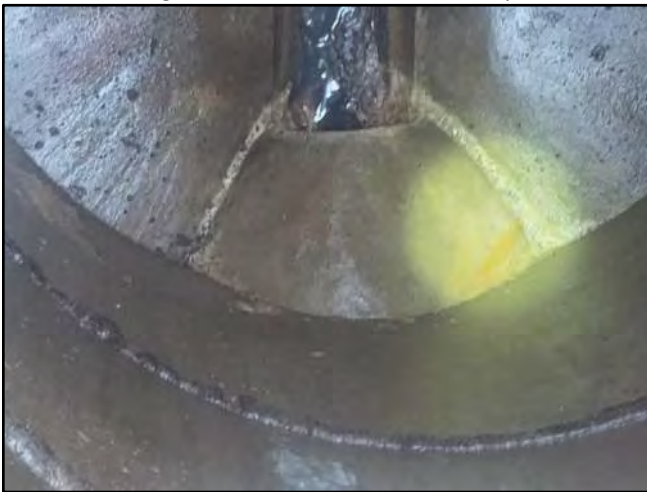
Image 5 – North Influent Connection

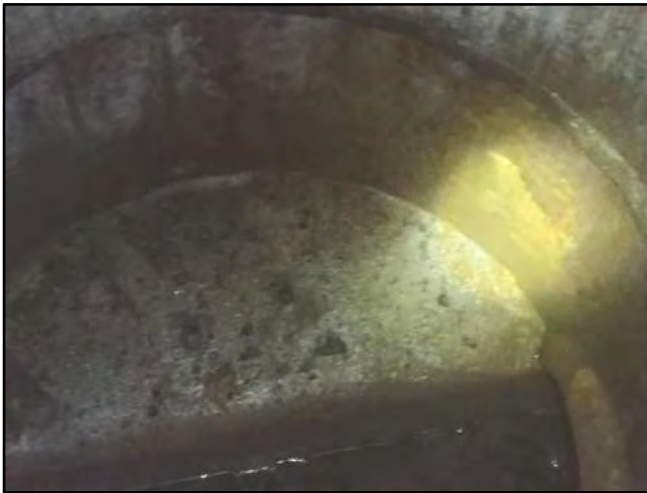
- Chimney layers are facing moderate root intrusion
- Large diagonal cracks in the base along East section
- I&I appears to come from the barrel/base joint, not from the cracks
- Mineralization from joint is present along North end of base

Image 3 – Large crack in Base

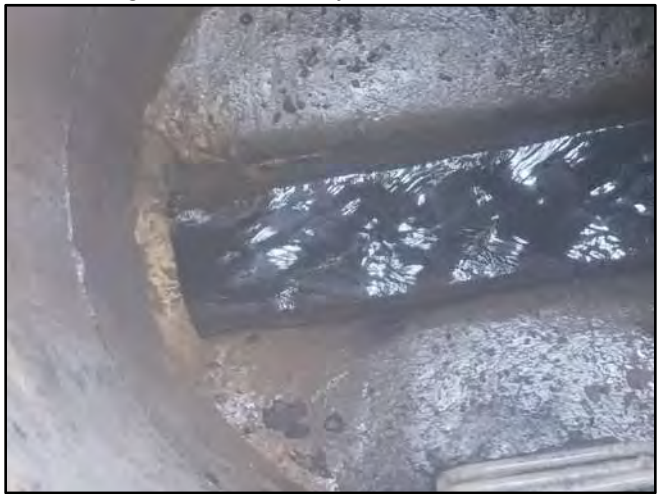
Image 6 – North Effluent Connection
