Talkeetna Sewer Condition Assessment

SEWER STRUCTURE INSPECTION REPORT

Structure #: MH19-0037

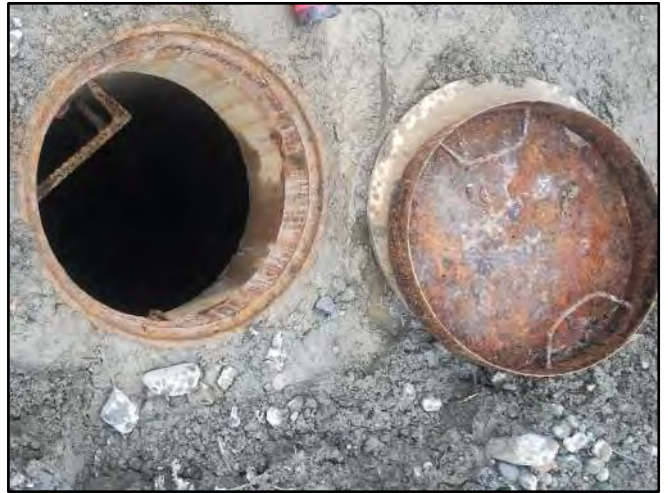
- Catch pan is unfunctional and has rusted entirely through
- I&I drippers present along East decommissioned pipe connection and North along significant cracks in the barrel
- Standing moisture present on entire shelf
- South base features old hand-turn valve that has been mineralized and warped

Image 2 – Frame & Unfunctional Catchpan

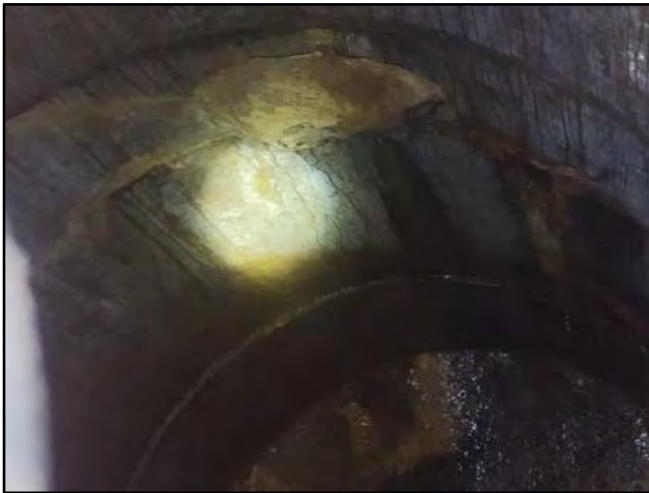
Image 3 – North Wall with Decommissioned Pipe

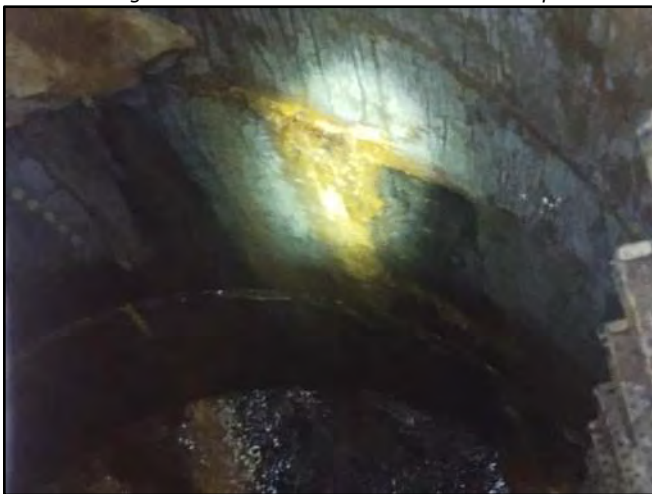
Image 5 – Crack in the Barrel

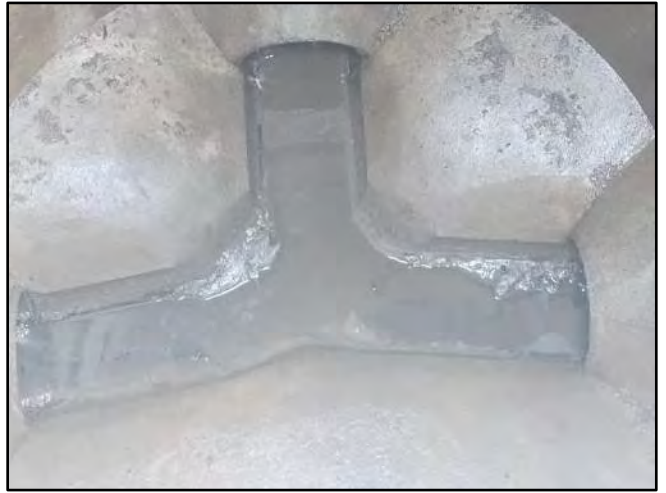
- Water is very static; depth of flow reflects standing water
- Moderate root intrusion along cone/barrel joint

Image 4 – Standing Water in Pipes

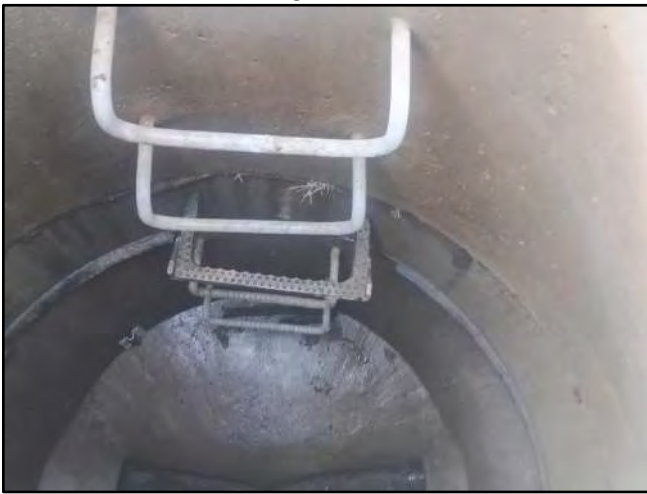
Image 5 – Minor Root Intrusion along West Section

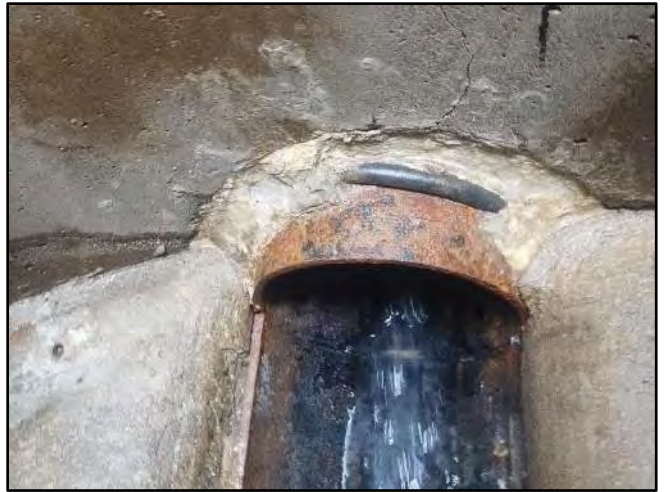
Missing grout on top of connection
 Gasket and pipe visible
 Graded score of 2

Image 4 – Effluent Connection with Exposed Gasket

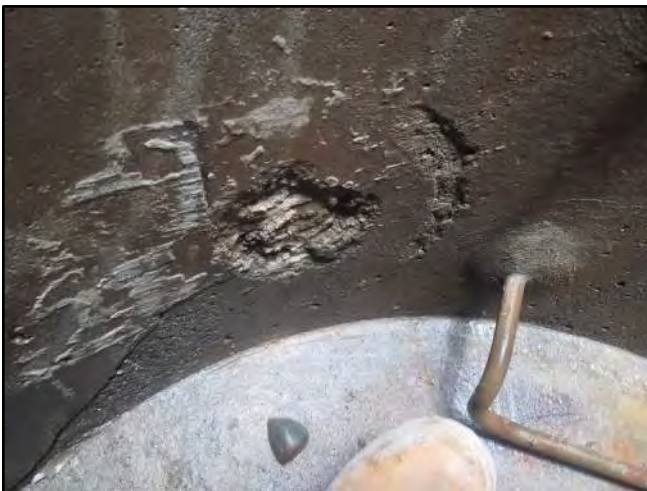
- Hairline crack extending upwards from West Effluent connection
- Small chunks of concrete missing from base

Image 5 – Missing Concrete along Base

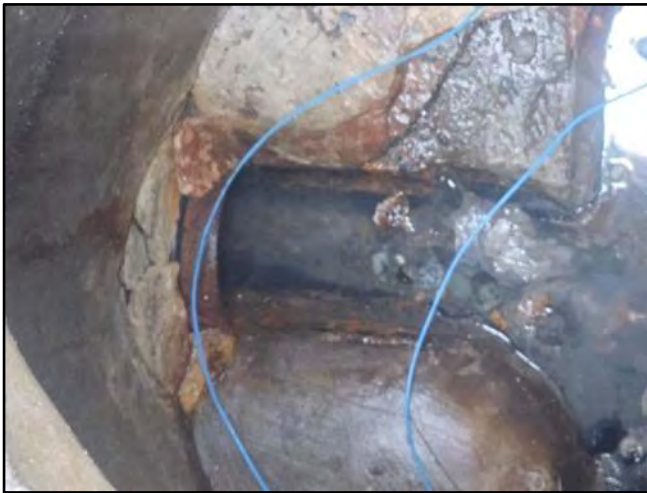
West Connection grout is broken, exposed gasket
 East connection some grout is missing, exposed gasket
 North connection has some mineralization
 Graded score of 3

Image 3 – West Influent Connection

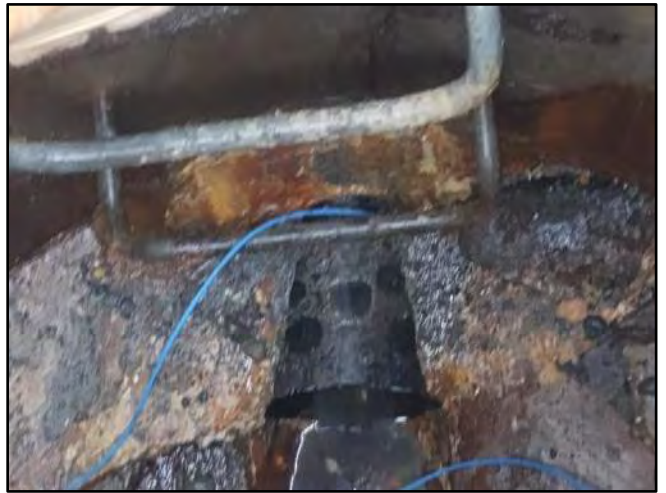
Image 4 – North Influent Connection

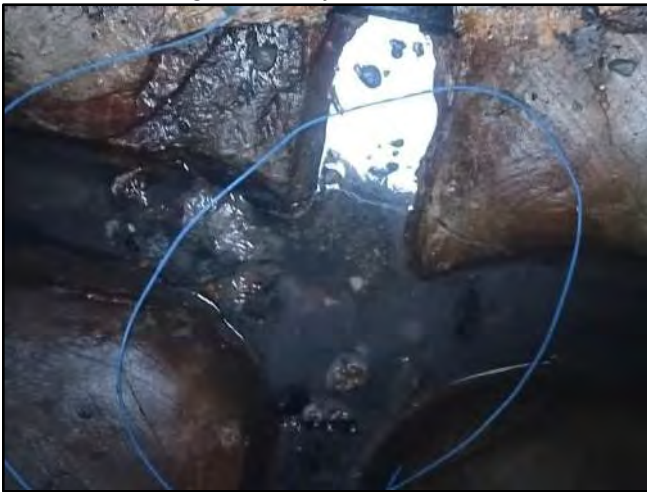
- Small fracture in channel invert
- Broken/missing channel present
- Concrete is fracturing along shelf
- 1" of debris in invert before cleaning

Image 5 – Missing Concrete along Shelf

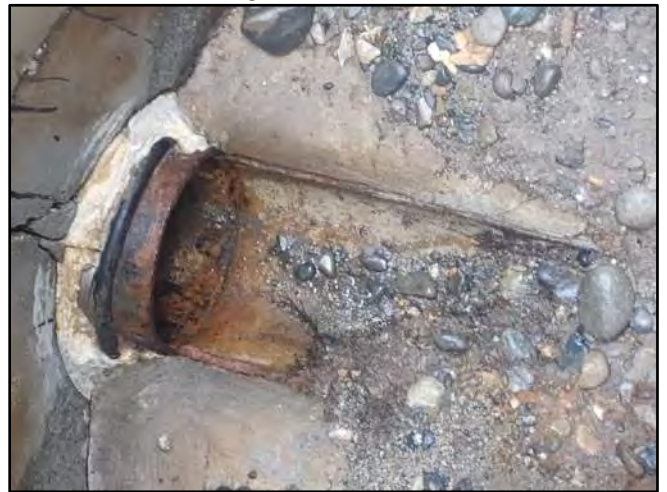
Some grout is missing

Image 6 – East Effluent Connection

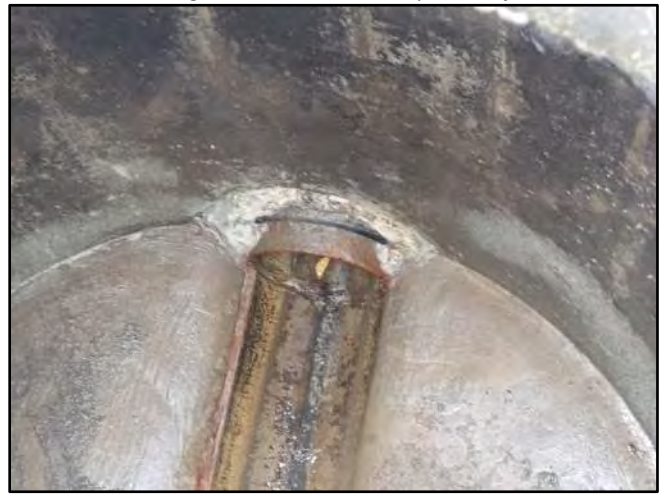
Some grout is missing
Gasket exposed
Graded score of 2

Image 6 – East Effluent Connection

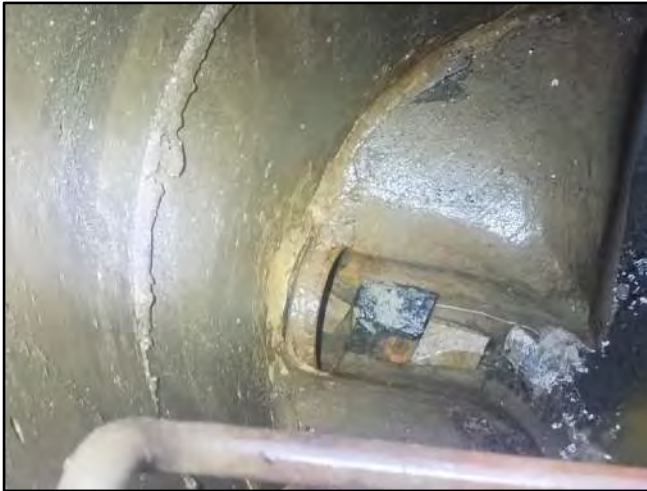
West Influent connection has some grouting missing, gasket exposed
Graded score of 2

Image 3 – West Influent Connection

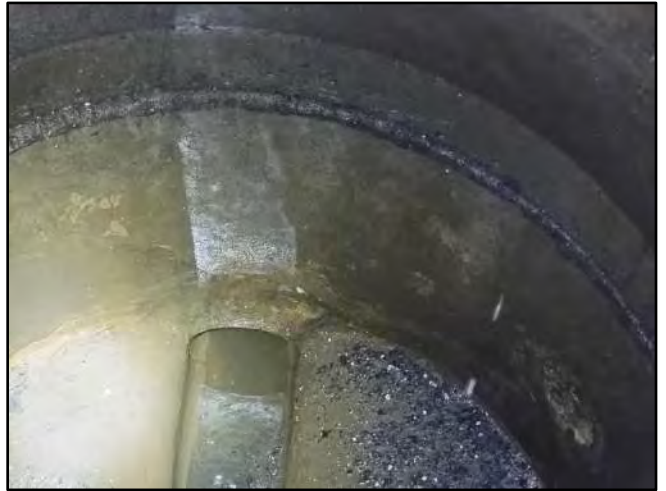
- Small chunks of concrete spalling in some parts of base and cone

Image 4 – North Influent Connection and Spalling

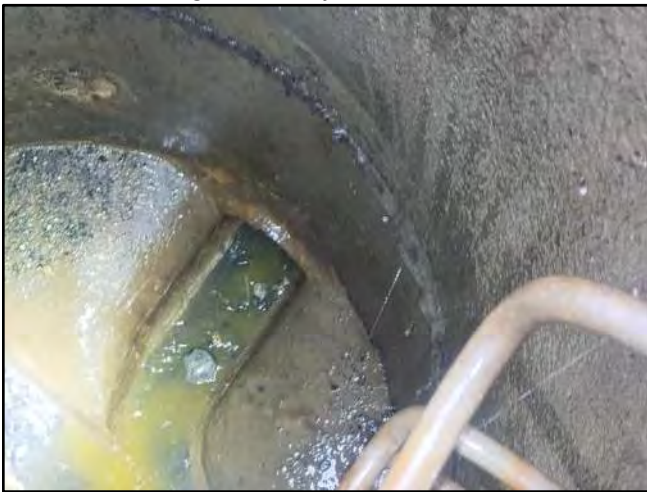
Image 5 – East Influent Connection

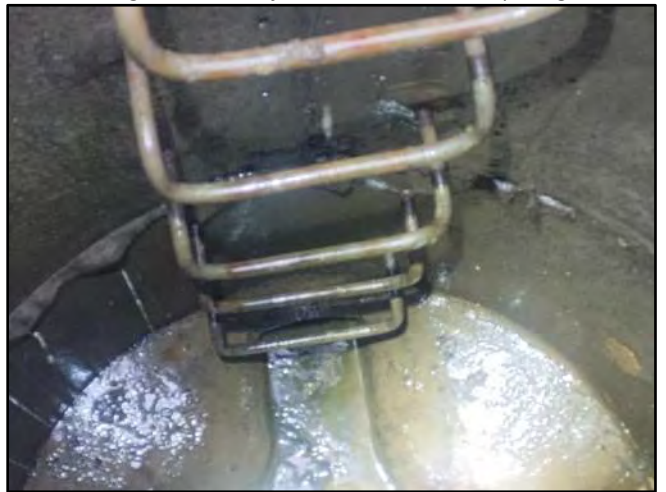
Some grout is missing, pipe exposed
Graded score of 2

Image 6 – South Effluent Connection and Stairs

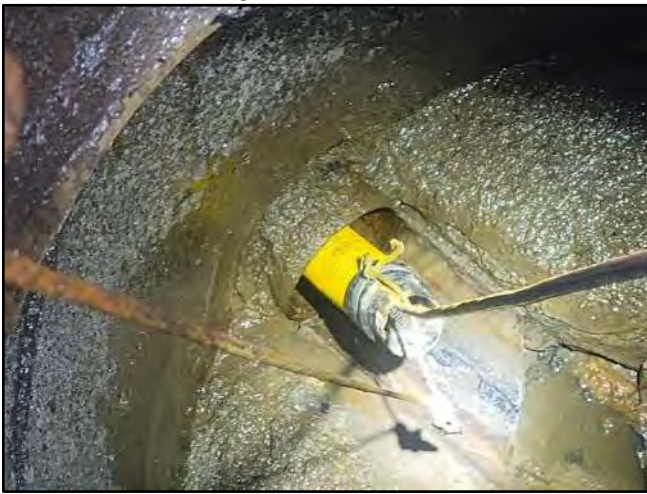
Connection has some grouting missing, gasket exposed
Graded score of 2

Image 5 – Southeast Influent Connection

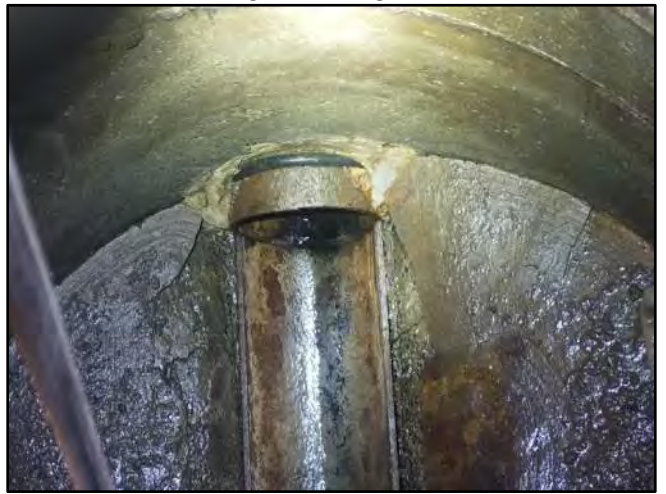
Missing most grout around connection, gasket very exposed
Graded score of 3

- Pipes' inverts are not connected for approximately 6"
- Frame is offset from the remainder of structure
- North side of Effluent pipe has significant chunk of concrete pipe missing

Image 6 – West Effluent Connection

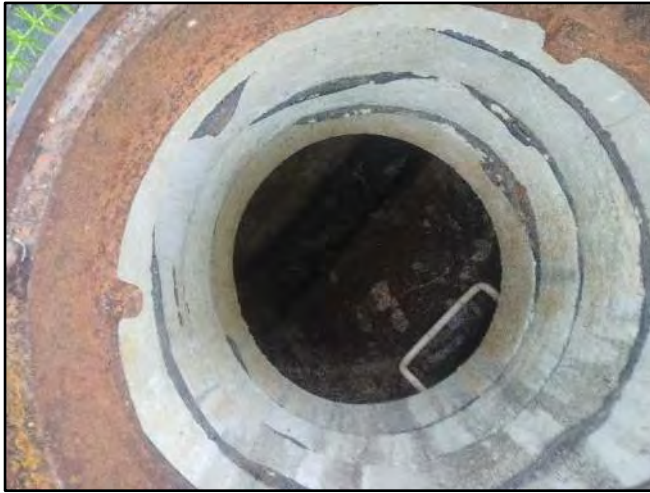
Image 3 – Frame and Chimney

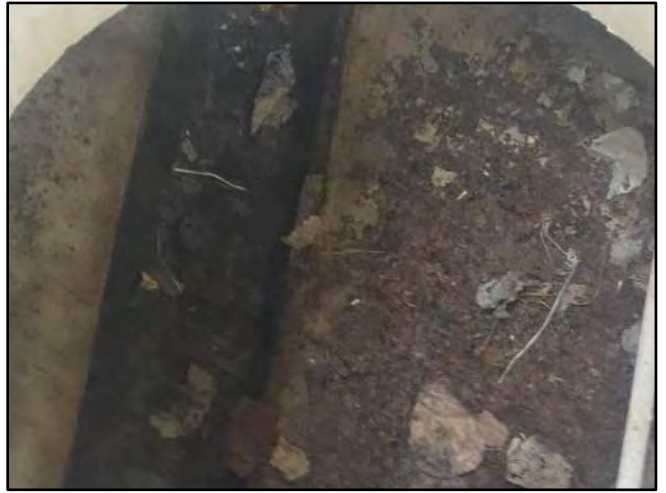
Image 4 – Debris along the Base

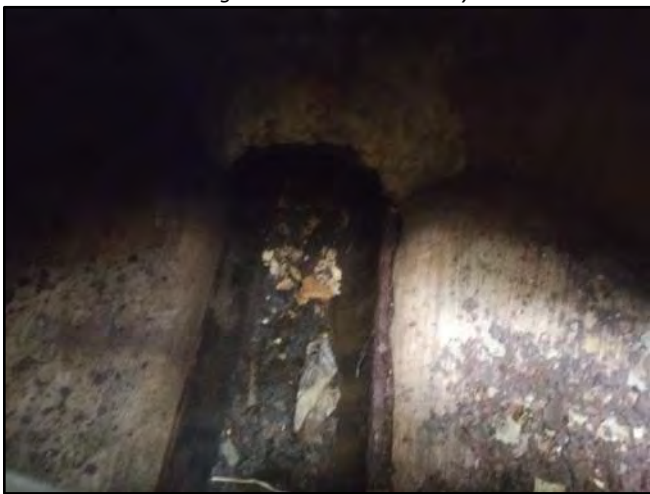
Image 5 – East Effluent Connection

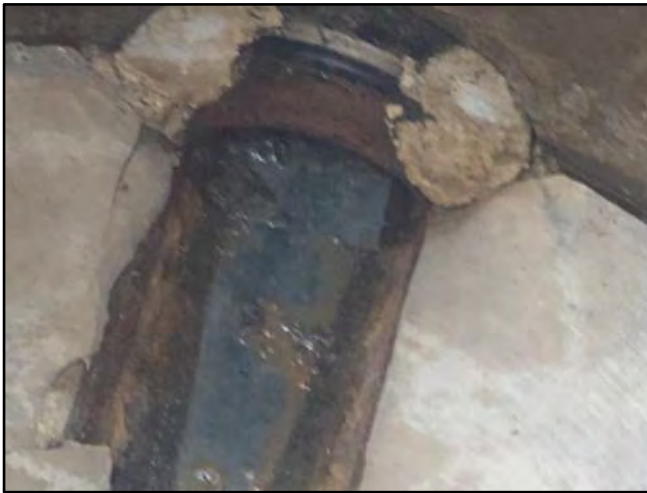
Image 3 – North Influent Connection

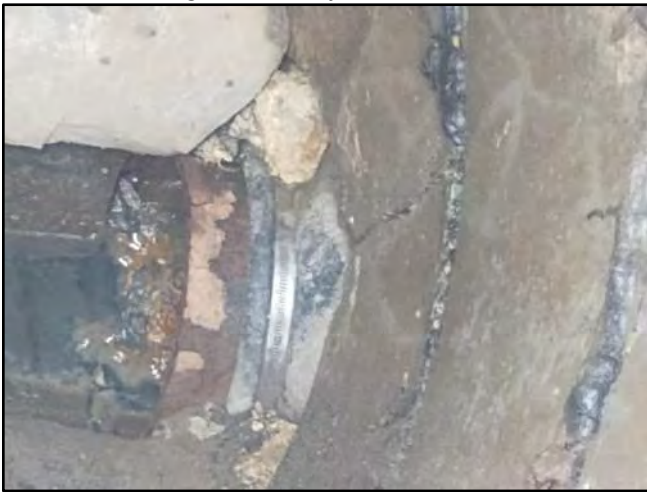
Decent grouting, pipe somewhat exposed
Z-boot connection with vertical crack above
Graded score of 3

Image 5 – East Effluent Connection and Crack

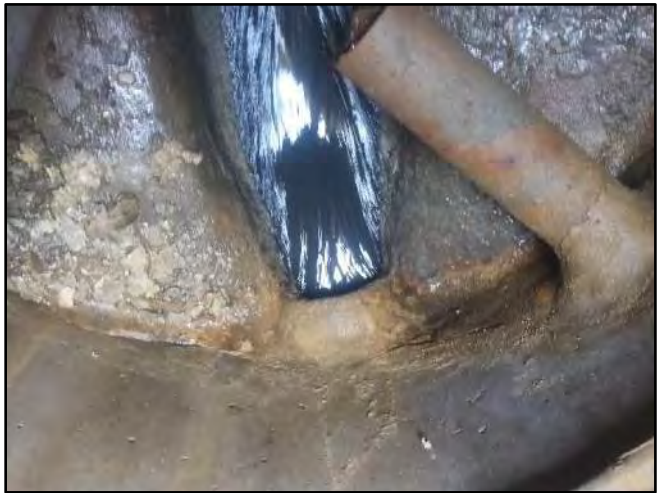
Solid grouting
Substantial Mineralization / Infiltration along West Influent Connection
Graded score of 3

Image 4 – West Influent Connection

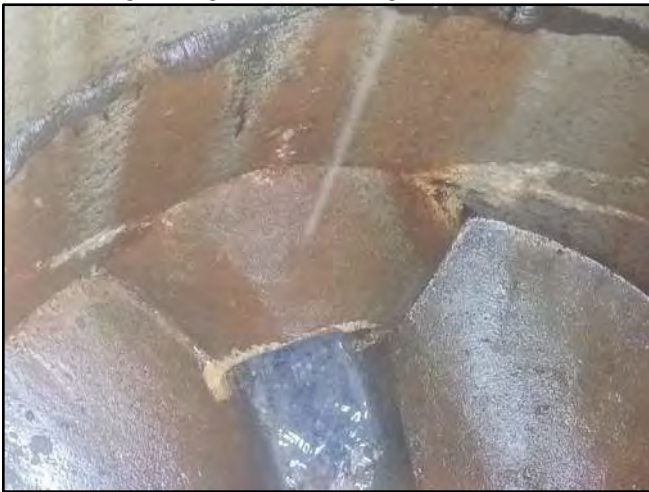
Solid grouting
 Large crack extending from North side of connection
 Significant mineralization
 Graded score of 2

Image 5 – West Influent Connection

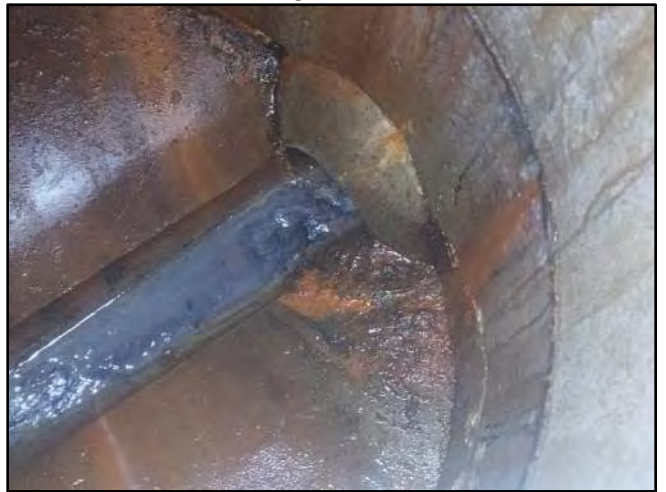
Solid grouting
 I&I Drippers present on both sides of connection
 Large crack extending from South and North end of connection
 Moderate mineralization
 Graded score of 3

Image 6 – East Effluent Connection

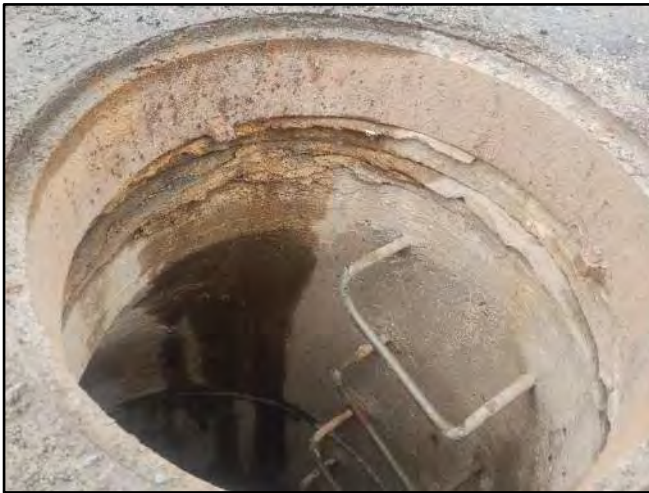
Image 3 – Cracks and Damage in Chimney

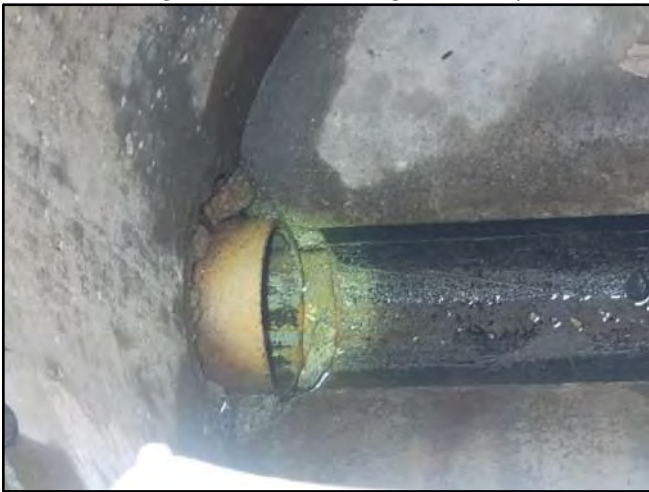
- Catchpan is rusted through and unfunctional
- No influent as North end of pipe ends in shear wall
- Steel bottom missing in invert right before shear wall, allowing I&I runner directly into pipe
- Steel bottom missing in invert directly before effluent connection as well
- Cone/base joint has some gaps, but no obvious mineralization
- All flow reflected in this MH is a product of I&I

Image 5 – Missing Invert and South Effluent Connection

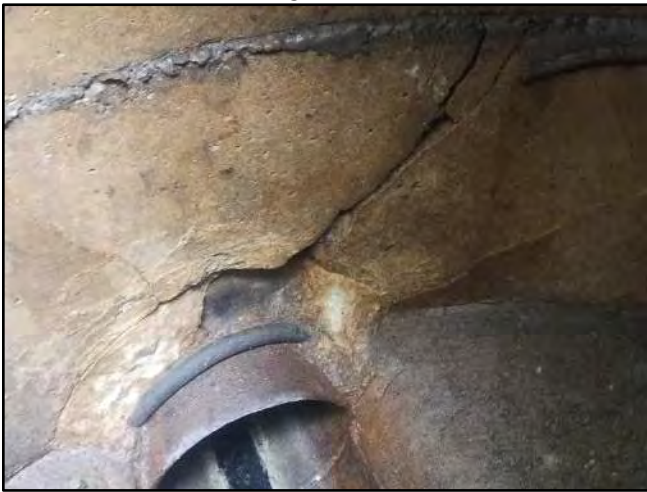
Large crack and missing piece of concrete above connection, some mineralization

- Significant structural cracking above both East and West Connections

Image 5 – West Effluent Connection and Crack

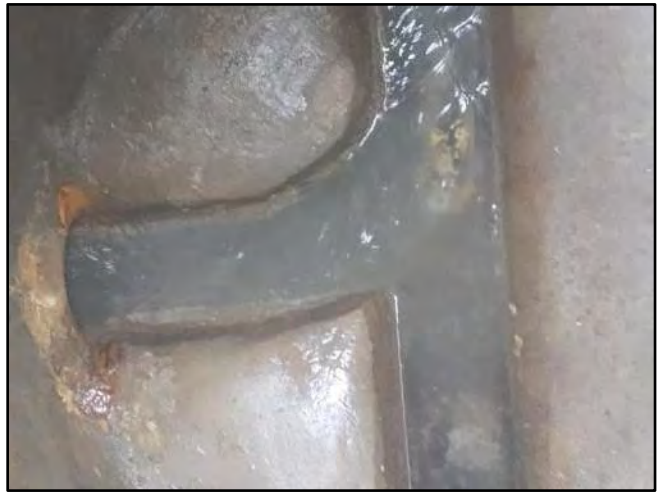
Image 4 – North Influent Connection

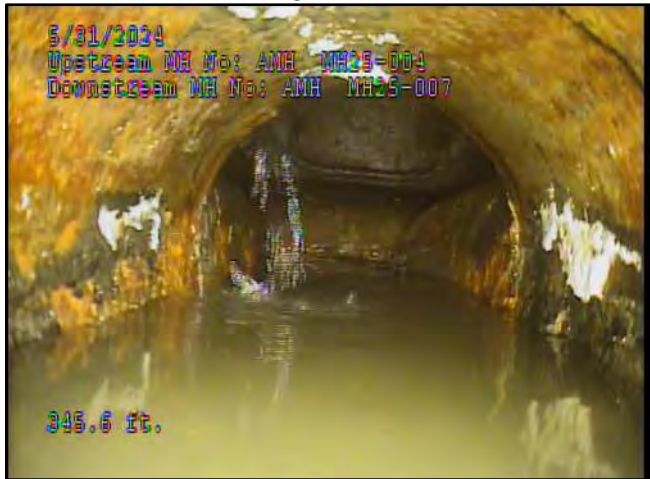
- Decommissioned 8" DI pipe connected 2 ft above West Influent connection
- Mineralization flowlines extending from not-in-use pipe connection
- Gusher difficult to discern until CCTV camera footage

Image 5 – North Connection Gusher CCTV

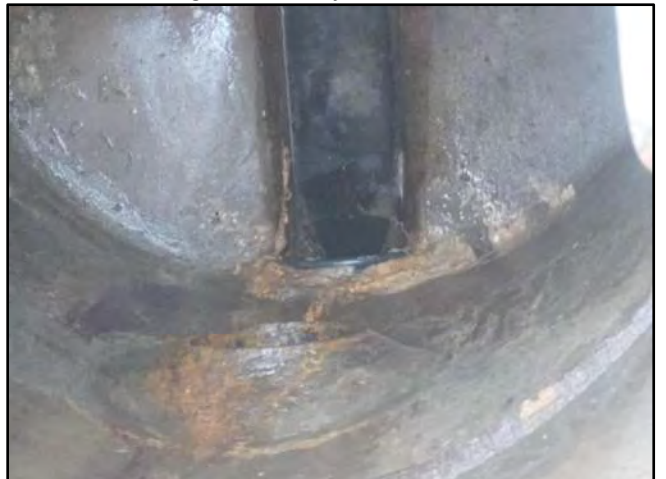
Image 6 – West Influent Connection

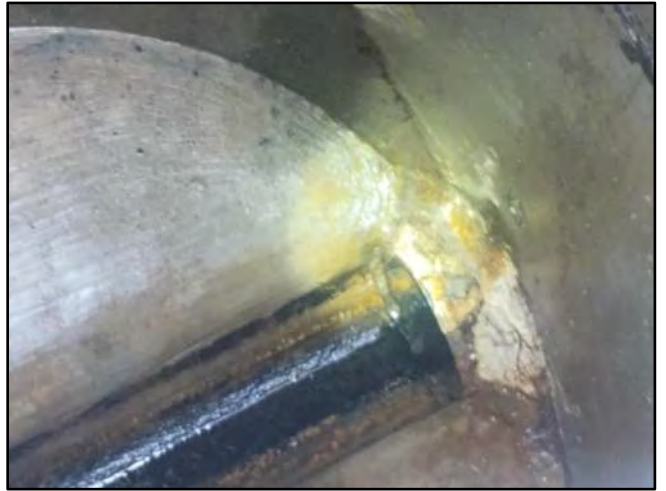
Crack extending from grouting with I&I dripper on North side of connection
Graded score of 3

Image 4 – West Influent Connection

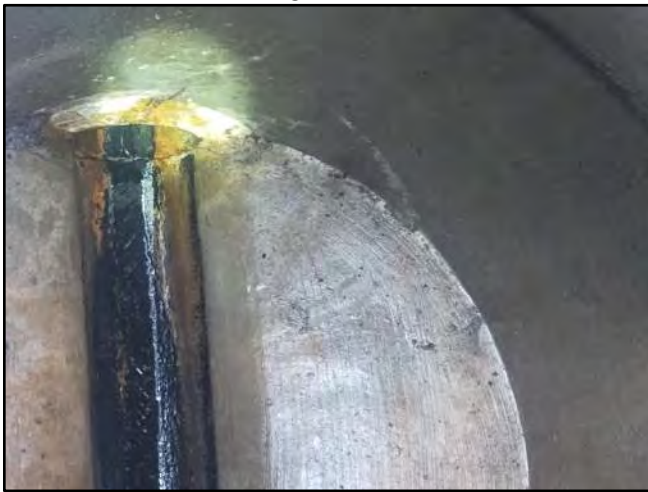
Mineralization and missing concrete above connection
Graded score of 2

Image 5 – East Effluent Connection

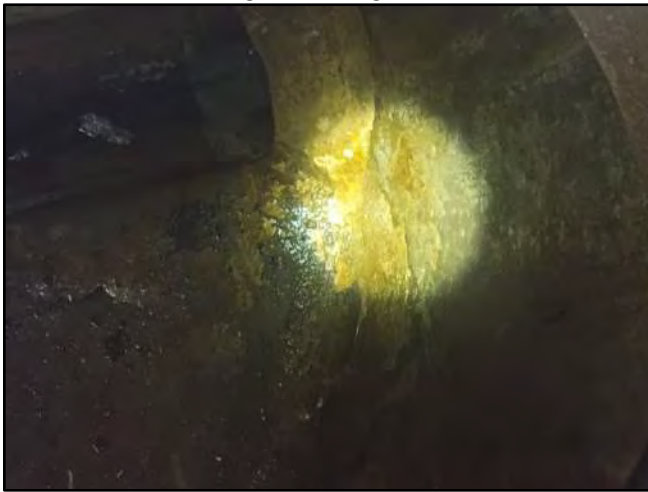
South end of pipe has crack extending upwards
Heavy mineralization
Graded score of 3

Image 5 – Northeast Influent Connection and Crack

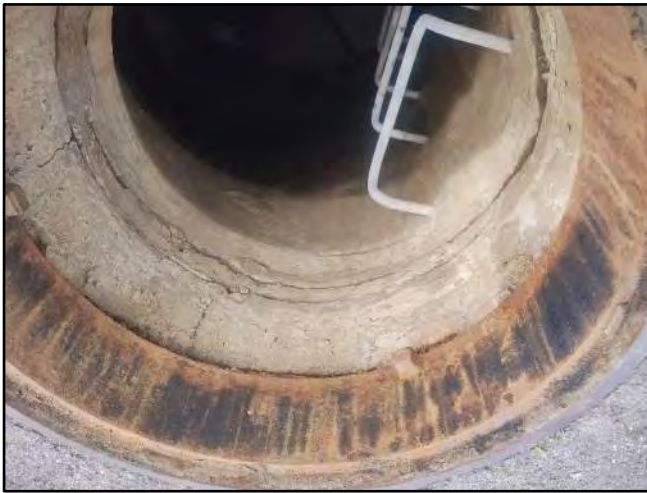
- 2 Reinforcing bars present, 1 is out of socket

Image 3 – Frame and Chimney

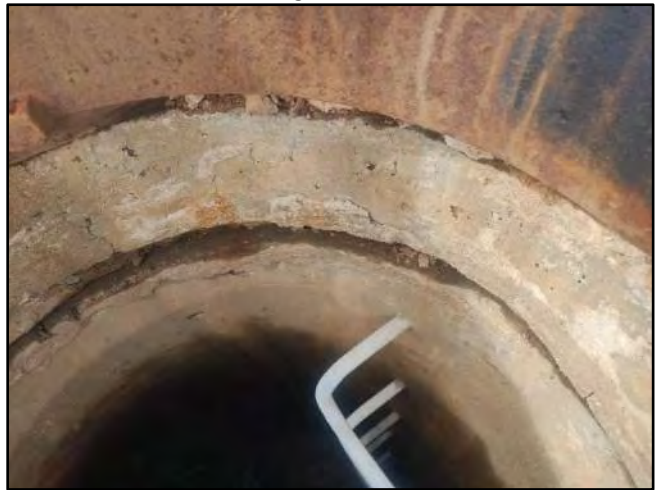
- Chimney and connecting joints are experiencing significant wear/crushing

Image 6 – Chimney Sections Eroding

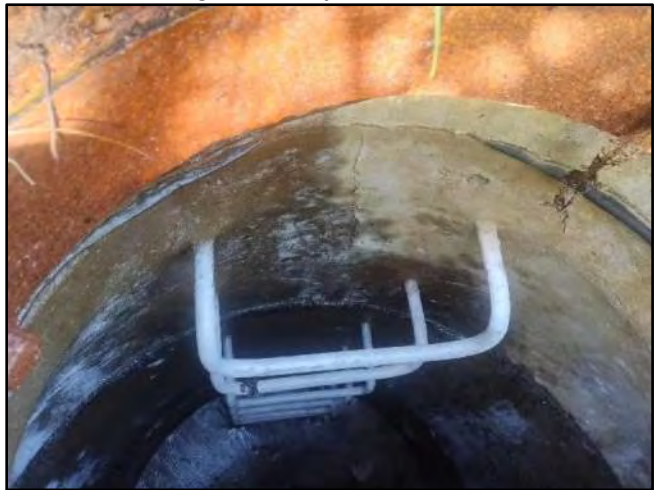
- Small crack along the East side of cone

Image 6 – Crack along cone

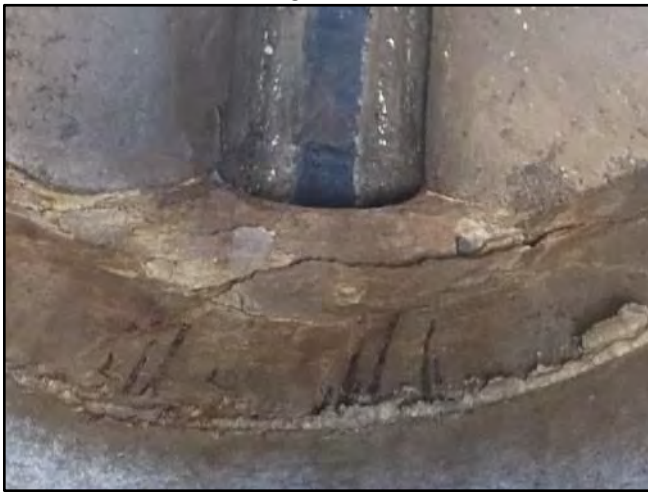
Image 5 – East Influent Connection

2" Depth of concrete missing above South connection
 1" Depth of concrete missing above North connection
 Graded score of 4

- Hairline crack along base that runs half the circumference along the East side (No I&I visible)
- Influent Pipe connections are in very poor shape

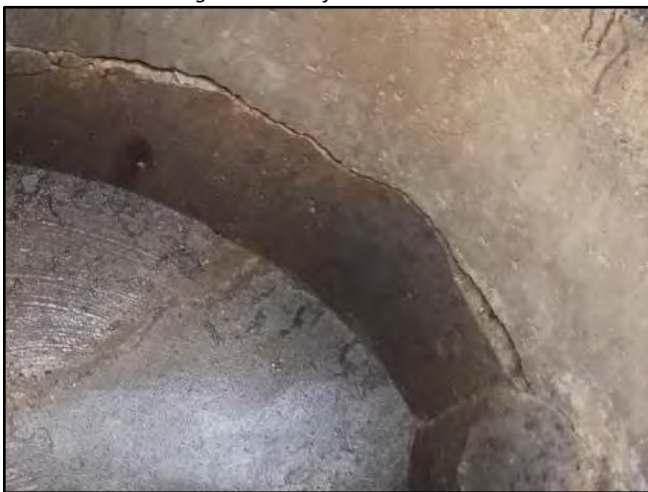
- Large crack along centerline of base for half the circumference along North side
- Several pieces of concrete missing
- Light mineralization descending from crack

Image 5 – East side of North Crack in Base

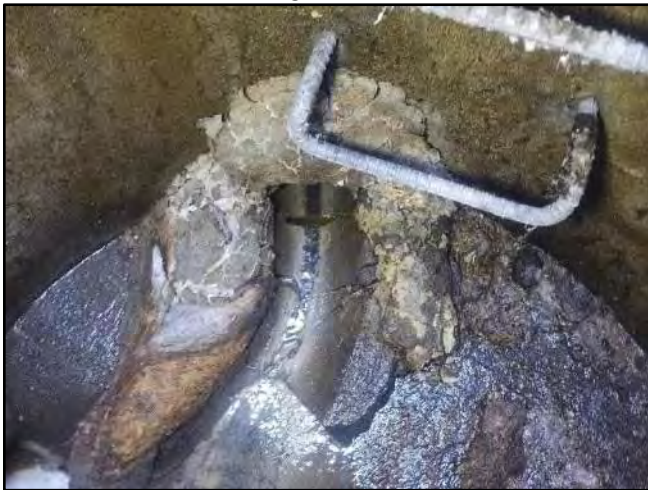
North connection has some grouting missing
Grouting soft and very brittle
Graded score of 3

Image 5 – Deteriorating North Influent Connection

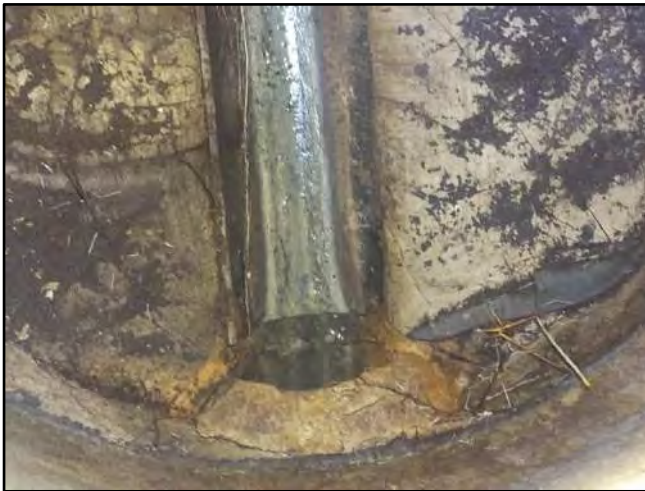
- South part of invert is missing pipe for 1" section
- Joint between cone and base is experiencing root intrusion on several sides
- Soil present along shelf before cleaning

Image 3 – South Influent with Missing Invert

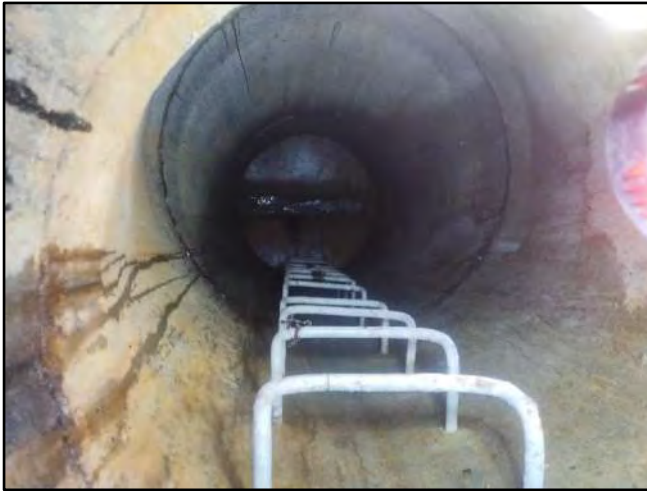
- Chimney and joint above cone are being penetrated by roots & organic matter

Image 3 – Chimney, Cone, and Stairs

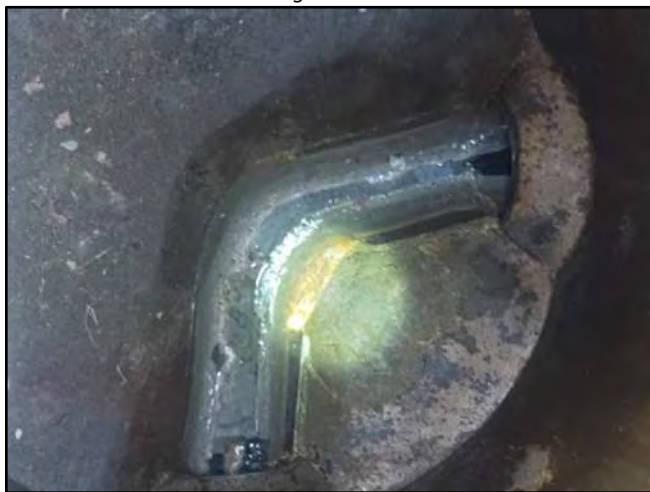
Image 5 – Missing Concrete on Shelf

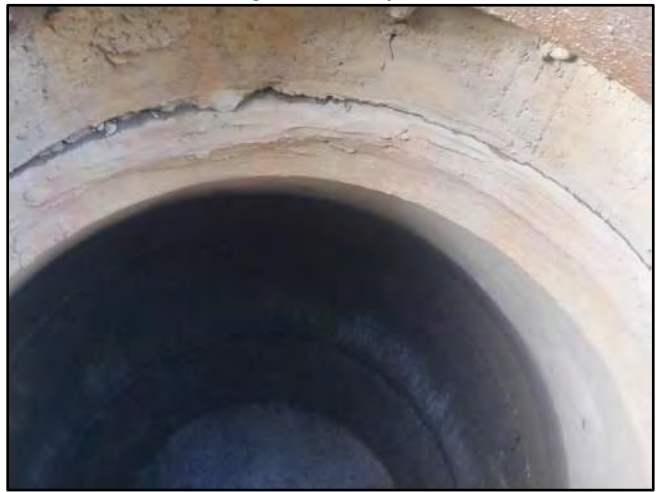
- Some concrete missing along chimney

Image 6 – Missing Concrete along Chimney

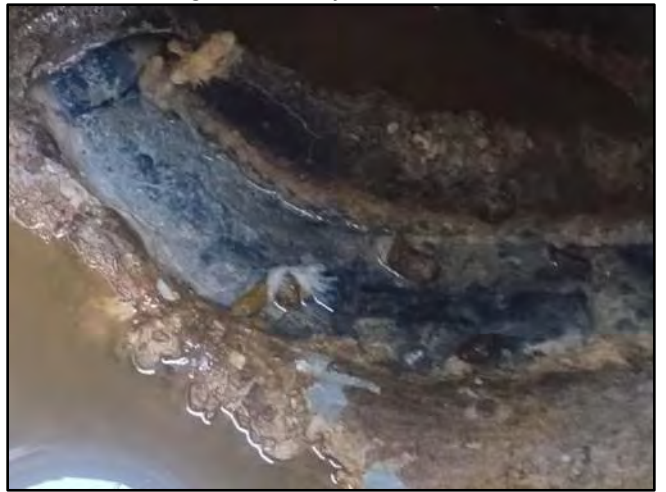
- Manhole is NOT a cleanout as listed on map
- MH is West of Intersection, not East as shown on map
- 3 inches of standing water present throughout the entire shelf
- Significant sediment/mineralization build-up lining the pipe

Image 6 – Solids Build-Up Lining Pipe

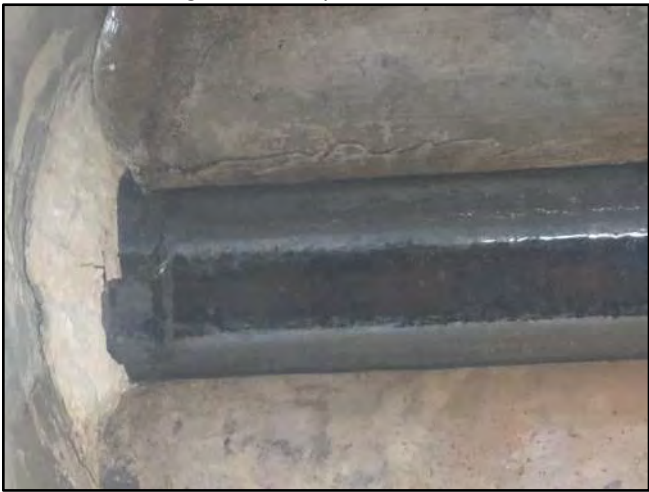
Solid grouting, small hairline crack
Graded score of 2

- Manhole is not labeled on original map and is 18" below road grade
- Catchpan is highly mineralized
- Small hairline crack present along East side of shelf
- Minor seepage North of West connection

Image 5 – East Influent Connection and Crack

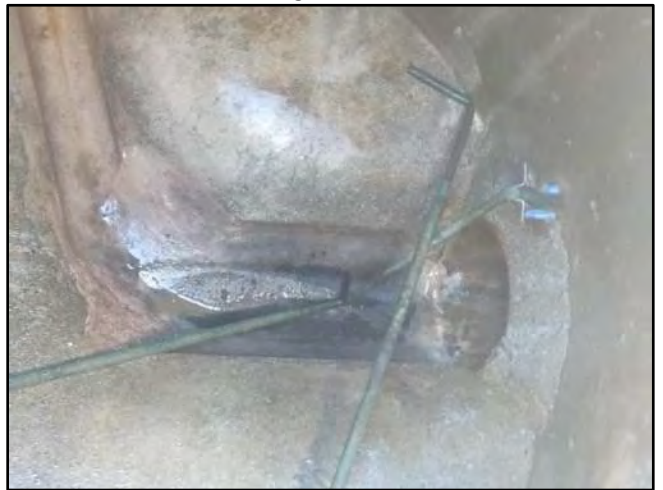
- Neither reinforcing bar is in place nor functional
- Pipe invert missing for approx. 6" section where the two pipes connect

Image 6 – West Effluent and Missign Invert
