Appendix C
MANHOLE SUMMARY AND REPAIR RECOMMENDATIONS

Talkeetna Sewer Condition Assessment

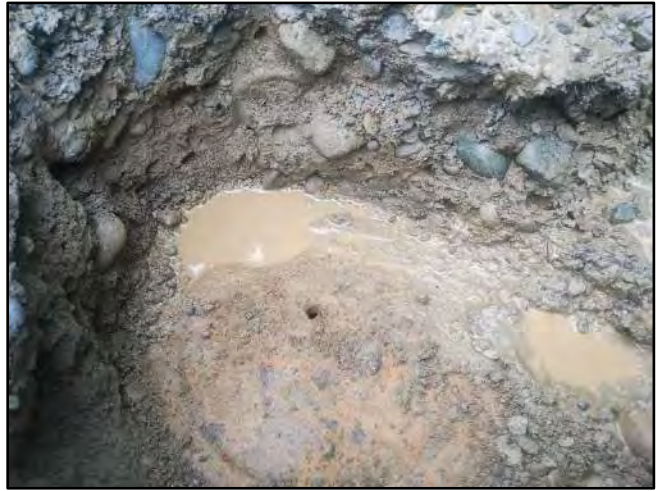
Image 4 – Cleanout Close-up

- Buried, exterior is highly mineralized

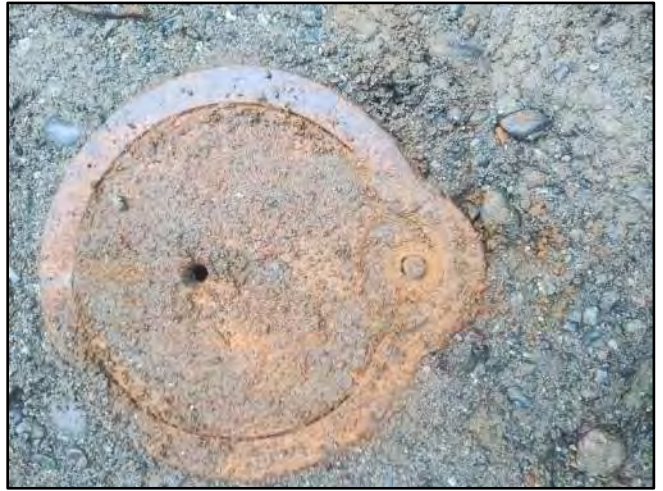
Image 4 – Cleanout Close-up

- Buried, exterior is highly mineralized

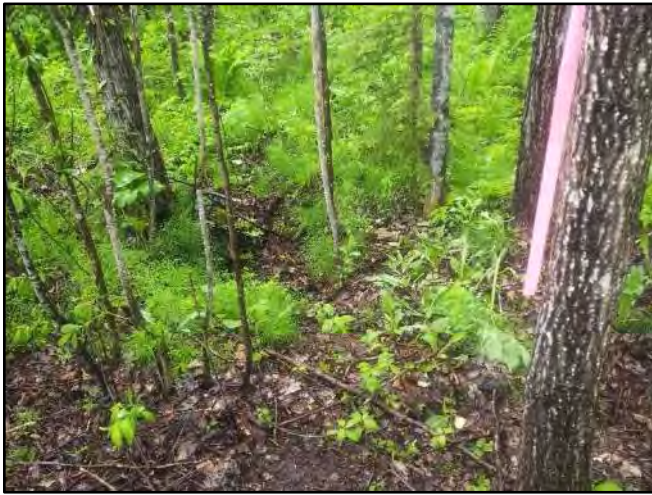
- Pipe appears to be running directly through a tree's root system

Image 1 – CO Facing West

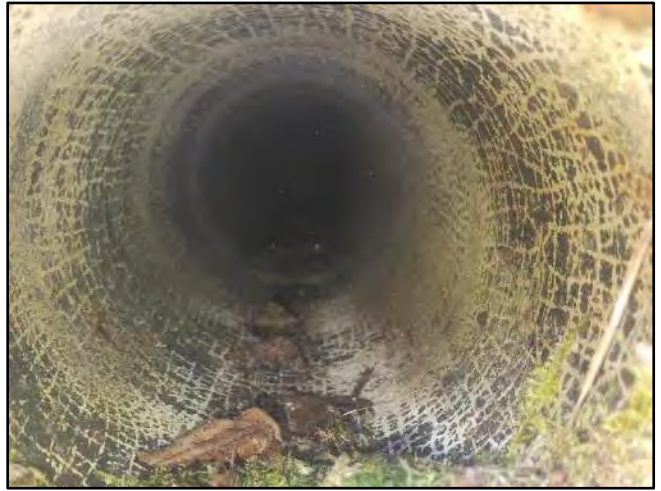
Image 4 – Cleanout Close-up

- Minor Hazard: the city's drinking water wells are within 200 ft of cleanout
- Cleanout does not have cover should it back up

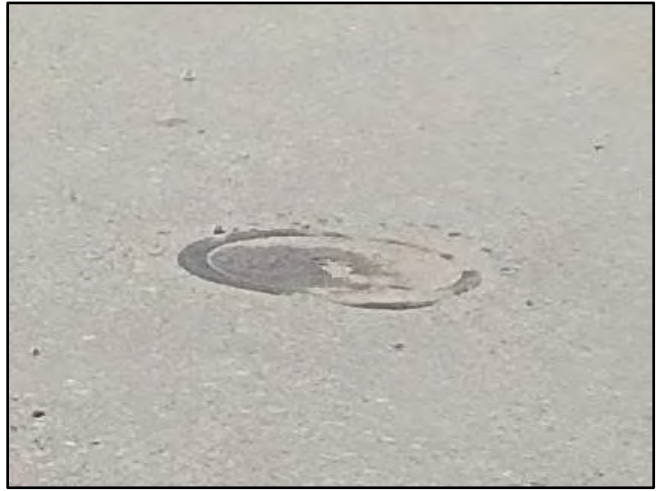
Image 4 – Cleanout Close-up

- Sediment build-up on lid, likely due to being slightly below grade

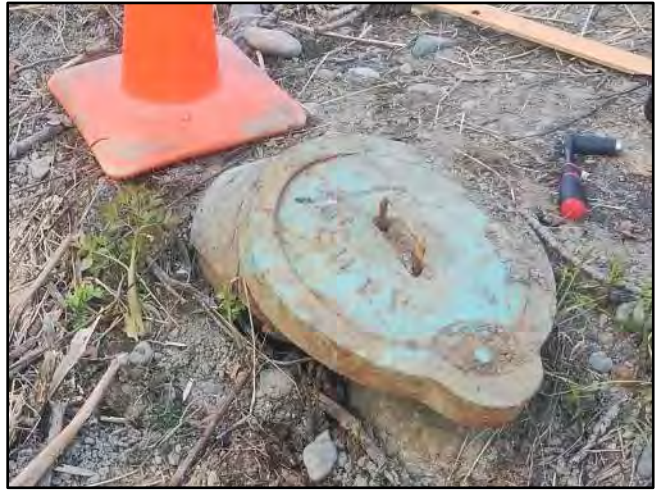
Image 4 – Cleanout Close-up

- Frame sits on top of effluent pipe connection, secured strictly via gravity
- Cleanout is exposed roughly 6" above grade, on very erodible surface

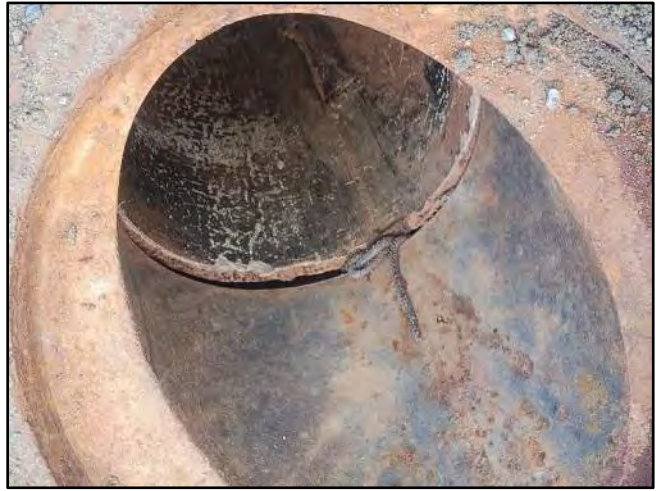
Image 4 – Cleanout Close-up

- Gap does not appear to be affected by I&I, well above the water table

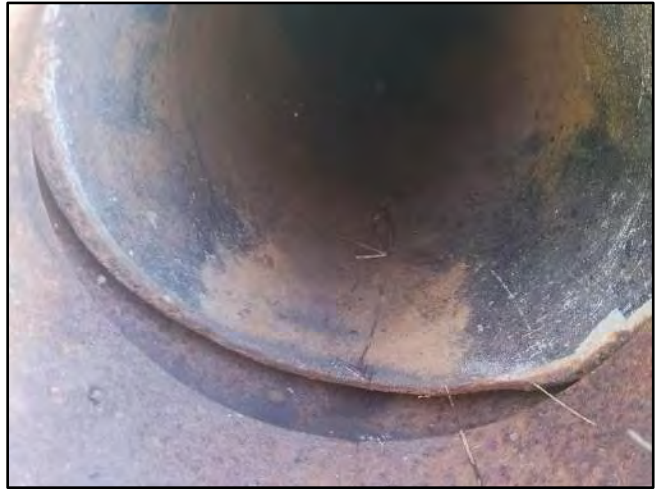
- Gap appears to be caused by large gouge in one side of pipe, while remainder of pipe is flush

Image 4 – Cleanout Close-up

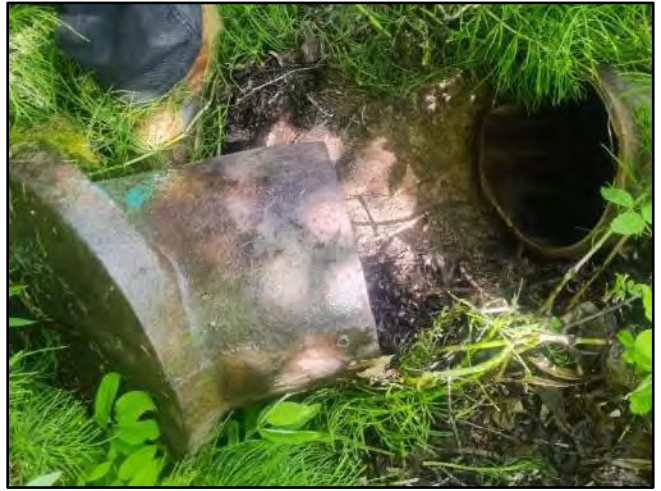
- Frame is secured via just gravity to protruding pipe

Image 4 – Cleanout Close-up

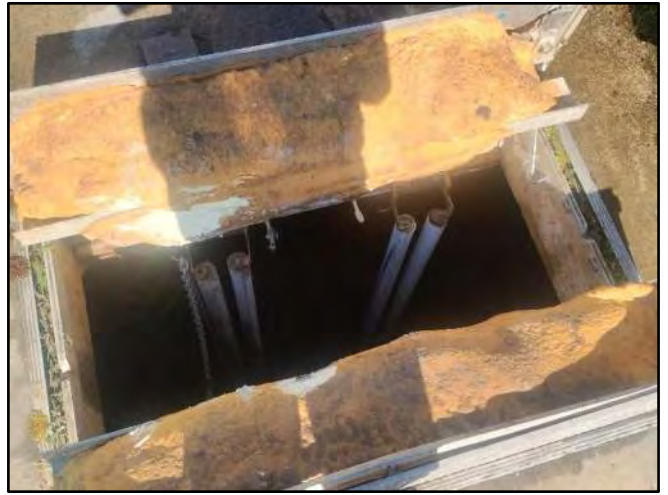
- Cover is located on 6' diameter concrete pad
- Heavy mineralization on steel frame
- Bottom of cover and reducing slab features 8" of insulation
- Before cleaning LS has approx. 8" thick FOG build-up around pumps and sidewalls

Image 2 – Cover and Frame

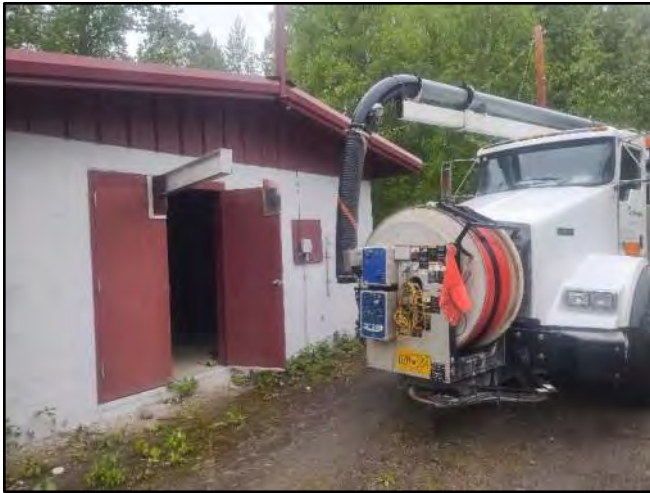
- Frawner was able to powerwash structure, but unable to vacuum it due to a closed roof
- Base of Lift Station widens out to approximately 10 ft diameter basin
- 2 grout repair sections in top barrel section, both appear solid
- No obvious I&I, nor heavy mineralization
- Biggest Concern: 1 ton winch's Metal I-Beam does not appear well-supported, hazardous to load to WLL

Image 1 – Lift Station Building Compared with Frawner Vac Truck

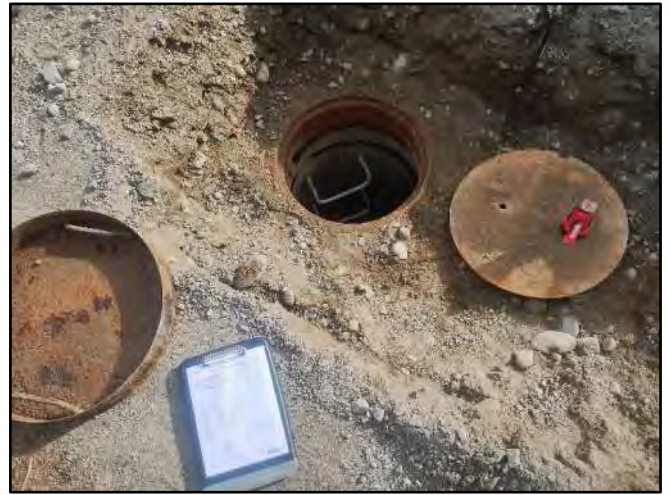
- Pipe directions are rotated approximately 45 degrees from Cardinal Directions
- Steps are present along opposite sides of MH
- Surface corrosion on frame and lid

Image 2 – Frame, Lid and Catchpan

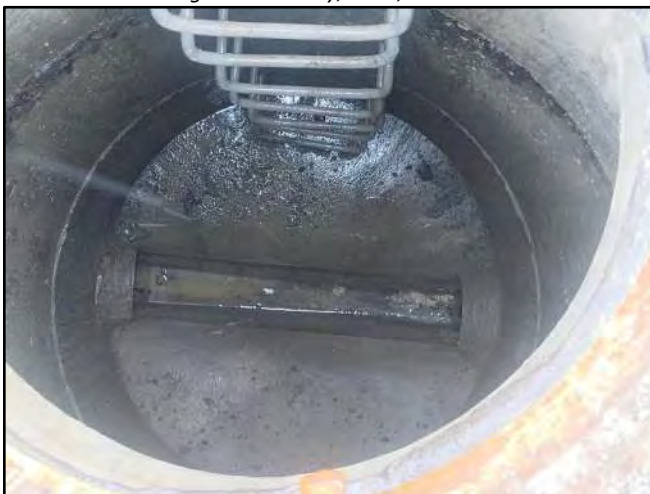
Image 5 – Base and Cone

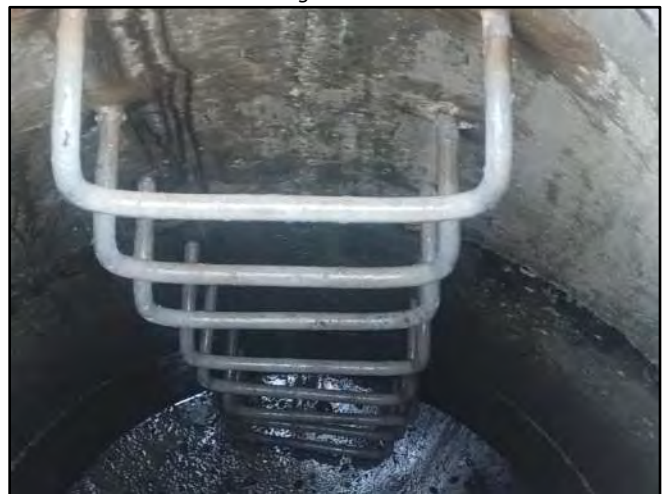
Image 6 – Stairs

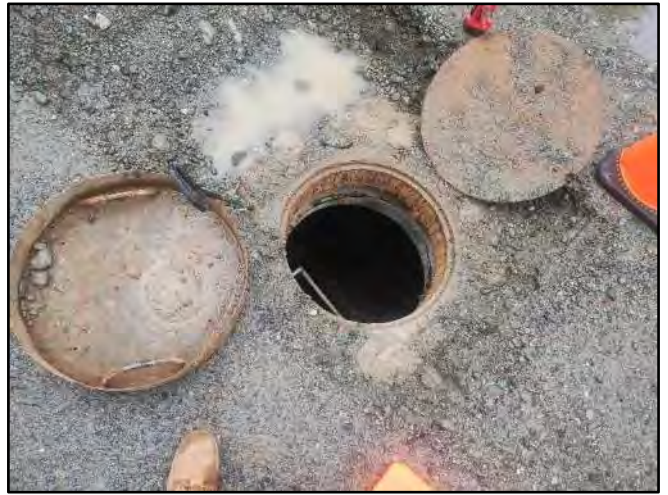
Image 2 – Frame, Catchpan and Cover

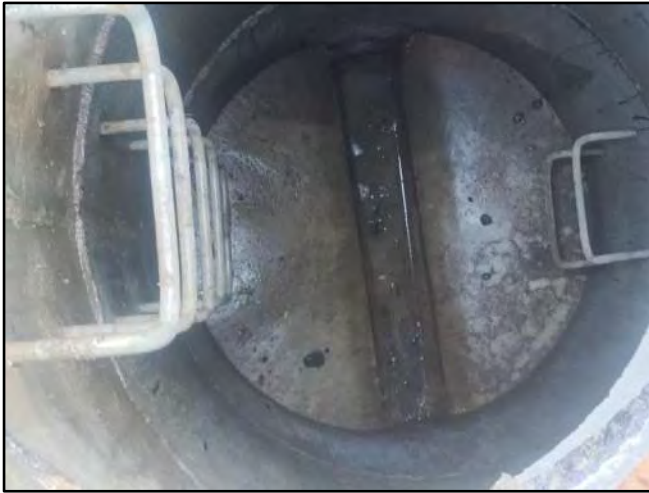
Image 3 – Base

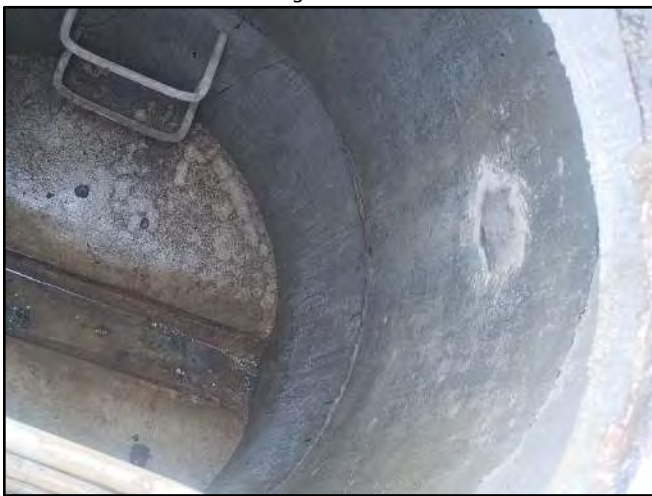
Image 5 – Base and Barrel

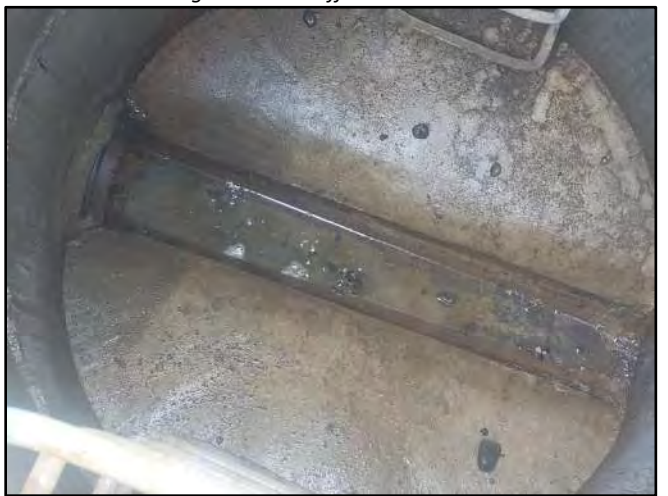
- Water within the pipe is static, standing water

Image 6 – Standing Water

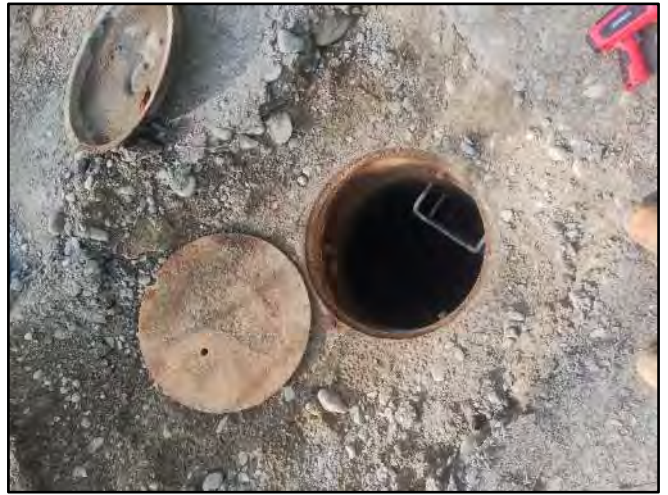
Image 2 – Frame, Catchpan and Cover

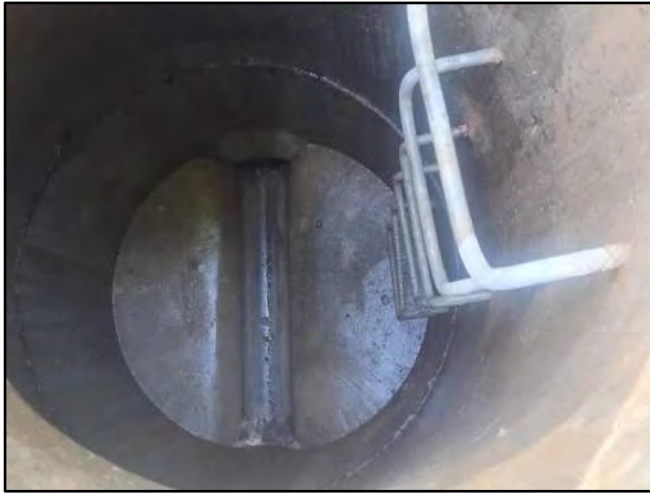
Image 3 – Base

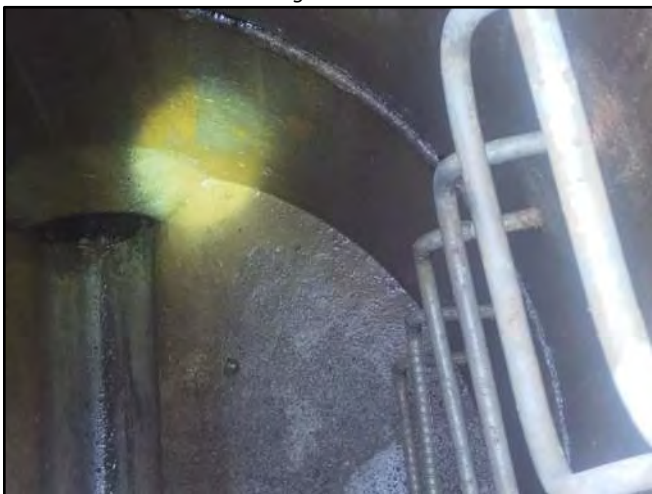
Image 5 – Mineralization

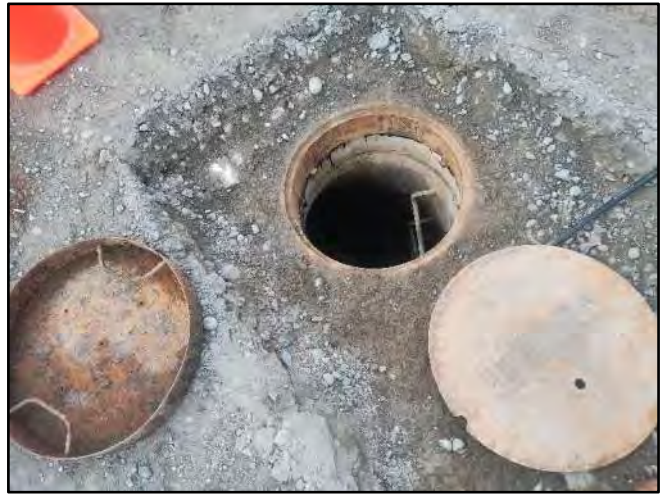
Image 2 – Frame, Catchpan and Cover

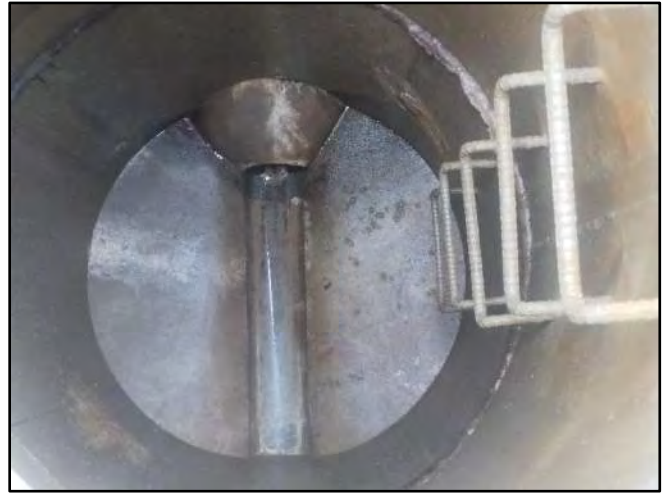
Image 4 – Base

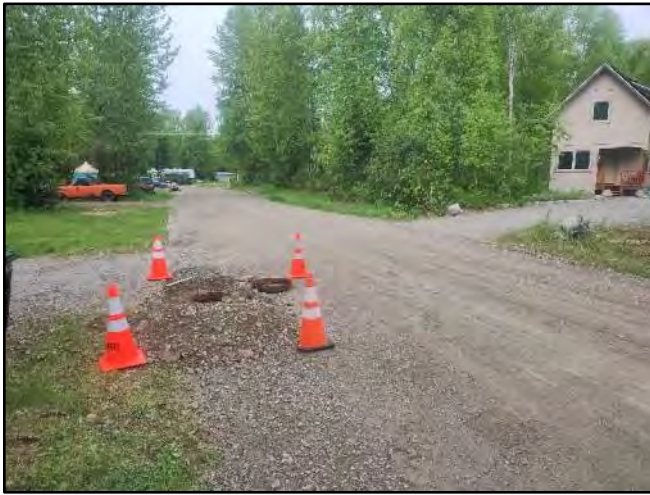
Image 1 – MH facing North along Easy St

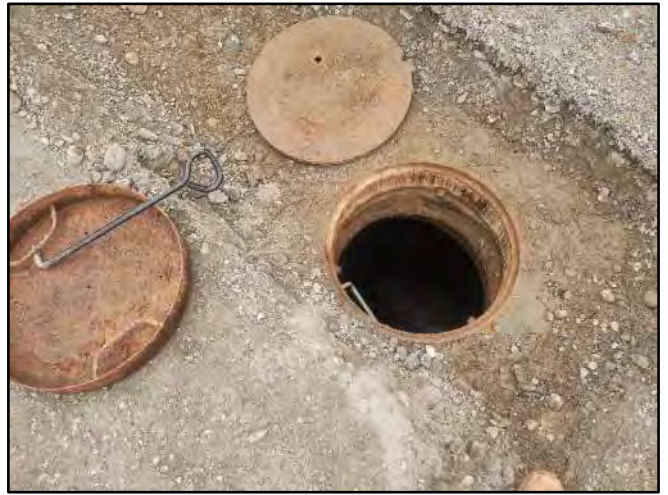
Image 2 – Frame, Catchpan and Cover

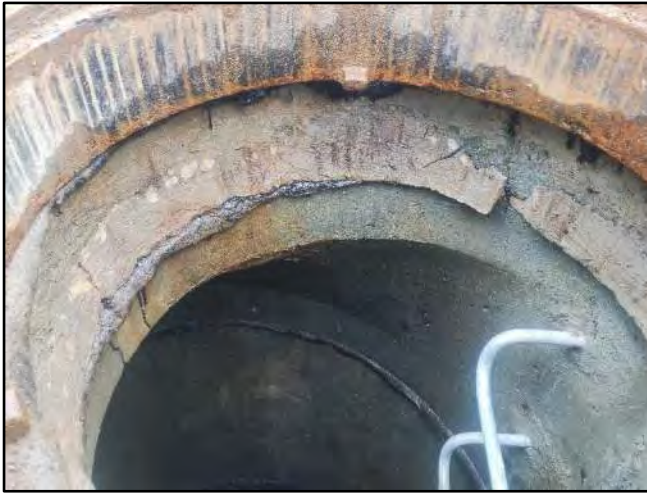
- Chimney has significant vertical cracks

Image 3 – Chimney Cracking

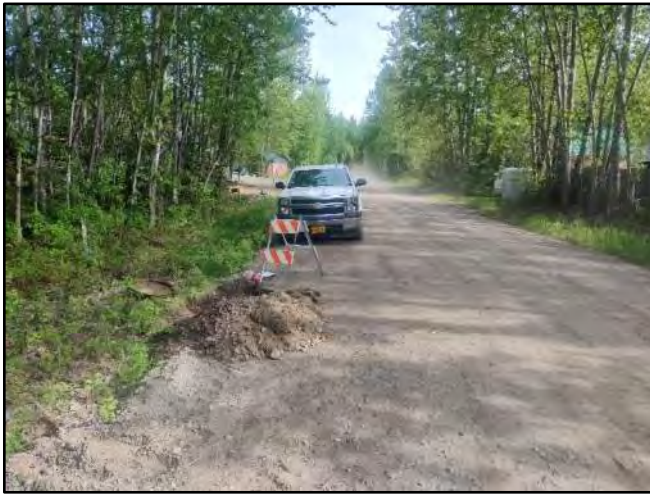
Image 1 – MH facing North along I St

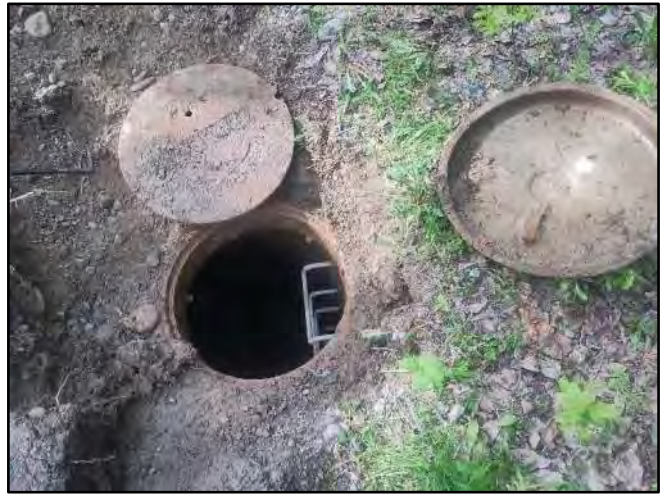
Image 2 – Frame, Catchpan and Cover

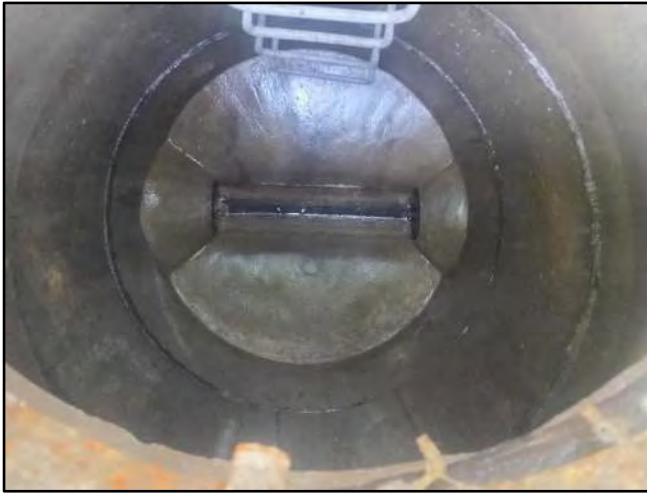
Image 3 – Barrel and Base

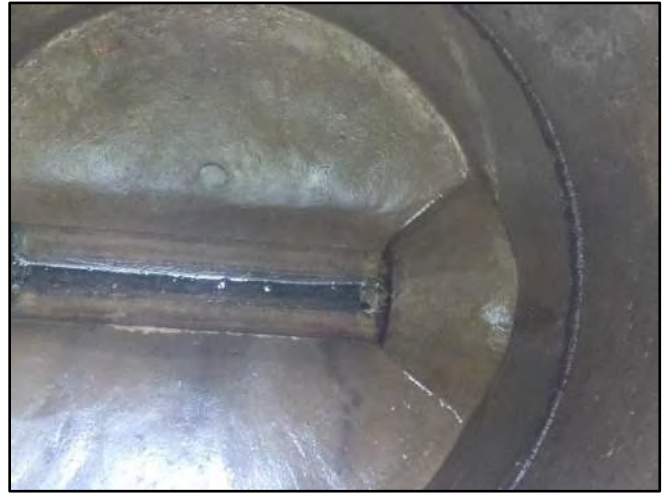
Image 4 – South Effluent

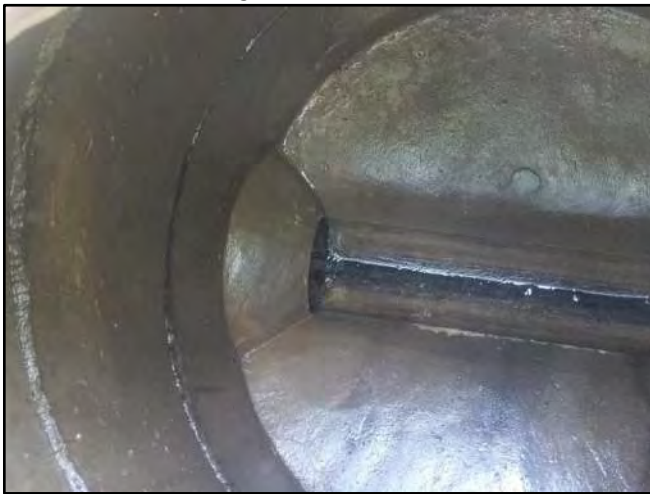
Image 5 – North Influent

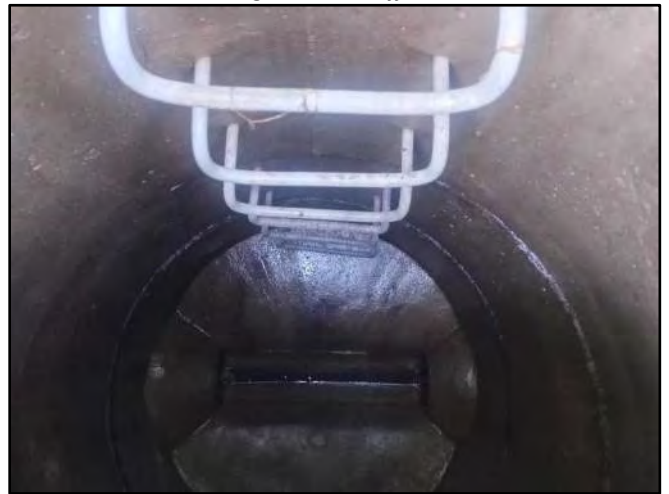
Image 6 – Cone, Stairs and Base

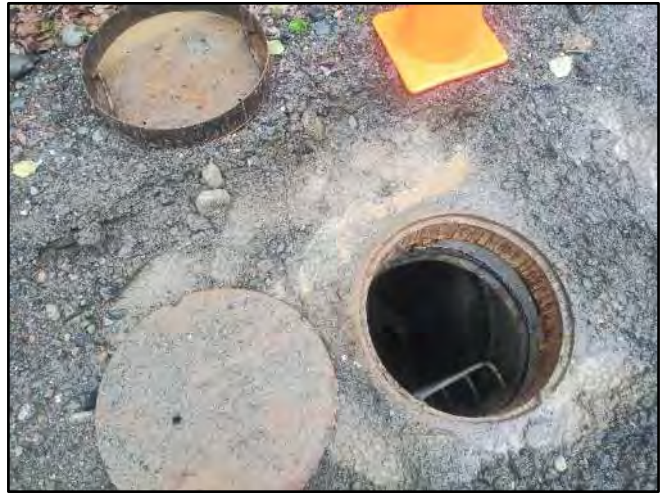
Image 2 – Frame, Catchpan and Cover

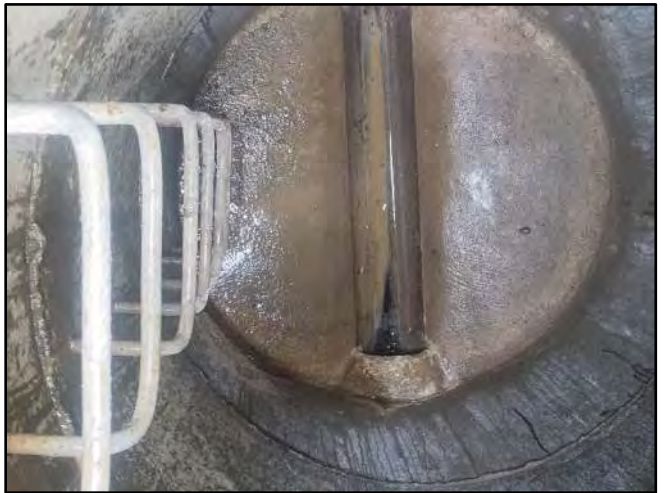
- Mineralization / I&I dripper in Northwest portion of base

Image 4 – Base

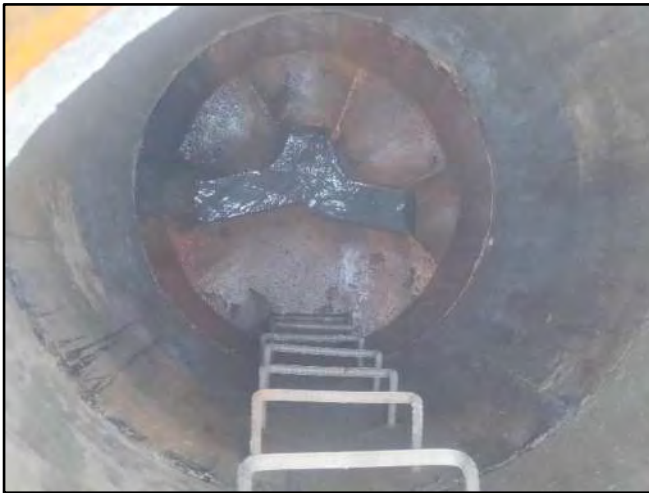
- Flowlines / Mineralization descending from barrel / base joint along all sides
- Several drippers present near South, West, and North side

Image 3 – Barrel and Base

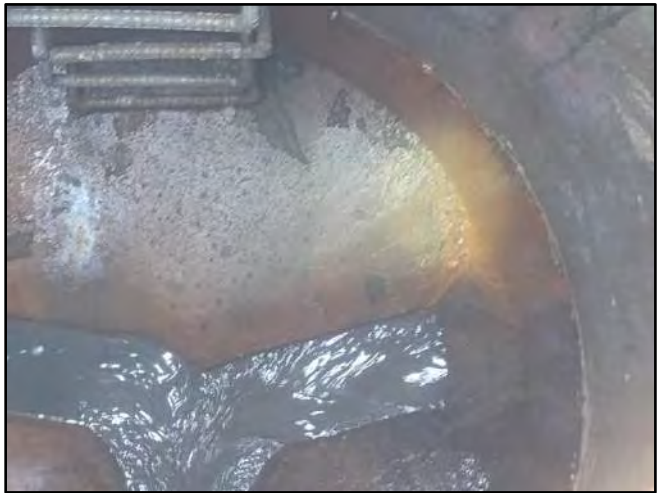
Image 4 – Dripper along South Section of Base

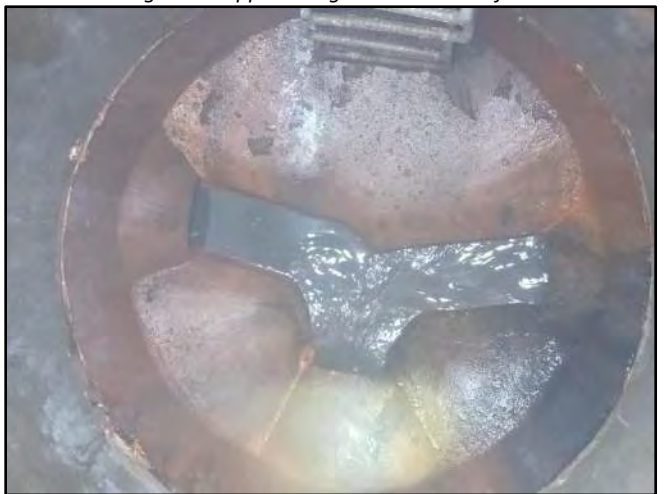
Image 6 – I&I atop West Connection

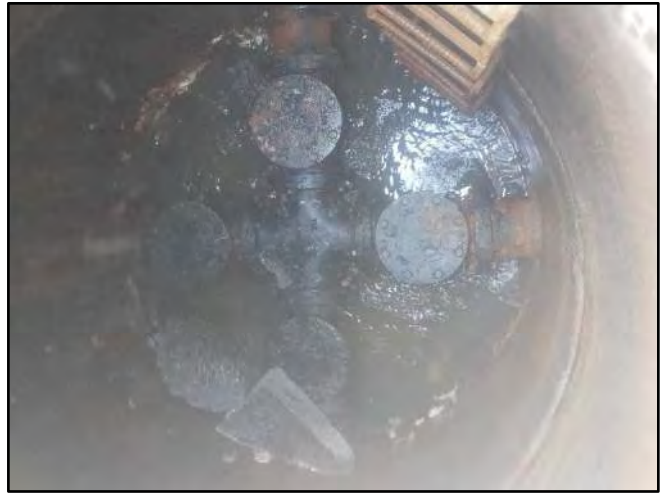
- All pipes are closed & sealed within manhole, no pipe's interior is visible
- Extremely heavy I&I with multiple gushers present along South and West portion of base
- Base is very corroded, likely experiences freeze/thaw damage as ice was present upon opening
- Unclear whether I&I enters the sealed pipes

Image 2 – Closed Pipe System

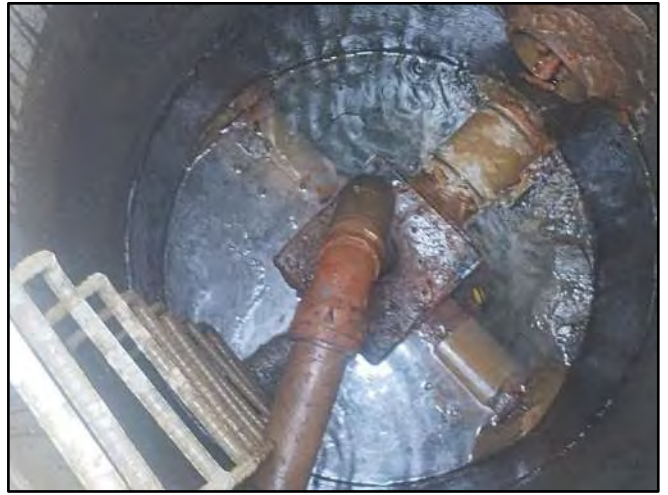
- All pipes are closed and sealed within manhole, no pipe's interior is visible
- Manhole's volume refills at approximately 6 in / min (approx. 50 gpm)
- No obvious signs of I&I into the pipes
- Massive I&I gushers along SE and North side of base

Image 2 – Closed Pipe System

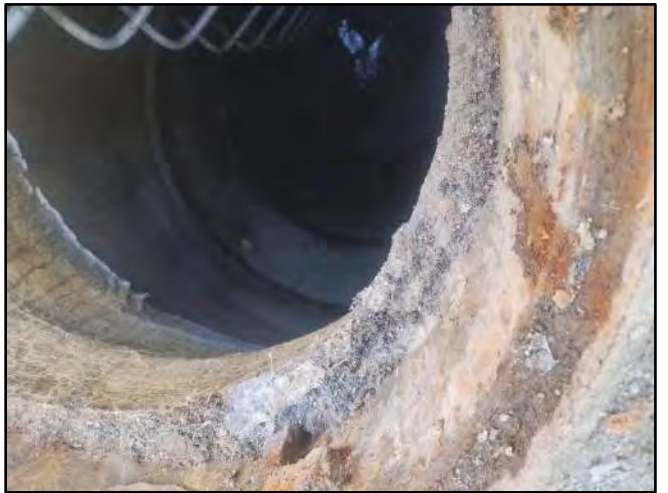
- Frame & Cone approximately 2" off-center from each other
- Both frame and cone are experiencing significant root intrusion
- I&I occurring around shelf, likely a product of poor connection seals
- Large crack in the shelf

Image 4 – Root Intrusion along Cone

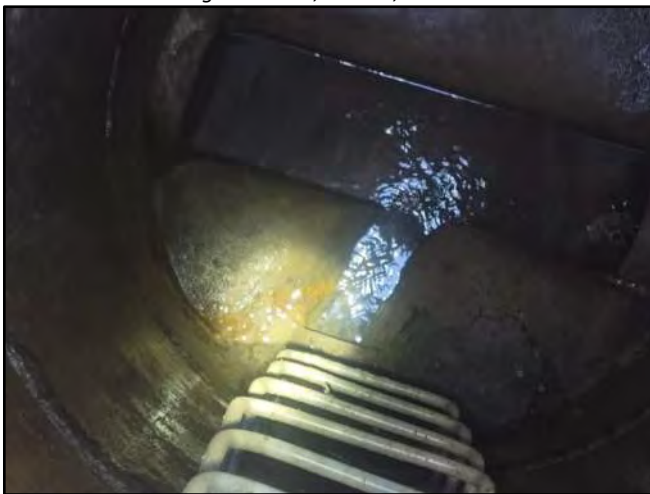
Image 5 – I&I Runner along East Portion of Base

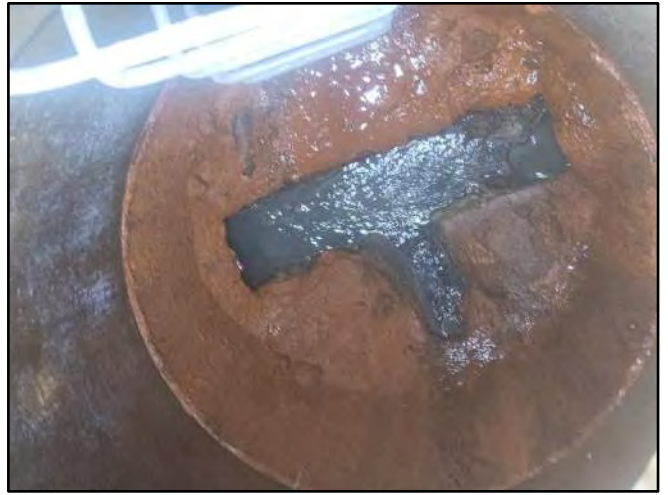
- Mass quantities of I&I coming from joint between barrel and base
- Mineralization suggests that I&I is occurring along the entire circumference of the joint
- Mineralization present on every base surface area, up to approx. 1" thick

Image 2 – Barrel and Base

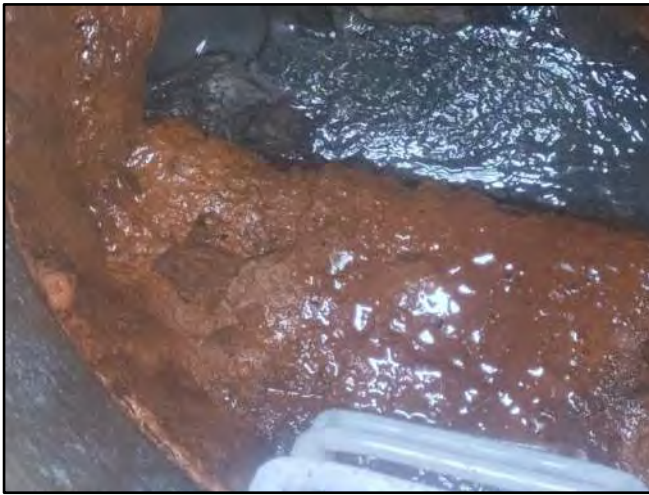
Image 3 – Standing Water along Base

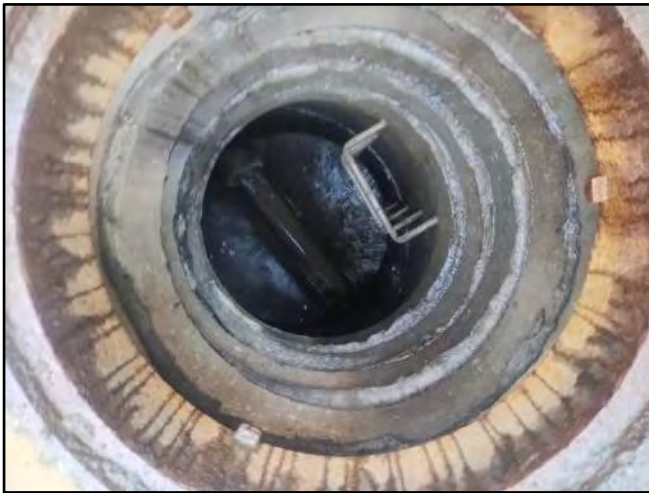
Image 3 – Frame, Chimney, and Cone

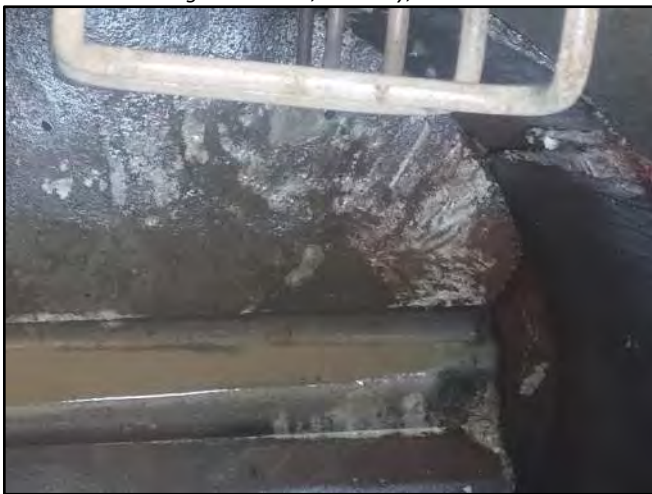
- Additional steps may be necessary for realistic accessibility
- Gradual offset between cone, chimney, and frame is approximately 2"
- Flowlines & mineralization along West end of shelf suggest I&I, difficult to determine in rainy conditions

Image 5 – Flowlines along West End of Base

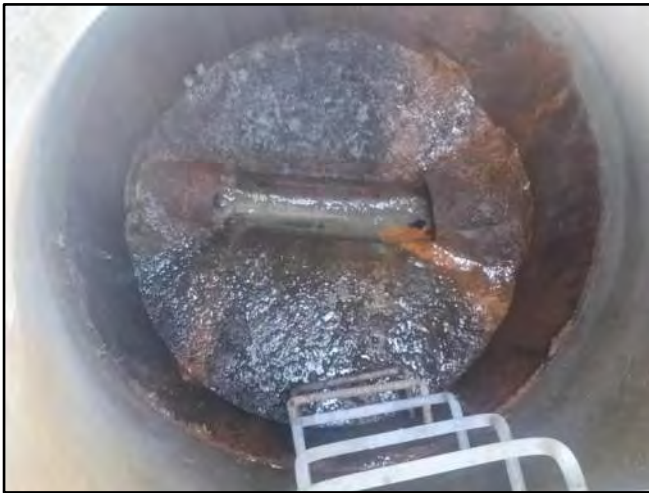
- South pipe exits at SSW direction
- Most I&I appears to be coming from the Base / Cone
- Joint, especially along North, East, and South sections
- Missing concrete, crack, and dripper along West side of Effluent connection

Image 3 – Base and Cone

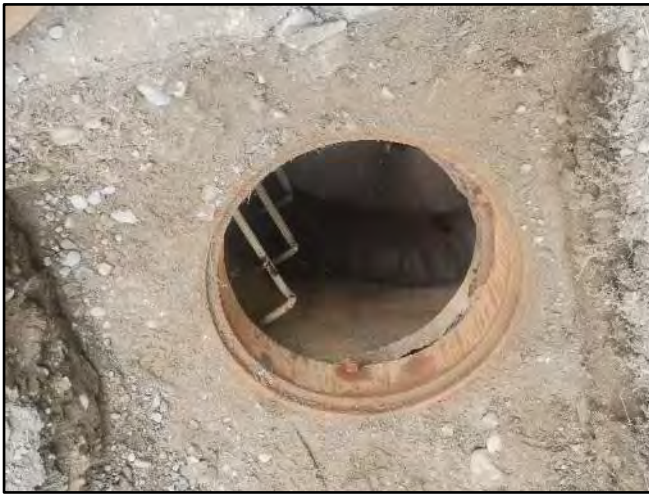
Image 3 – Frame and Cone Offset

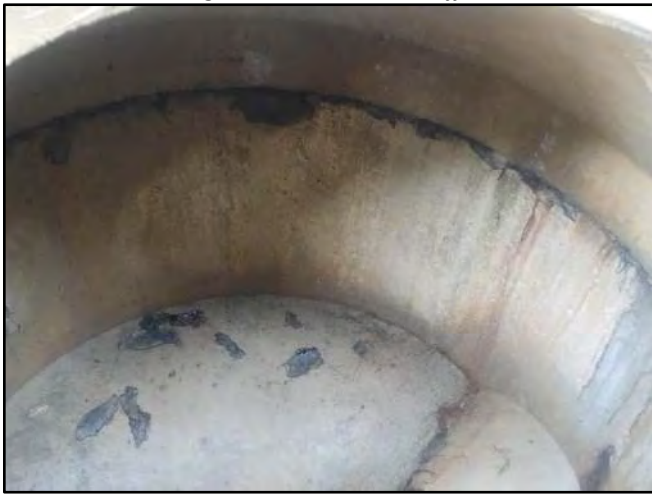
- No Influent Pipe as pipe ends at South end in shear concrete wall
- Frame is offset approx. 1" from cone and base
- Mineralization present on West side of effluent connection coming from cone/base joint
- Large portion of static water in the pipe's invert

Image 5 – Mineralization from Cone/Base Joint

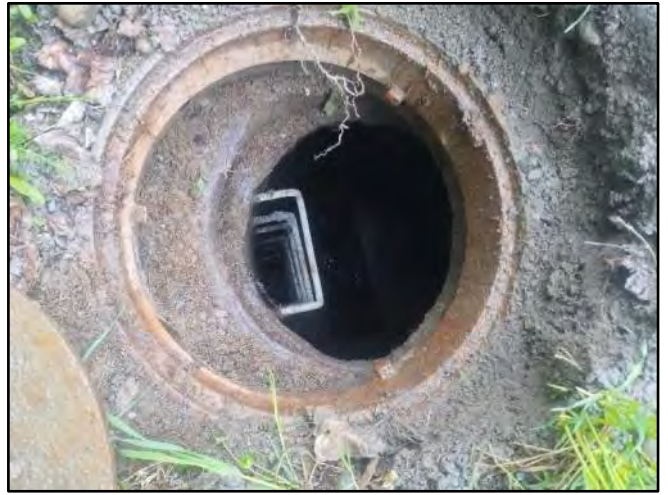
Image 2 – Frame, Chimney, and Cone Offset

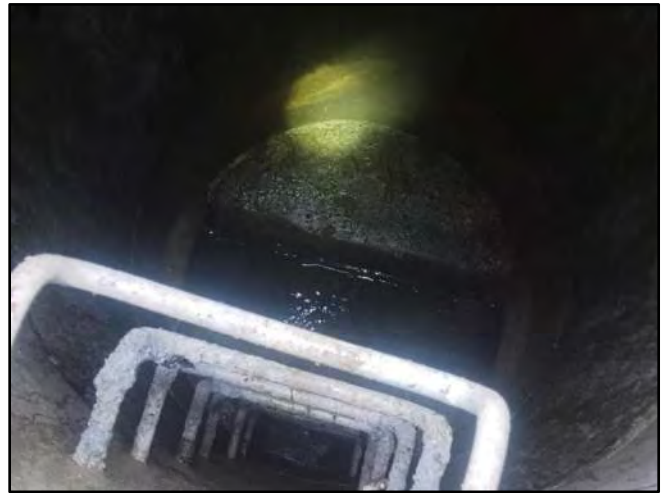
Image 4 – Mineralization along East Side

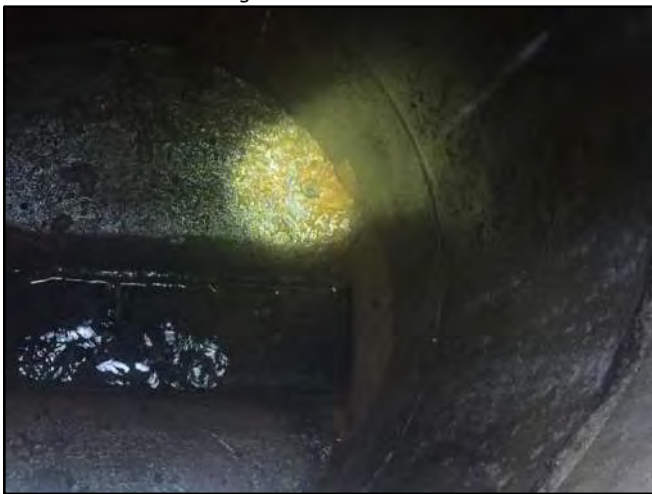
Image 5 – Mineralization and Dripper near Influent Connection

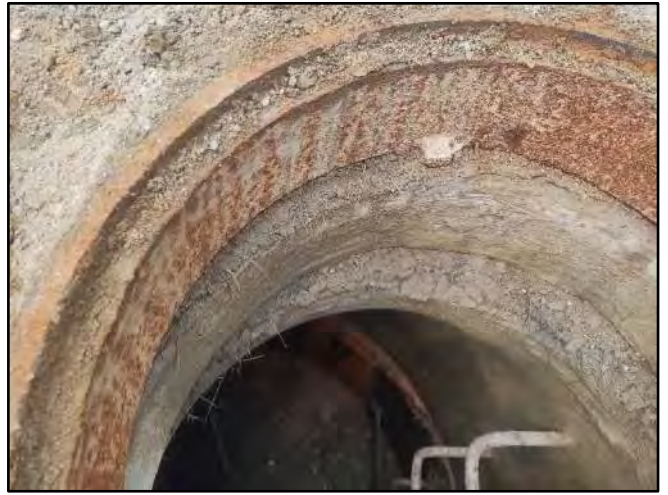
- Chimney & frame offset: 1"
- Cone & chimney offset: 2"
- Base & cone offset: 1"
- Root intrusion along joints between frame, chimney, and cone
- Heavy mineralization and I&I along base/cone joint
- Large cracks on North and South of base, unclear whether I&I is from these cracks or joints

Image 2 – Frame, Chimney, and Cone Offset

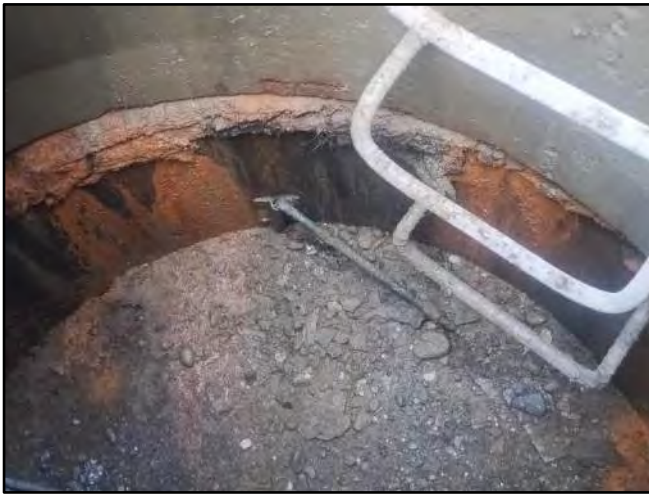
Image 3 – Cone and Base Offset

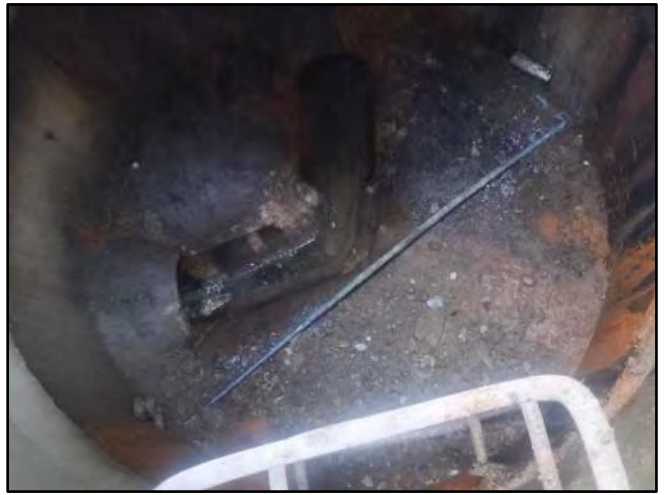
Image 4 – Base

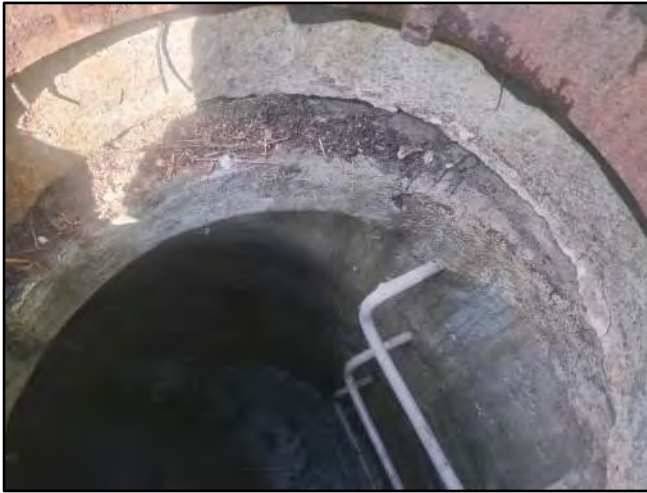
- No Influent as East pipe ends in a shear wall
- Chimney & cone are 4" off-center
- Root intrusion at base/cone joint
- Mineralization present along the South section of base

Image 3 – Chimney and Cone Offset

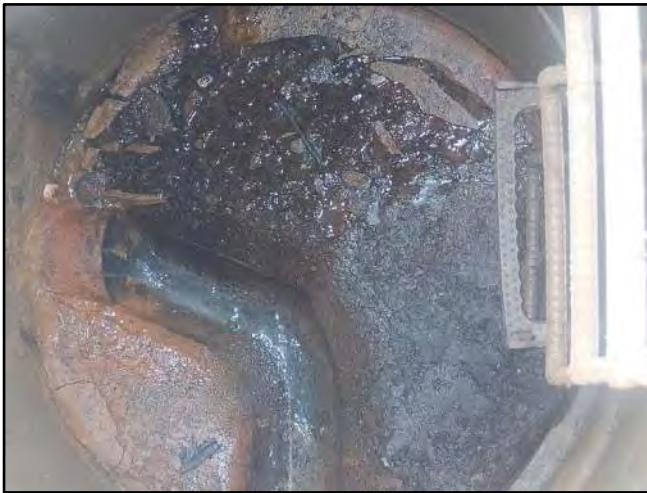
- Very heavy I&I along base directly at shelf
- Concrete shelf is eroding, cracking, and collecting debris
- Heaviest infiltration and standing water along East side of base

Image 3 – Base

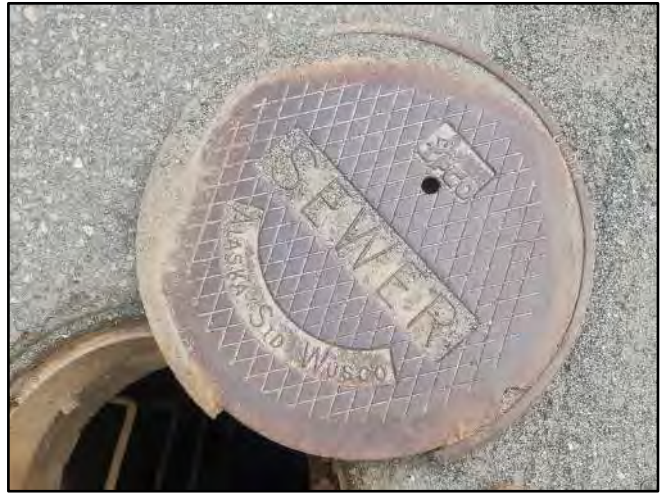
- Cover/Lid has permanently attached to frame and separated frame along the top seam
- Chimney and frame have 4" offset from cone
- Chimney section is experiencing significant cracking
- Evidence of I&I along joint between barrel and base

Image 2 – Cover and Frame Attached

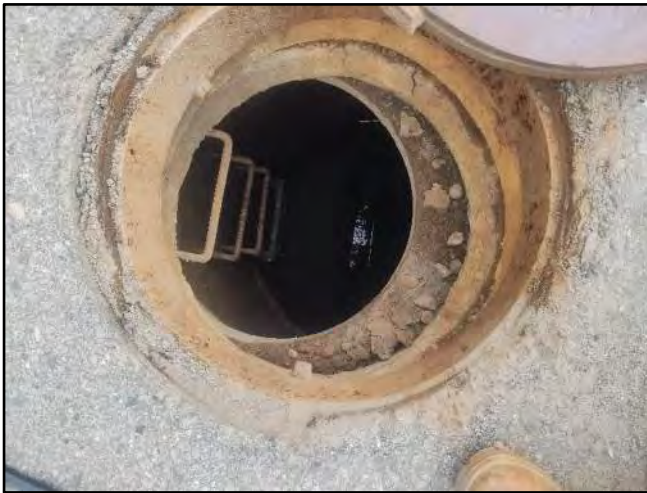
Image 3 – Chimney and Cone Offset

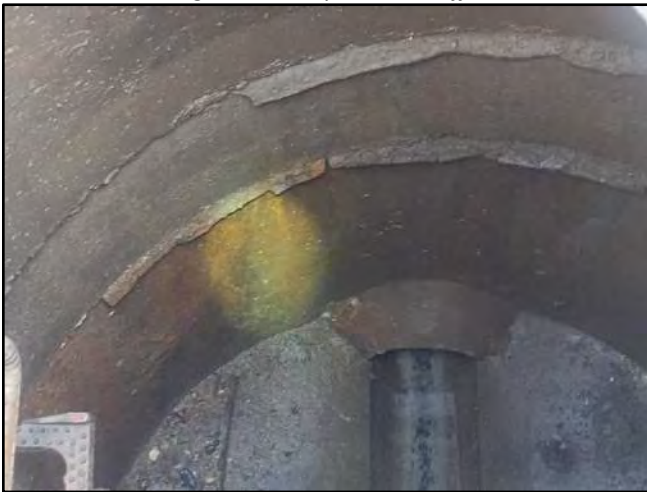
Image 5 – Mineralization and Influent Connection

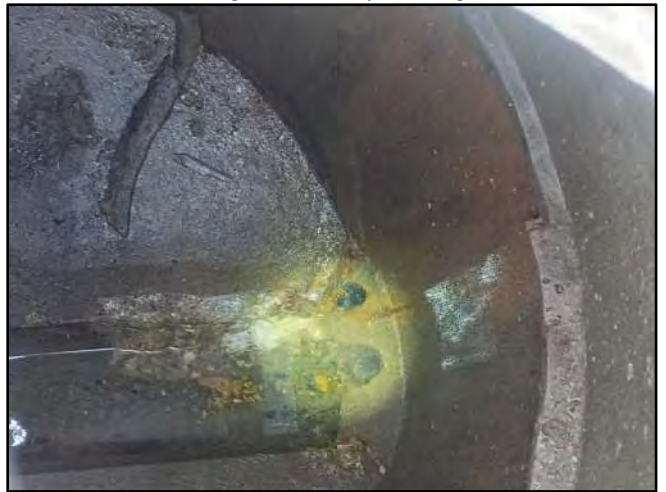
Image 6 – I&I Mineralization and Effluent Connection

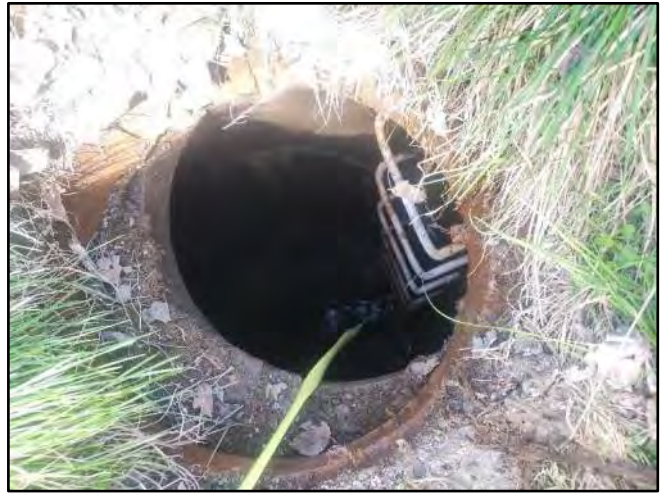
- Frame has shifted 6" off-center from cone
- Joint between frame and cone is experiencing major root intrusion
- Sludge and solids present on Southern section of shelf, high mineralization suggests I&I

Image 2 – Frame and Cone Offset

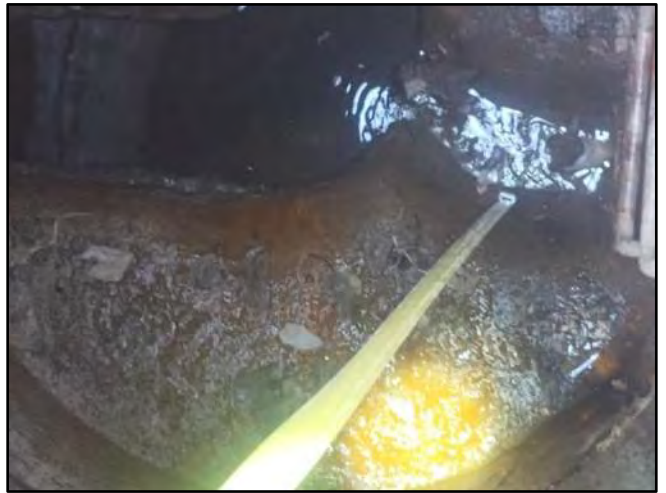
Image 4 – Mineralization on Southern Shelf

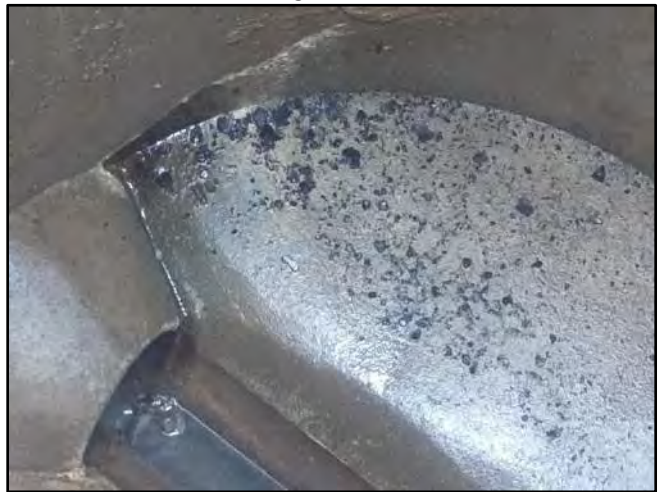
Solid grouting
 Crack and missing concrete along South end
 I&I Dripper and mineralization coming from crack
 Graded score of 2

Image 6 – South Effluent Connection and I&I Dripper

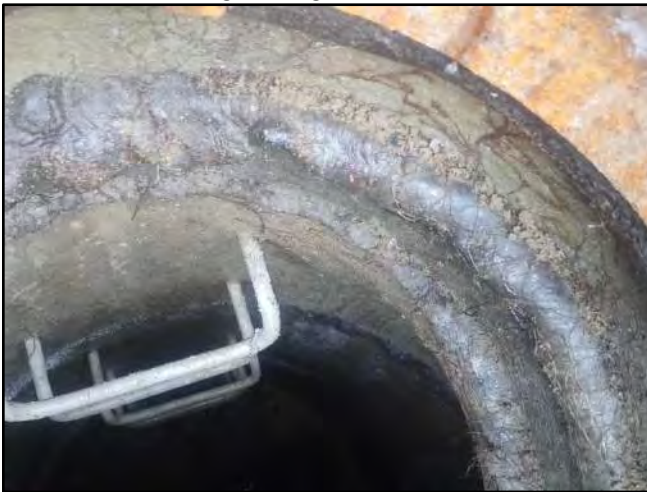
- Chimney layers are facing moderate root intrusion
- Large diagonal cracks in the base along East section
- I&I appears to come from the barrel/base joint, not from the cracks
- Mineralization from joint is present along North end of base

Image 5 – Root Intrusion along Chimney

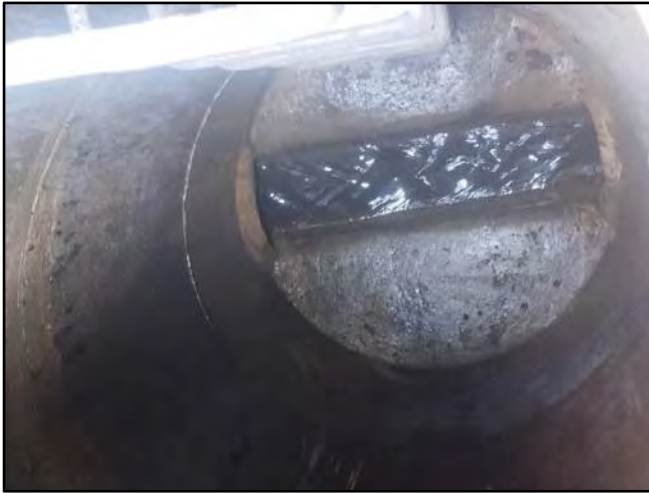
Image 3 – Barrels and Base
