Appendix C
MANHOLE SUMMARY AND REPAIR RECOMMENDATIONS

Talkeetna Sewer Condition Assessment

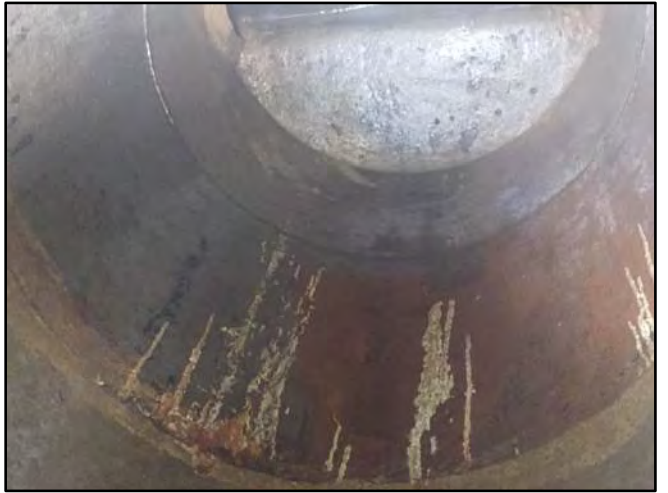
- All I&I appears to occur at the joint between the two barrels, especially along the East side
- More steps may be necessary for realistic MH access

Image 4 – Mineralization from Barrel/Barrel Joint

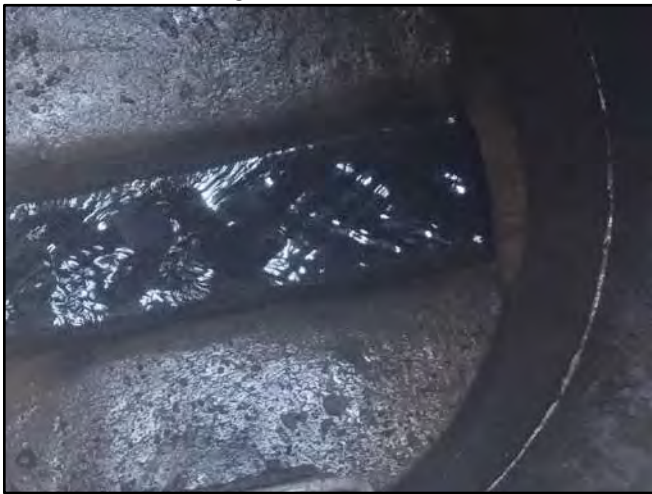
Image 5 – South Influent Connection
