Talkeetna Sewer Condition Assessment

SEWER STRUCTURE INSPECTION REPORT

Structure #: MH19-0037

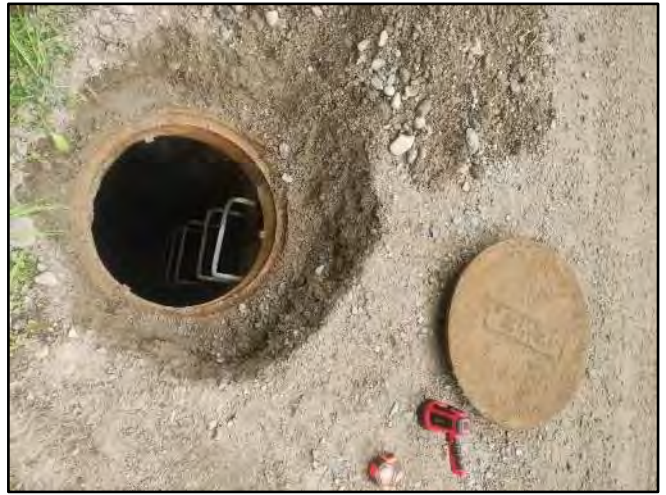
Cover/Lid: 25" Type – C.I. Score – 2

Frame: Height – 5" Type – C.I. Score – 2

Image 2 – Cover & Frame

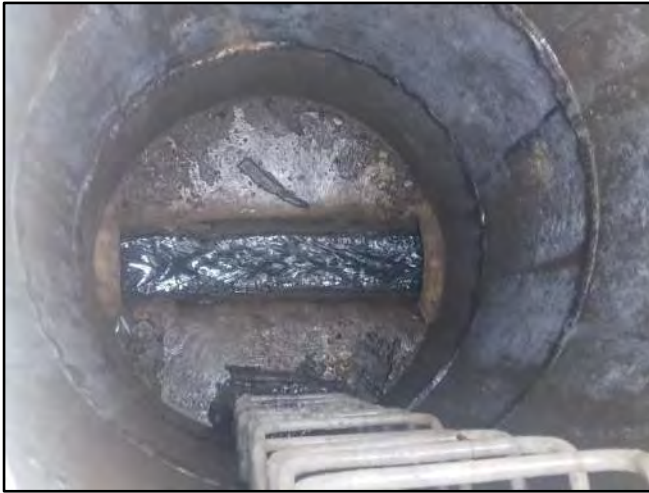
Barrel Sections: Number/Height – 1/24", 2/48" Score – 1

Base: Height – 34" Score – 2

Image 3 – Barrels and Base

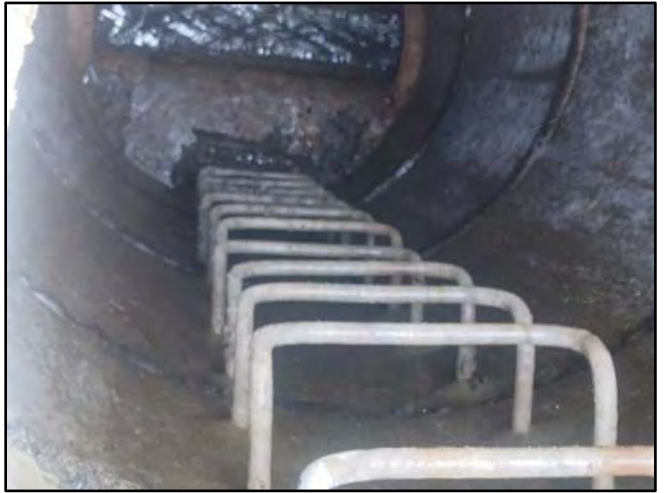
Steps: 12 Type: Metal Score – 1

Image 4 – Steps and Barrels

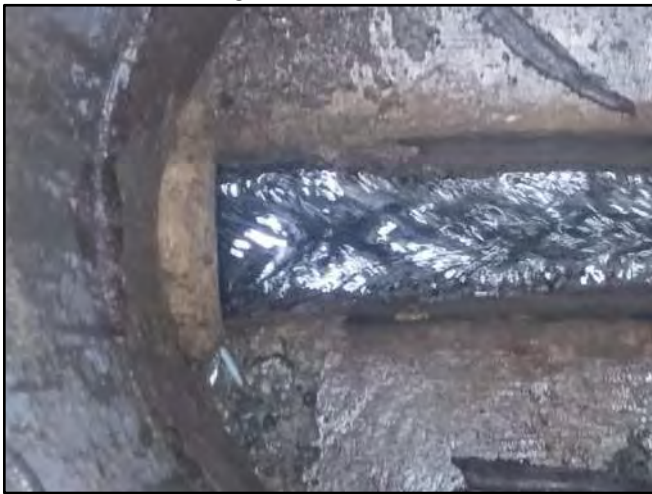
Solid Grouting

Graded score of 1

Image 5 – South Influent Connection

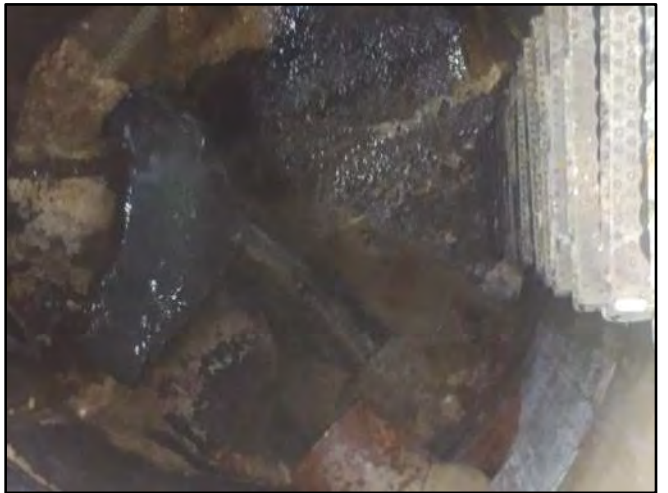
Image 4 – Base & Shelf

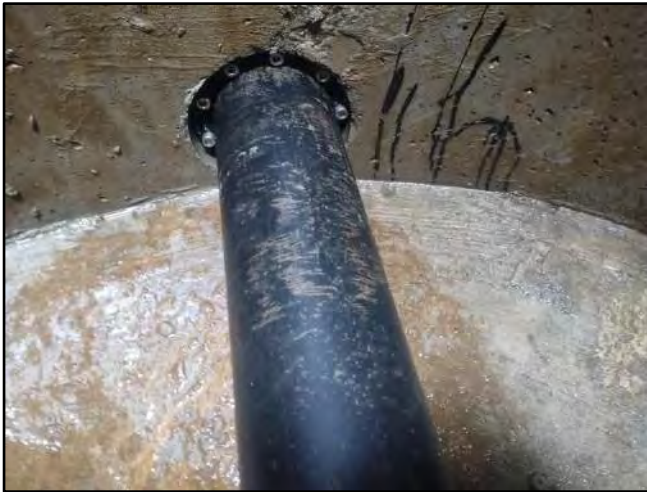
Link seal for PVC should be monitored for infiltration
 Moderate mineralization underneath connection
 Graded score of 2

Image 3 – PVC Connection Link Seal

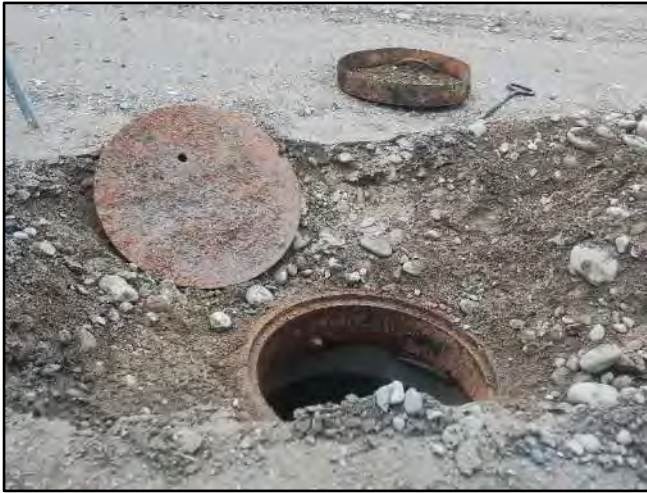
- Pipe dead ends along the West section of the base
- Heavy sediment build-up along the shelf
- Catchpan is bent and semi-unfunctional

Image 3 – Cover, Catchpan, and Frame

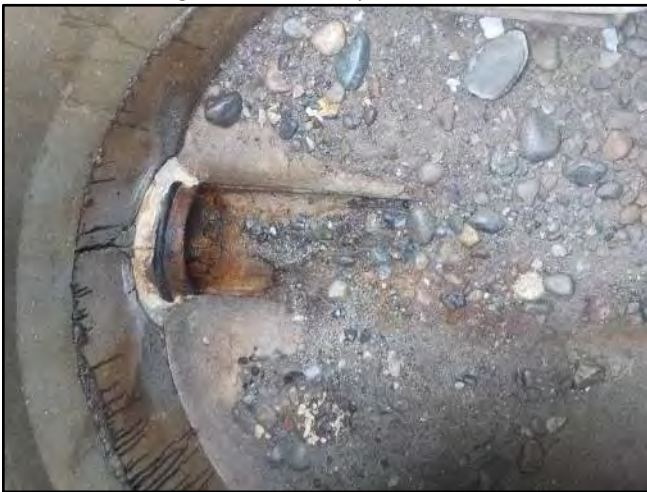
Image 5 – Sediment Build-up

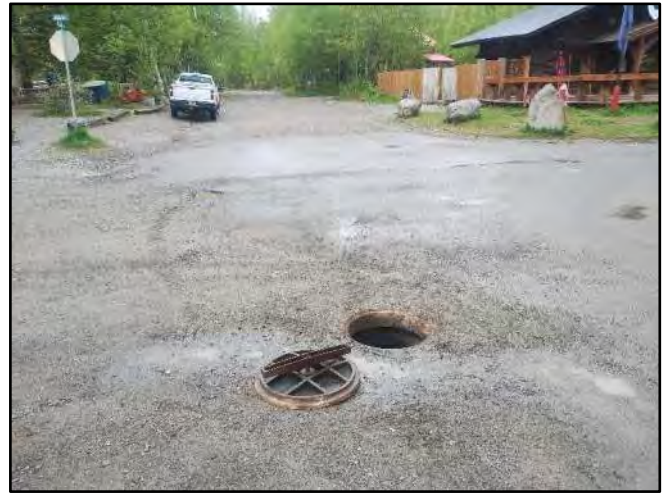
Image 2 – MH facing North along B St

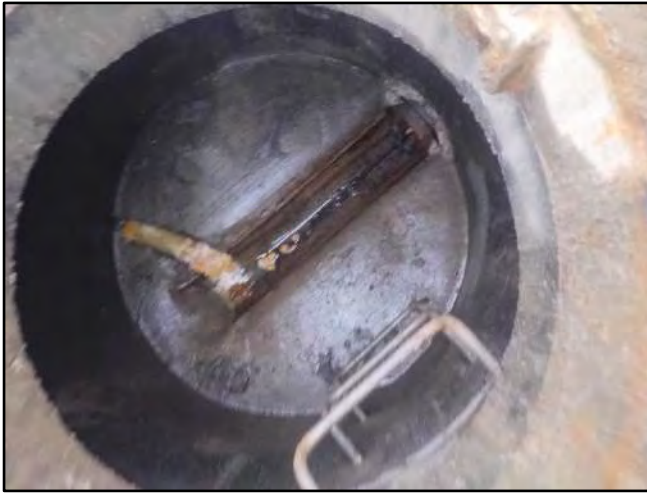
Image 3 –Cone and Base

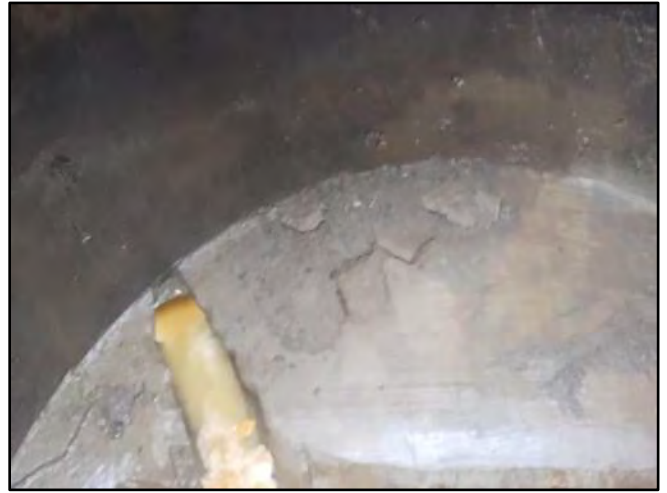
- Shelf has moderate decay/sediment build-up along North edge

Image 4 – Sediment Build-up on Shelf

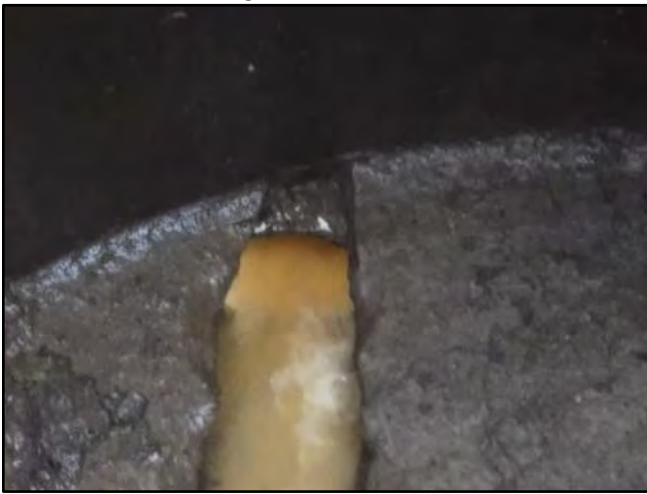
Image 5 – NW PVC Influent

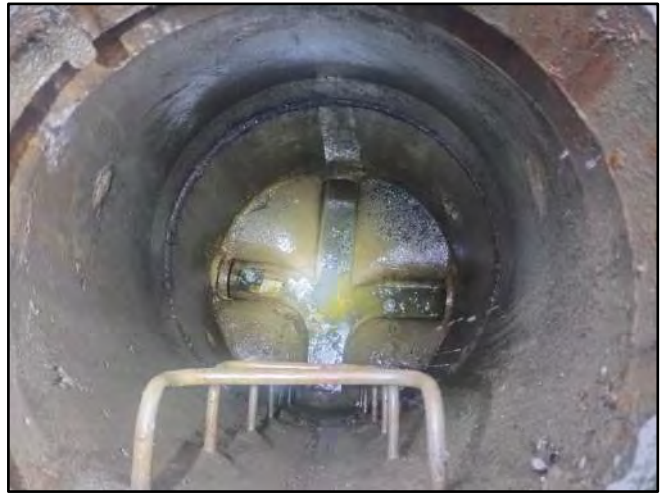
- Small chunks of concrete spalling in some parts of base and cone

Image 2 – Cone and Base

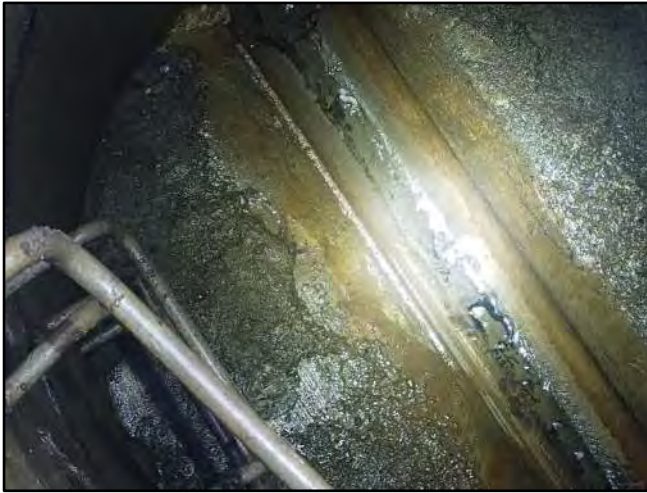
Connection has some grouting missing, gasket exposed

Image 4 – East Influent Connection

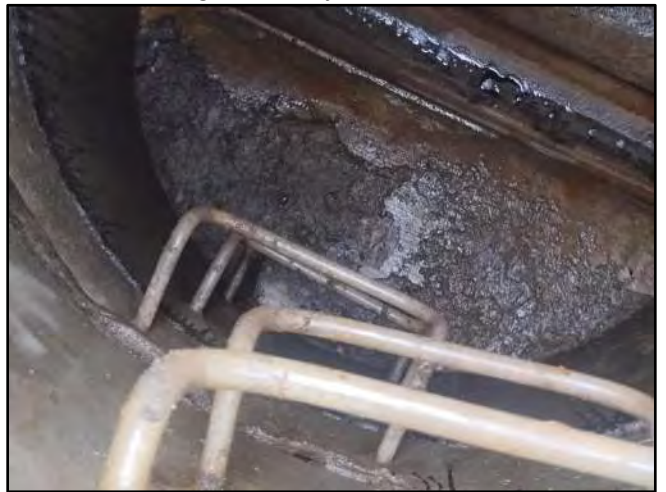
- Some sediment build-up along the shelf of base
- Steps are not in line with one another

Image 6 – Solids Build-up on North Shelf

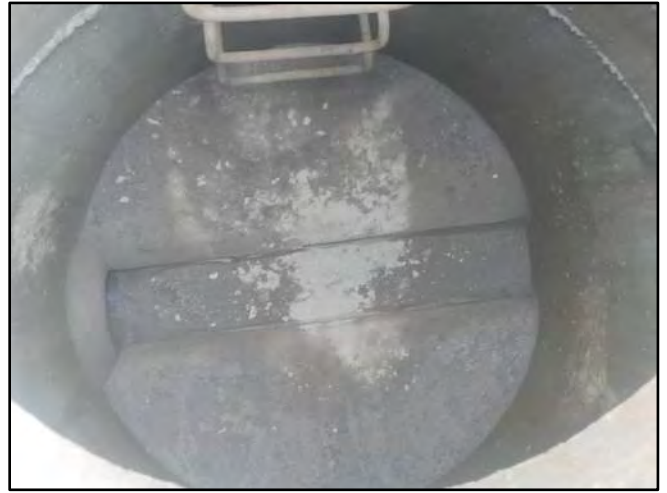
- Pipe ends along South wall in shear wall
- Chimney's grout is experiencing some peeling
- Large amount of sediment in the bottom shelf and invert

Image 4 – Sediment along Base

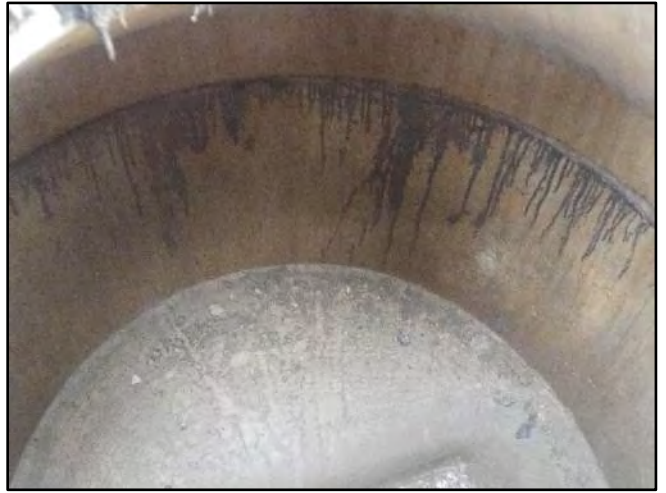
- Pipe dead ends in North section of base
- Water in pipe is static and not directionally moving
- Flowlines descending from cone/base joint
- Significant solids build-up along the shelf

Image 4 – Cone/Base Joint

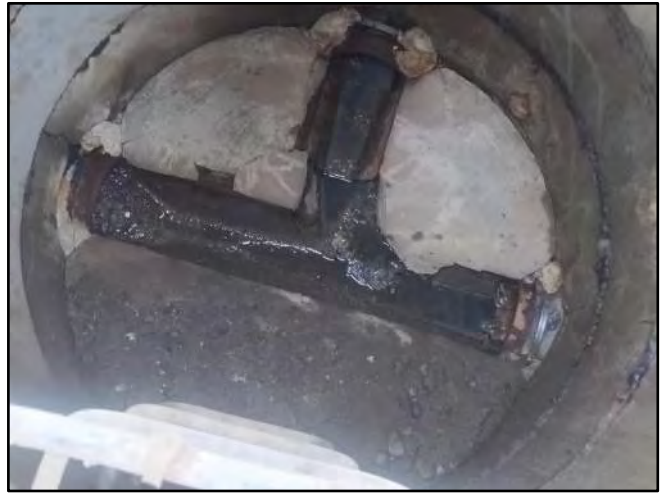
Image 2 – Barrels and Base

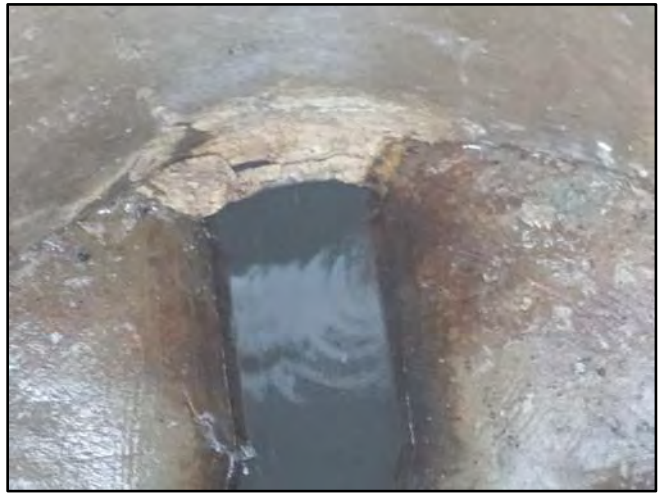
- Infiltration along shelf on the West section of base and East side of North connection
- Runner along the North side of West connection
- Significant crack on South side of West connection

Image 4 – West Influent Connection and Runner

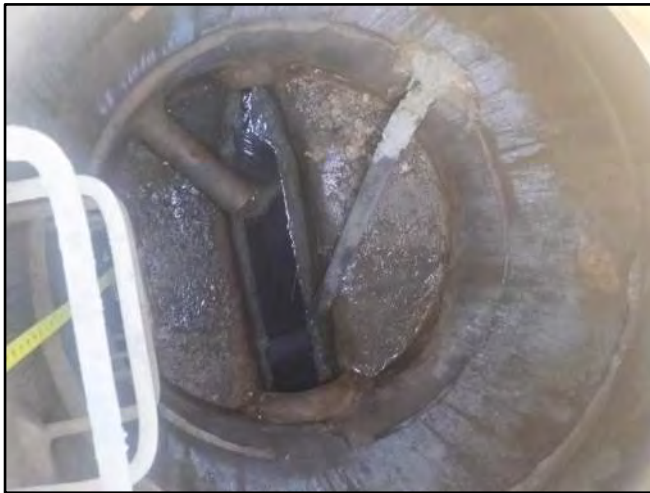
- Pipe expands from 8" to 12" diameter
- Significant cracking along the top of cone and the chimney/cone joint
- Moisture present throughout the base
- Severe wear on the shelf has created lots of loose debris from excess I&I

Image 3 – Barrel and Base

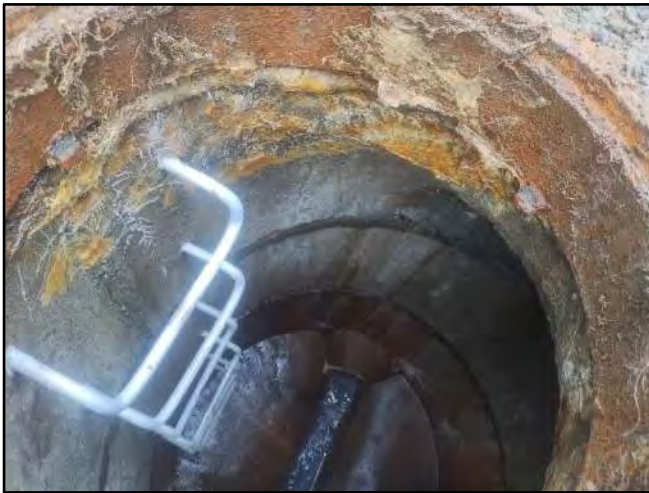
- Most I&I appears to be coming from the joint connecting the barrel and base
- Significant organic/root growth along the cone
- Base is heavily mineralized, especially along East side

Image 3 –Organic Growth along Frame and Cone

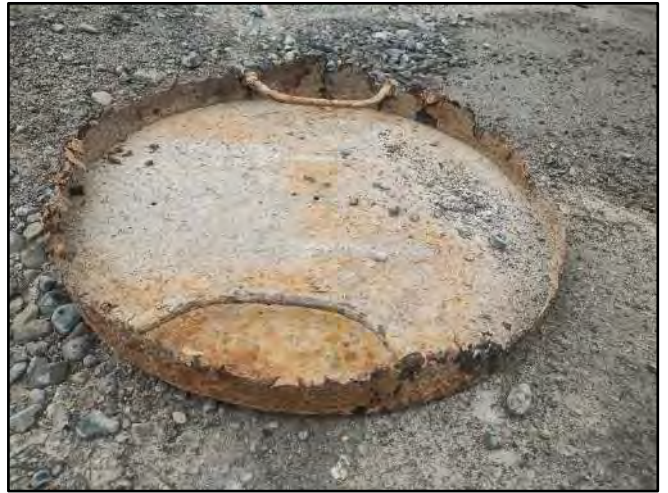
- Catchpan is rusted through and unfunctional
- No influent as North end of pipe ends in shear wall
- Steel bottom missing in invert right before shear wall, allowing I&I runner directly into pipe
- Steel bottom missing in invert directly before effluent connection as well
- Cone/base joint has some gaps, but no obvious mineralization
- All flow reflected in this MH is a product of I&I

Image 2 – Unfunctional Catchpan

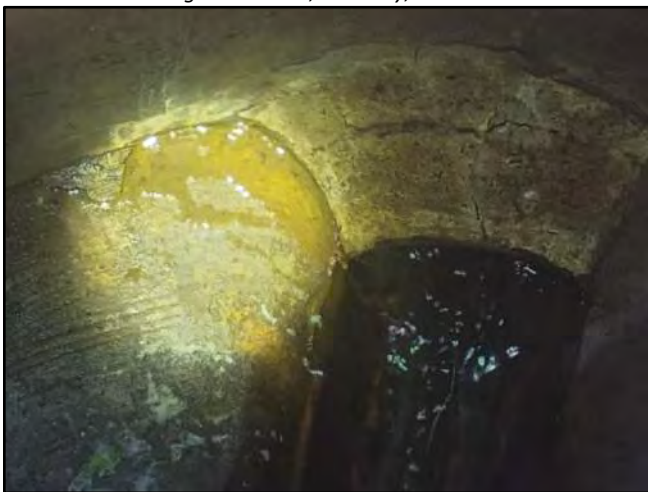
Image 5 – Runner alongside North Connection

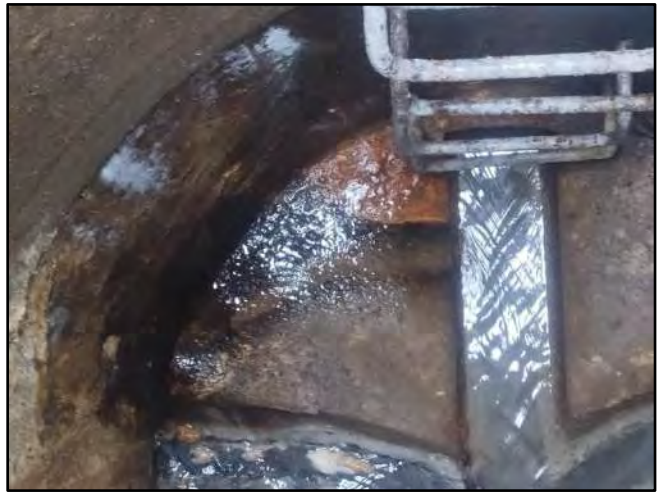
- I&I runners present along Northeast and Southeast section of base/shelf
- Multiple I&I drippers present along East side of base
- General seepage can be seen from cone/base joint around entire circumference

Image 4 – Northeast I&I Runner / Dripper

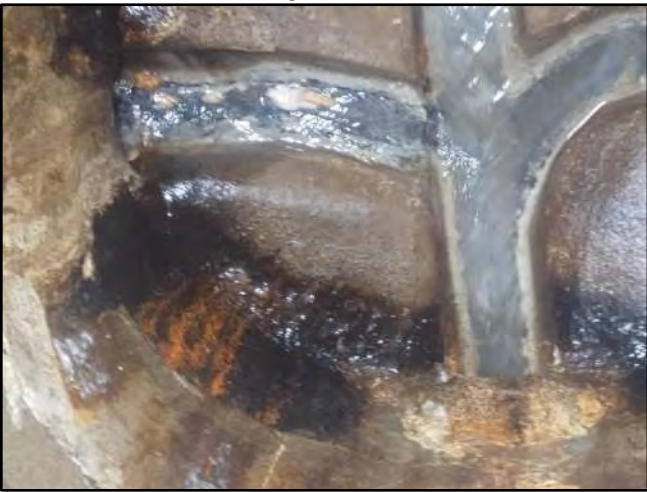
Image 5 – Southeast I&I Runner / Dripper

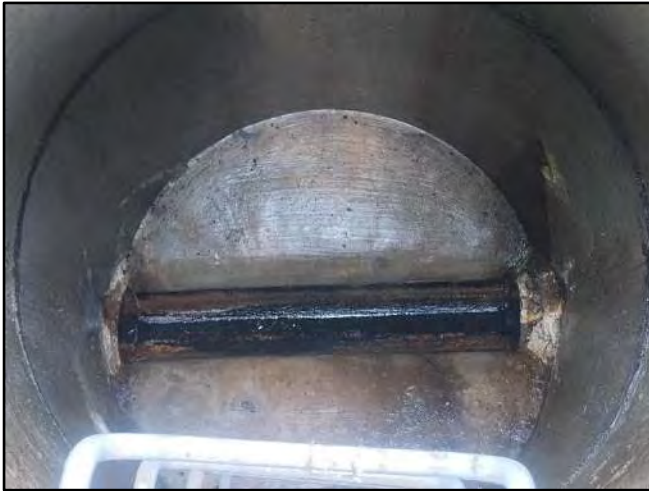
- I&I dripper coming from crack in West side
- Some mineralization present along South shelf

Image 3 – Base

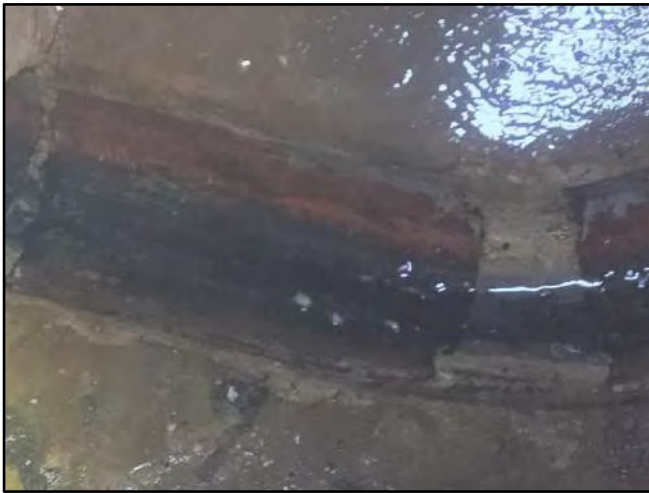
- Steel missing in 2" sections along both ends of invert's connection
- Steel missing in center of pipe for approximately 6"
- Concrete missing along South side of base
- Large amounts of moisture present on shelf

Image 3 – Missing Invert

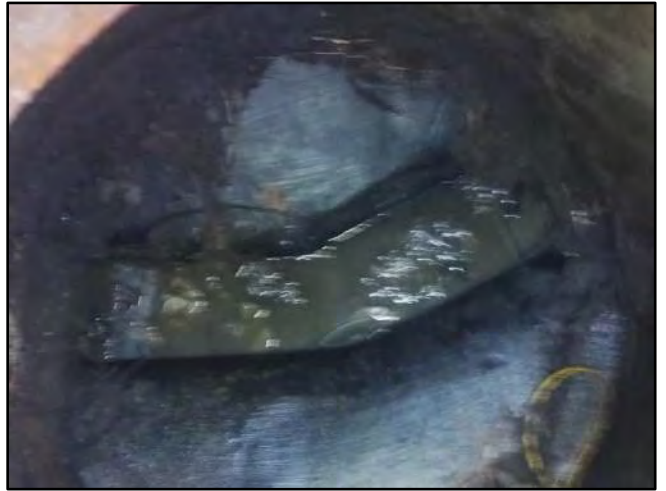
- Water in MH is standing water, no water movement
- Pipe experienced massive sludge clog before cleaning
- Base & connection difficult with remaining debris

Image 4 – Base

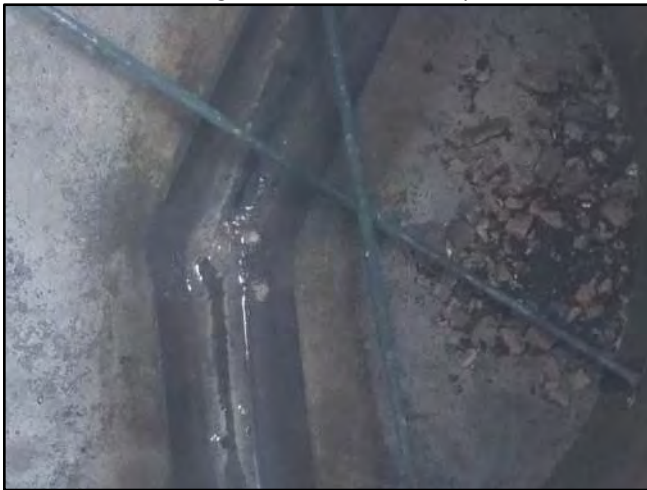
- Sediment present on West shelf

Image 5 – Sediment Build-up on West Shelf

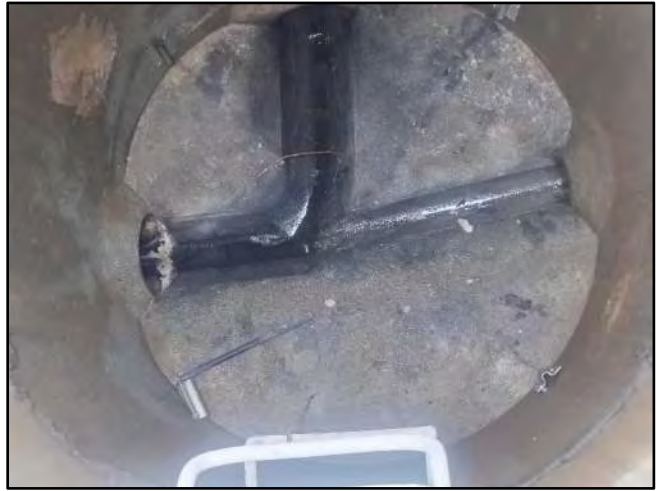
Joint between cone and base shows minor cracking

Image 4 – Base

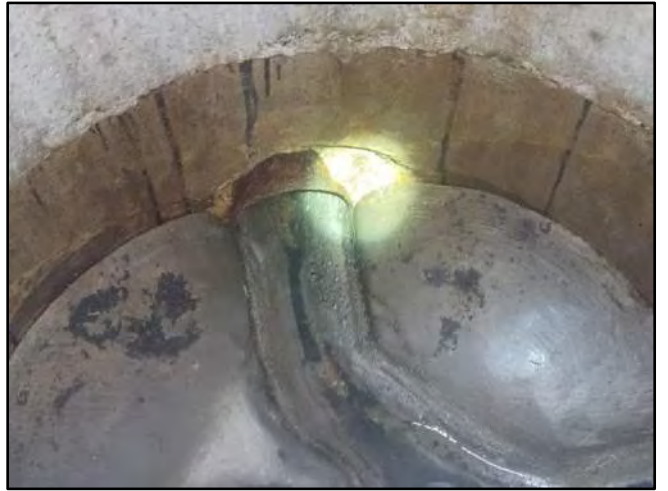
Image 4 – South Influent Connection

2" Depth of concrete missing above South connection
 1" Depth of concrete missing above North connection
 Graded score of 4

- Hairline crack along base that runs half the circumference along the East side (No I&I visible)
- Influent Pipe connections are in very poor shape

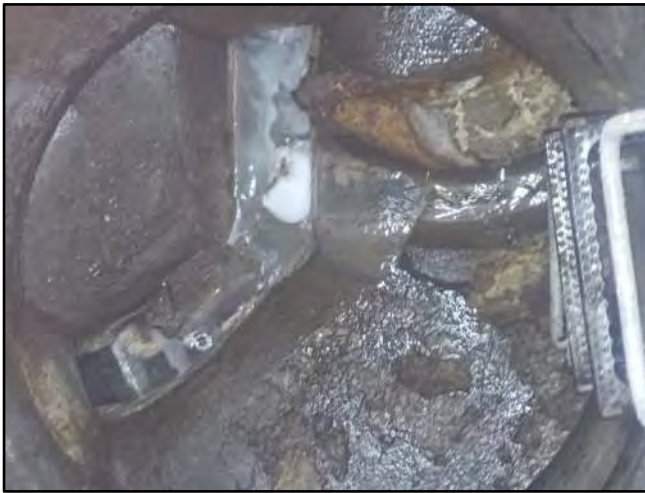
Image 3 – Base

- Shelf missing concrete in several sections
- Concrete shelf extending from North pipe is actively eroding and very soft
- Invert is missing at attachment point from North pipe to main flow, water pooling in exposed concrete
- Moisture and sludge present along shelf, possible I&I but likely from high flows
- Cone's concrete spalling slightly

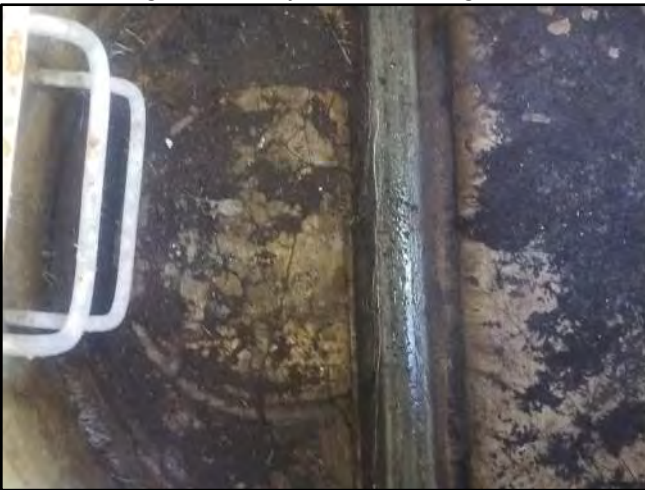
- South part of invert is missing pipe for 1" section
- Joint between cone and base is experiencing root intrusion on several sides
- Soil present along shelf before cleaning

Image 5 – Shelf and Root Intrusion

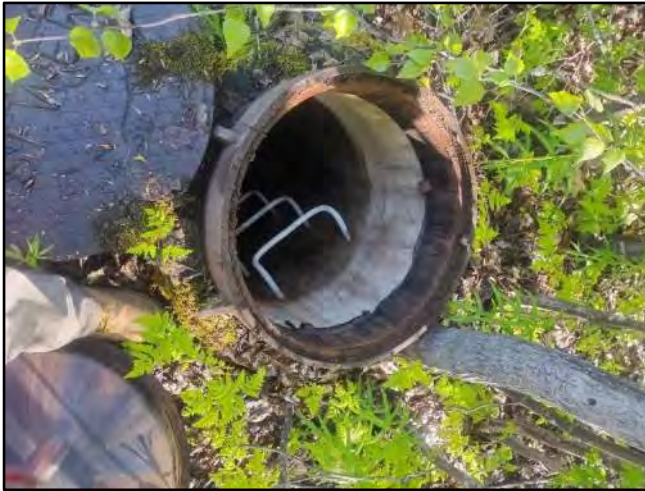
Image 3 – Frame, Chimney, and Cone

- Root & plant growth along East interior of cone, barrel and base, no cracks visible

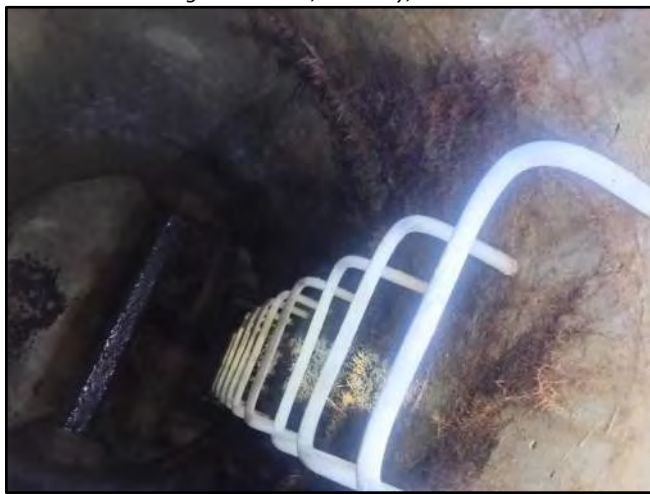
Image 5 – Root Growth on East Cone and Barrel

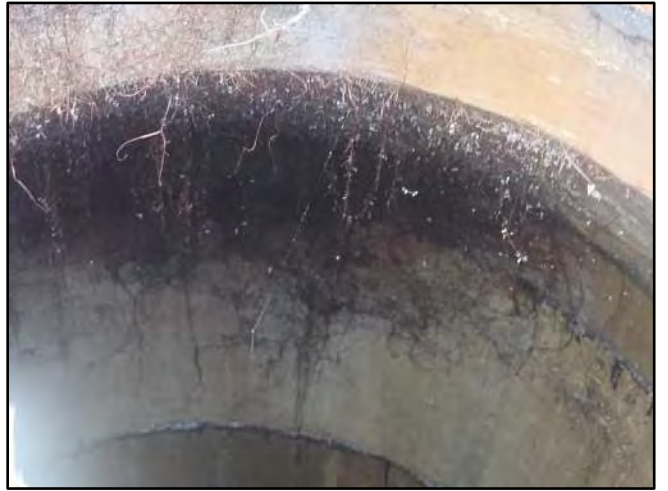
- Extensive plant roots growing along West side of cone
- No evidence of I&I from plant roots
- Missing concrete section along shelf with mineralization present

Image 4 – Root Growth along Cone

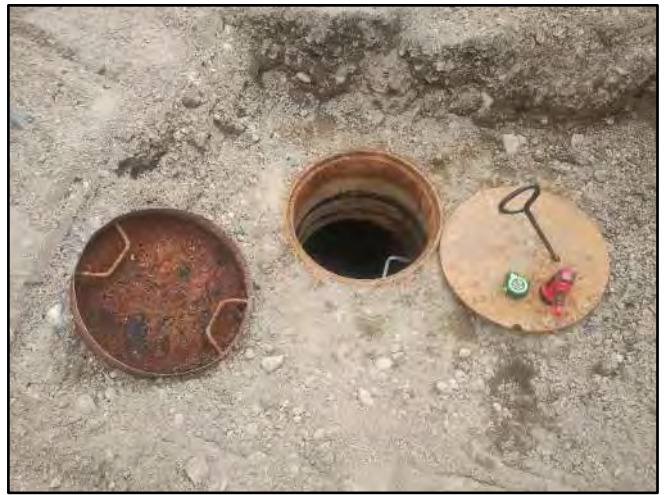
Image 2 – Frame, Lid, and Catchpan

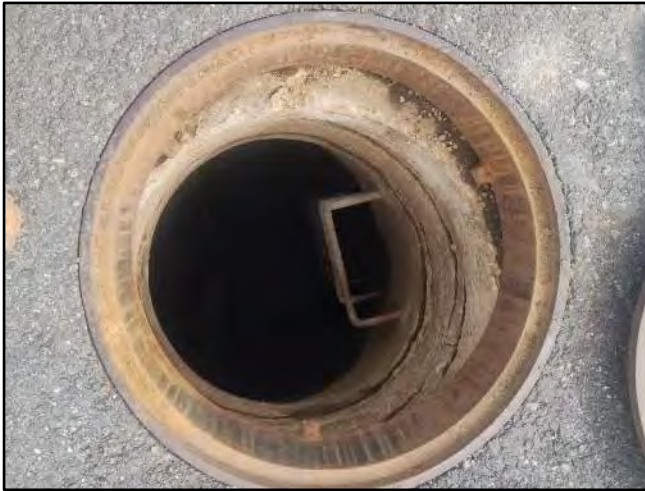
- Frame and chimney are 3" off-center
- Chimney is experiencing significant cracks and wear
- 2 reinforcing bars are present, only 1 is operational

Image 3 – Frame and Chimney Offset

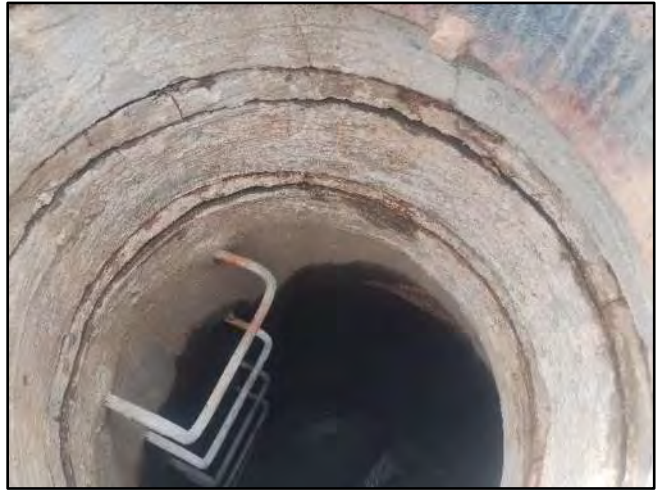
Image 4 – Chimney Cracking

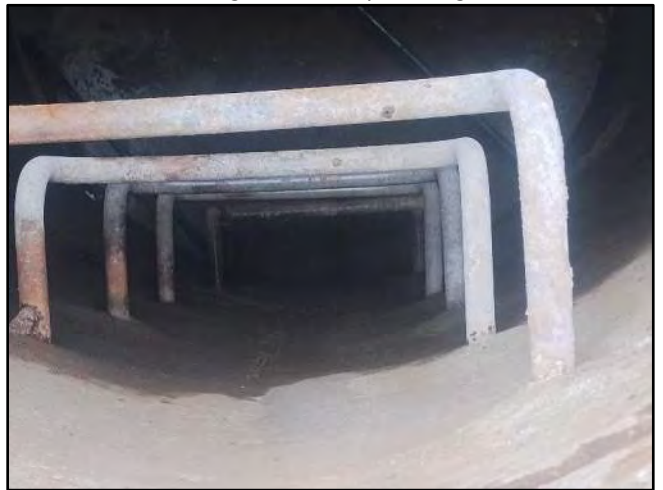
Image 6 – Wear Along Steps
